DAMAGE ASSESSMENT AND DIAGNOSIS FORM

Cloister of St. Clara-a-Nova Monastery – Coimbra, Portugal.

LNEC

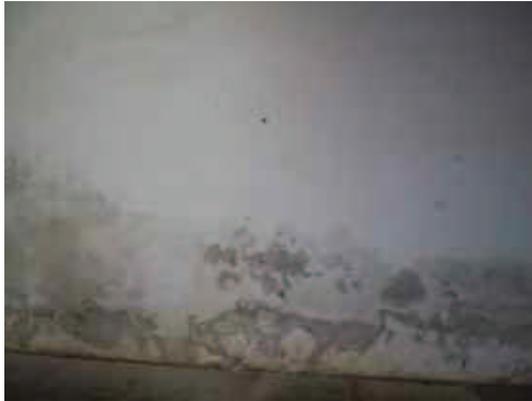
The render/paint system shows very (salt) damaged areas located close to the pavement. The salt damaged areas are associated to the presence of moisture spots. At these areas, detachment of the render superficial coat, as well as sanding of the render and further crumbling of the render/paint system are visible. Detachment of paint is visible at a few places, where the degradation is not yet very severe.

Fig.7 - Cloister gallery: damage of the render/paint system at the base of a wall (2003-11-27)

Replace the damaged cement-based render. Renders of low capillary absorption or low water vapour permeability, which may amplify the effects of the capillary rise, should be avoided. A transporting render seems adequate. Not very strong lime-pozzolana, lime-cement or lime-cement-pozzolana traditional mortars may be used. The constitution materials should have low alkali, sulphate and chloride contents, as well as be sulphate resistant (cement with low aluminates content and aggregates without reactive alumina). These new renders should have a good resistance to cracking.

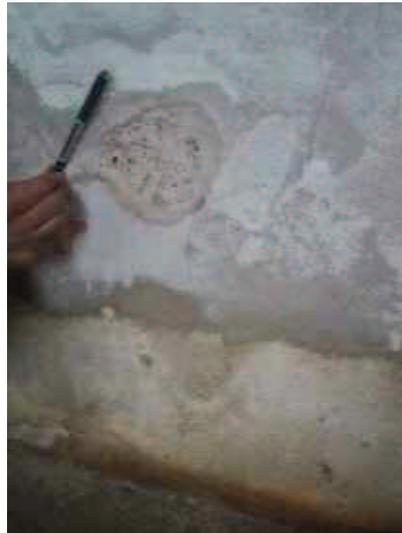
Cracking of render/paint system is especially visible at these moist salt damaged areas (damage of render/paint system seems to start at the cracks), although it can also be seen at other zones that do not present salt damage.

Fig. 8 – Cracking and erosion of the render/paint system (2004-01-08)

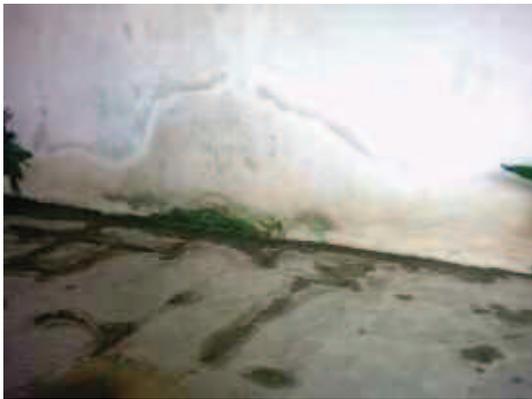
Biological development is present under the form of moss, particularly at the base of the walls.

Fig. 9 – Moss and moisture spots on the base of a wall and on the pavement (2004-02-05)

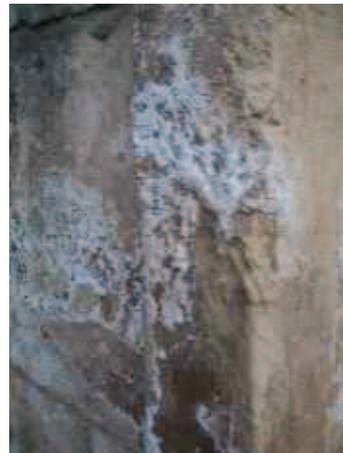
Fig. 10 – Efflorescences on stone (2004-01-08)

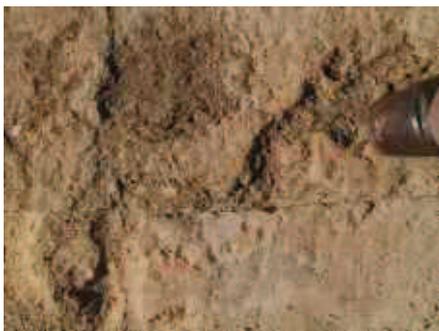
Moisture spots are generalized. Moss is present in many places, mainly on the joints. Many stone plates are eroded. Dispersed efflorescences were observed during one of the inspections.

Fig. 11 – Erosion of stone pavement (2004-02-05)

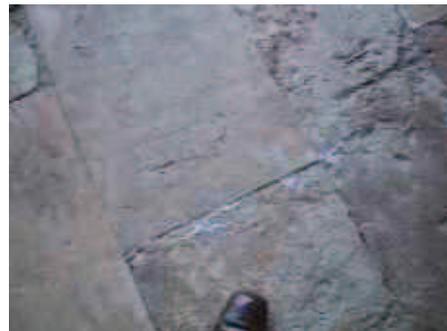
Fig. 12 – Efflorescences on stone pavement (2004-02-05)

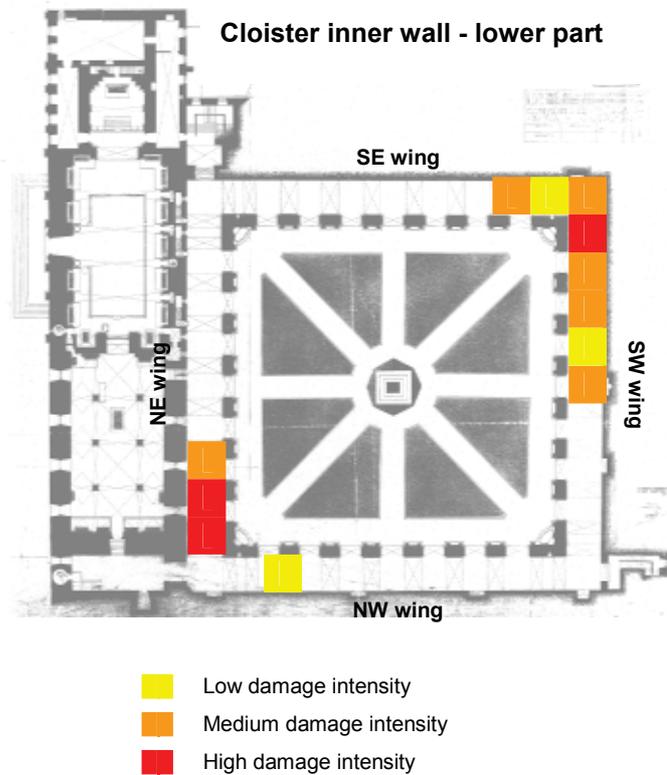
Fig. 13 – Chart of damage intensity on the lower part of the cloister inner wall

The moisture profile of the NE wall clearly shows the rising damp (from the soil or surface water) as the fundamental origin of the moisture at this wall. Visual signs of superficial condensations were also detected but the relevance of this other source of moisture needs further investigation. A direct correlation between the fact that two of the cloister walls are semi-embedded and salt damage intensity was not found (fig 13).

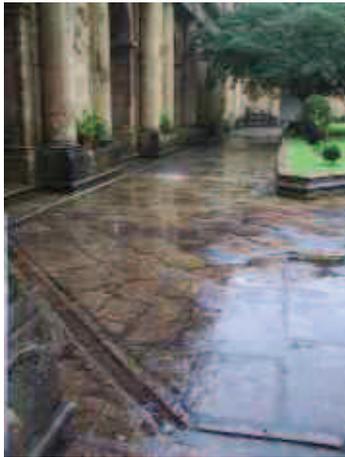
On 2004-01-08, a rainy day, accumulation of water at the cloister garden pavement was seen (fig. 14). This water drains slowly (due to the low slopes of the garden pavement) towards a perimetral gutter and then (also slowly) in the direction of a single drainage point (as shown in fig. 5).

Fig. 14 – Accumulation of water at the cloister garden
(2004-01-08)

Measures may be taken for trying to lower the amount of moisture reaching the base of the walls, namely to improve the drainage of the cloister garden and to prevent the excessive use of water in cleaning operations.

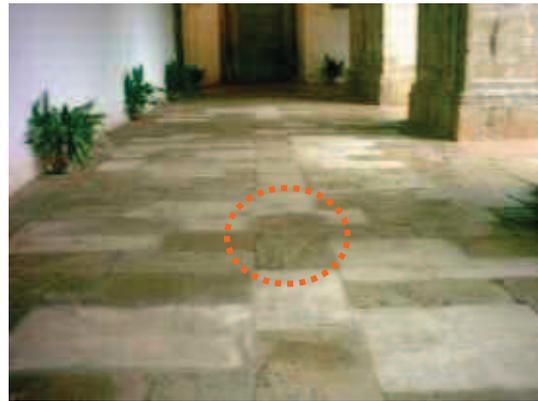
On 2004-02-05, a sunny day that followed several cold rainy days, spots of liquid water were observed on the pavement of the cloister ground floor (fig. 15). This place is protected from the rain, so that leads to the hypothesis of those water spots being due to condensation or rising damp.

Fig. 15 – Liquid water on the vaults and pavement stones
(2004-01-08)

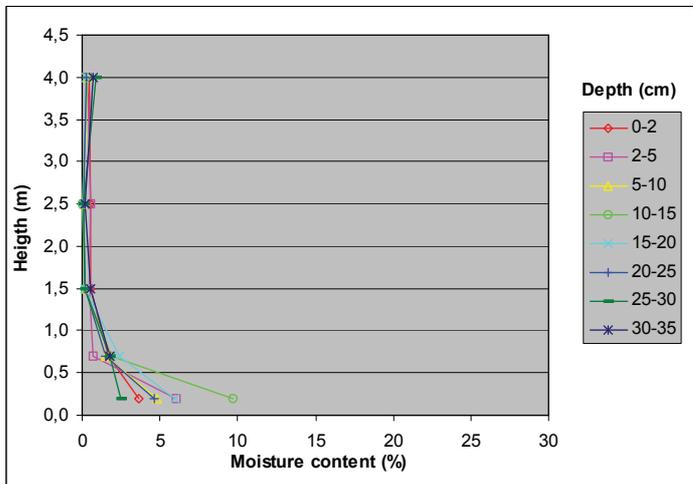
Fig. 16 – Moisture content profile of the NE wall

The maximum measured moisture contents are of 10% at the base of the wall. The rising damp seems to be relevant until a maximum level located between the 0.7 m and the 1.5 m from the pavement. The renders salt damage maximum level is also located around 0.8 m from the pavement.

The present moisture contents due to capillary rise do not seem high enough for justifying the introduction of capillary-cuts at the base of the cloister ancient and very thick walls, as long as renders which may amplify its effects (low capillary absorption or low water vapour permeable renders) are avoided. Therefore, a transporting render should be used.

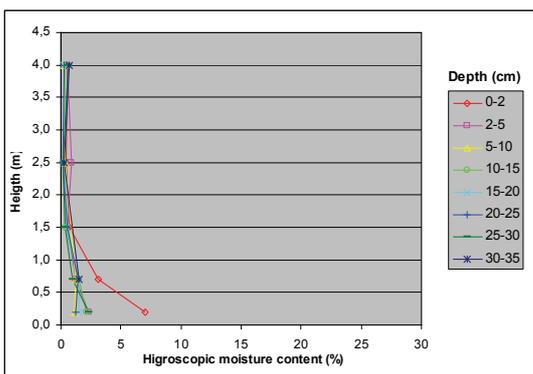
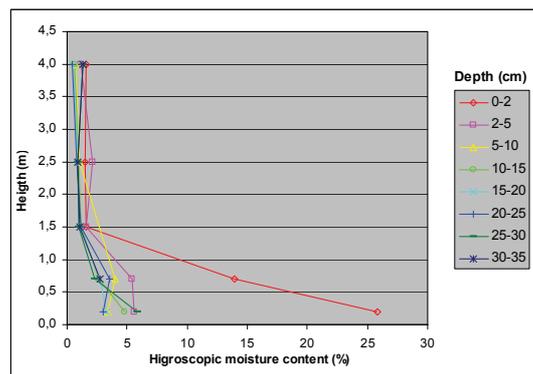
Fig. 18 – NE wall: HMC at 80% (left) and at 95% RH (right)

The HMC profiles in this wall indicate higher salts contents at the base. The ion chromatography analyses also indicate a decreasing content of ions from the base to the top of the wall, with relevant salt contents at 0.2 m and 0.7 m and irrelevant contents at 2.5 m. It is therefore likely that these damaging salts are being carried by the rising damp.

In depth, the maximum HMC was found in the superficial coat 0-2 cm (render).

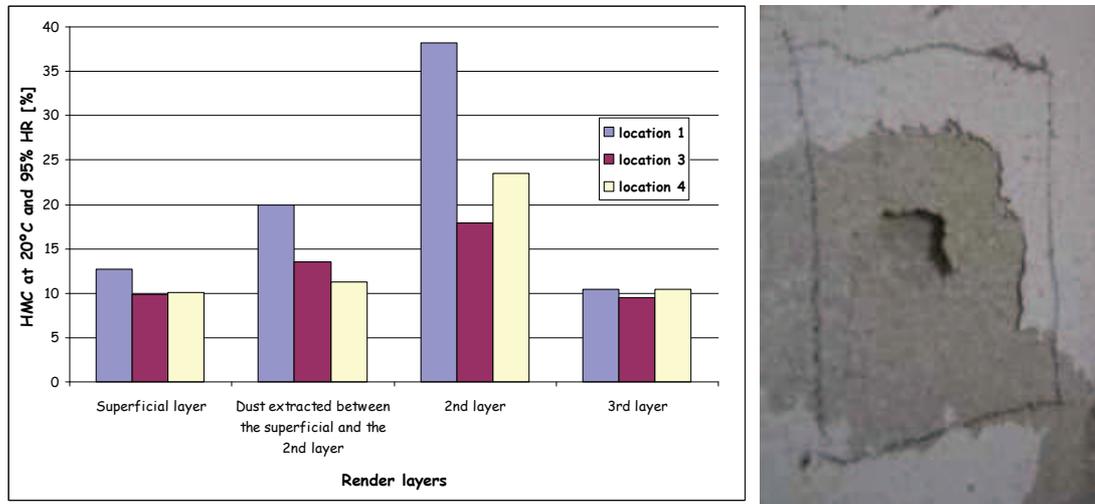
Observation of crossed sections of the render with a binocular glass: the thickness of the detached superficial layer (2 mm) of the render first application coat corresponds to the paint penetration depth

Fig. 19 –HMC at 95% of different layers of the render (left) and picture of one of the sampled areas showing the different layers (right)

The penetration of paint particles seems to give different hydric characteristics to the render superficial layer (around 2 mm thick). The salts preferentially crystallize beneath this superficial layer, making it to detach. The damage then progresses in depth, with sanding of the underlying render.

A paint with high adherence to the support, high vapour permeability and high capillary absorption should be used.
