An experimental approach to the treatment and consolidation of degraded timber elements from a XIX century building

Dulce Franco Henriques¹, Lina Nunes², Jorge de Brito³

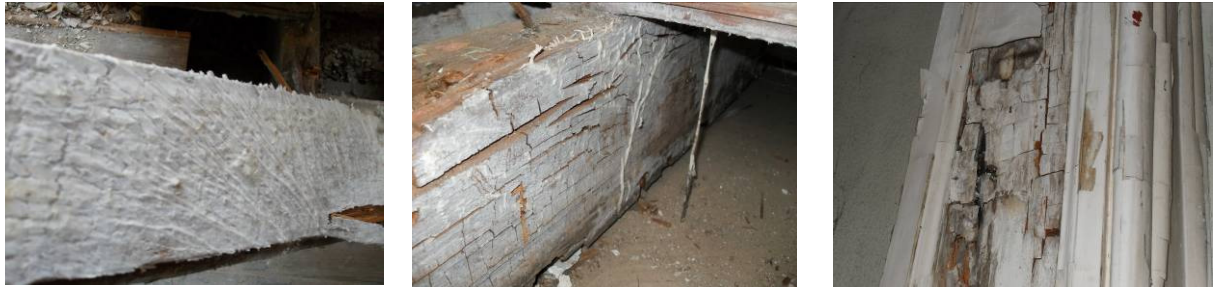
The building has been vacant since 2003 but remains in a reasonable conservation state. In terms of the timber elements condition some disperse and superficial degradation by wood-worm can be found as well as some fungal degradation in specific areas. This particular degradation results mainly from water leakage points in the roof and façades and also from the rupture of a pipe from the domestic water system.

Figure 2 – Details of rotted timber *in situ*.

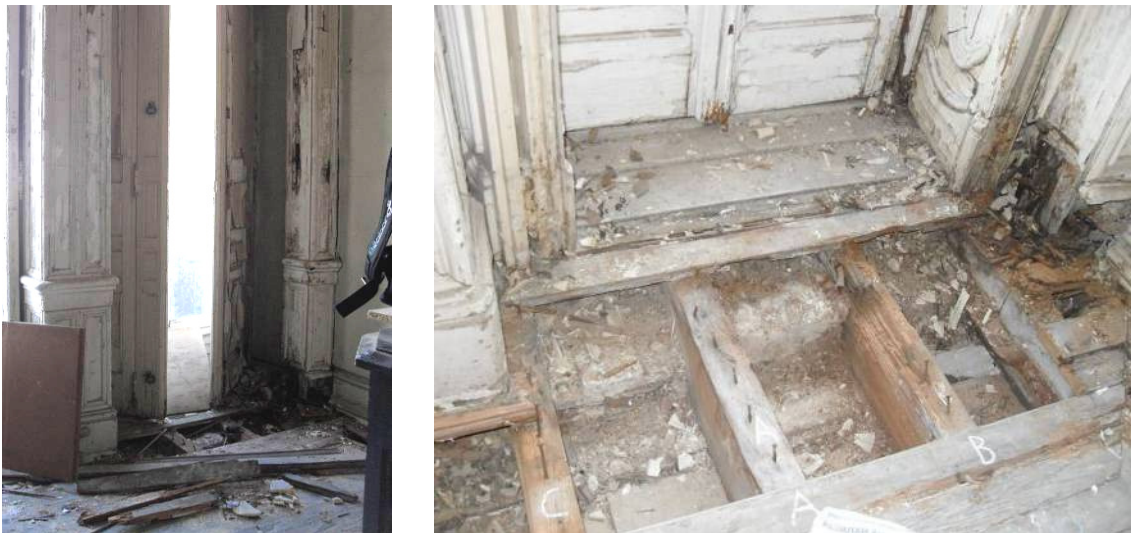
Figure 4 – Pavement1 – Location of the floor beams where treatment and consolidation was conducted.

Area located near one of the many exterior windows (Figure 4). The probable cause of degradation (cubic rot) was the deficient performance of the window and consequent water entry. These anomalies have been repaired and the moisture content of the timber seems to be stable again. To gain access to the three tested beams some floor boards had to be removed.

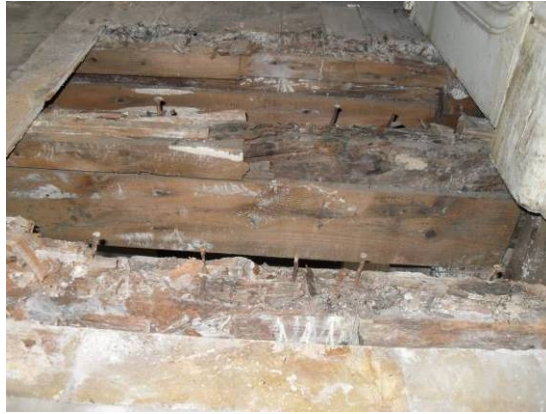
Figure 5 – Pavement2 - Location of the floor beams where treatment and consolidation was conducted.

Interior area of the building used for sometime as bathroom but lately adapted to storage room. The wooden floor had a vinyl cover. Due to the use as bathroom and the vinyl layer that kept moisture in the wood, the floor beams were either degraded or severely degraded (cubic rot). Only two beams were tested as it was not possible to identify an element that could be considered as sound (Figure 5).

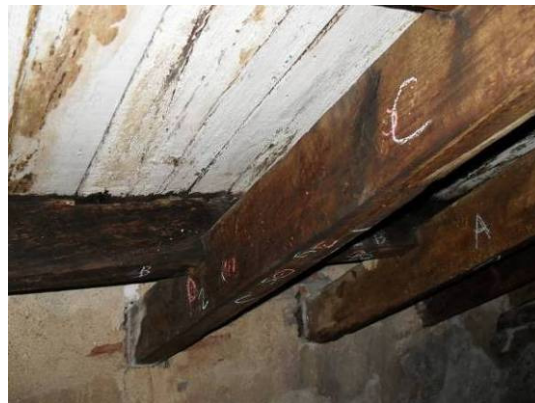
Figure 6 – Roof - Location of the roof beams where treatment and consolidation was conducted. (A) “low” degradation; (B) “high” degradation and (C) sound

The third area identified (Figure 6) was in the roof and was circumstantially exposed to water leakage due to the blockage of the exterior water drainage system. The incoming water problem was solved and the elements were again dry and stable though showing some degradation (cubic rot).

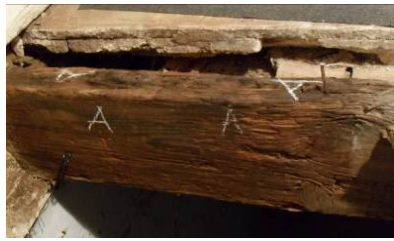
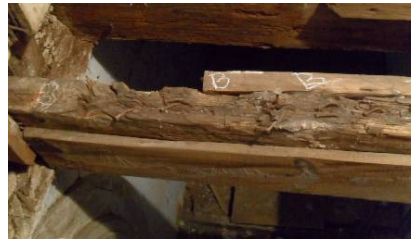
Table 2 – Pavement2 - Physical and mechanical measurements of beams A and B

Both tested beams showed by visual inspection a higher degree of degradation than the ones of pavement 1 and that was supported by the NDT measurements.

In the case of Beam A, the consolidation had a clear positive impact as shown by the high increase in the resistographic measurement.
