VALTORNO-MOURÃO DAM. REINFORCEMENT OF THE FOUNDATION GROUT DUE TO COMPLICATIONS DURING FIRST FILLING

João Marcelino*, Manuel Romeiro¹, José Boal Paixão²

Keywords: Embankment dam, first filling, grouting

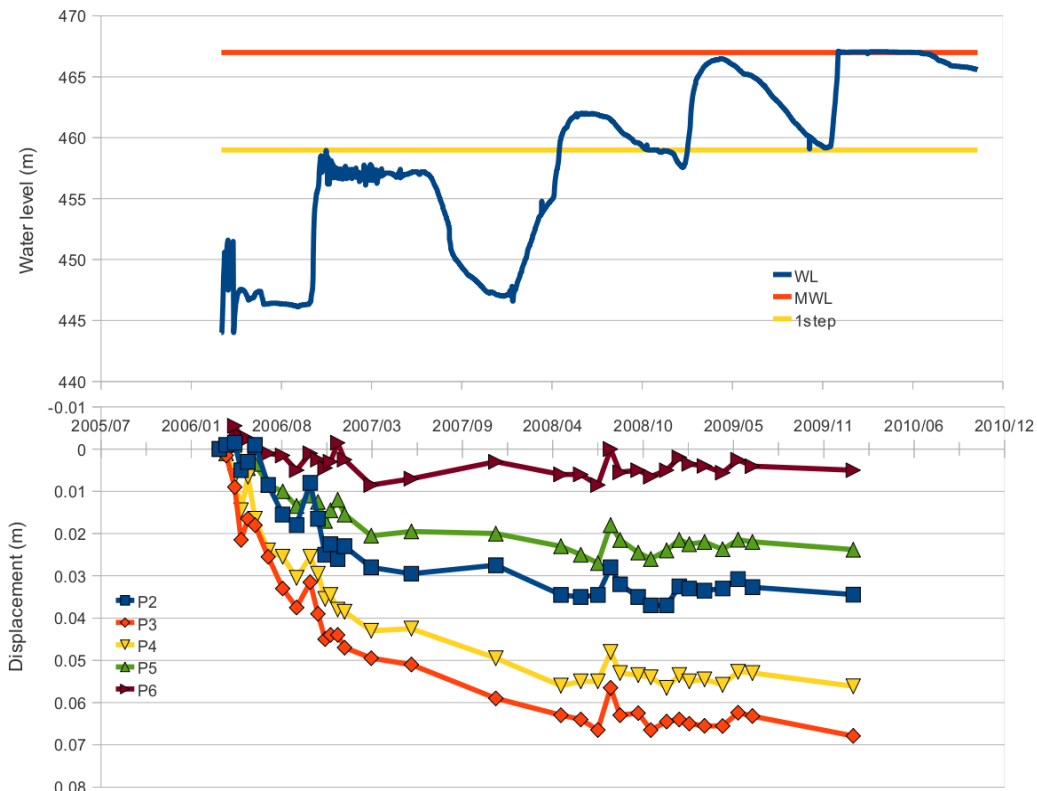
Figure 4: Water level and crest displacement records

2006, giving an average rise of the water level of 22 cm per day (Figure 4).

The displacement records at that time were quite normal. The maximum settlement was recorded at the cross-section P3, which at the time was about 5 cm. This value was inside the expected range.

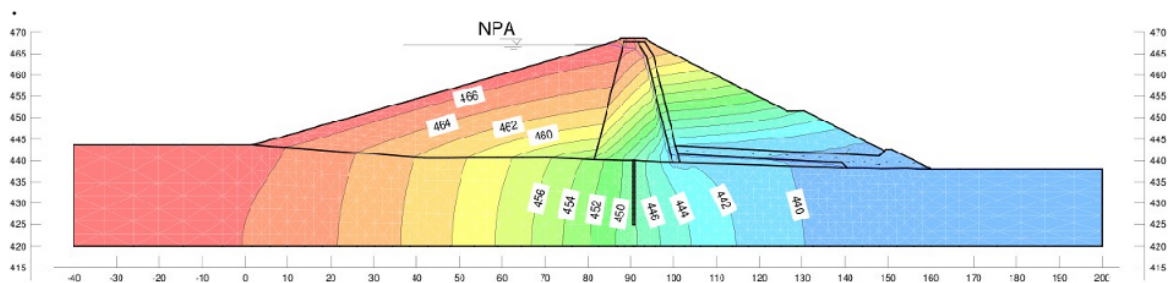
Figure 5: FEM model results (equipotential lines)

On the other hand, seepage flow recorded at the dam's toe was much higher than expected. According to the FEM model established in the monitoring plan (Figure 5), the total flow to the maximum water level, should be about 2.6 l/s. Instead, values recorded were up to 10 times this value.

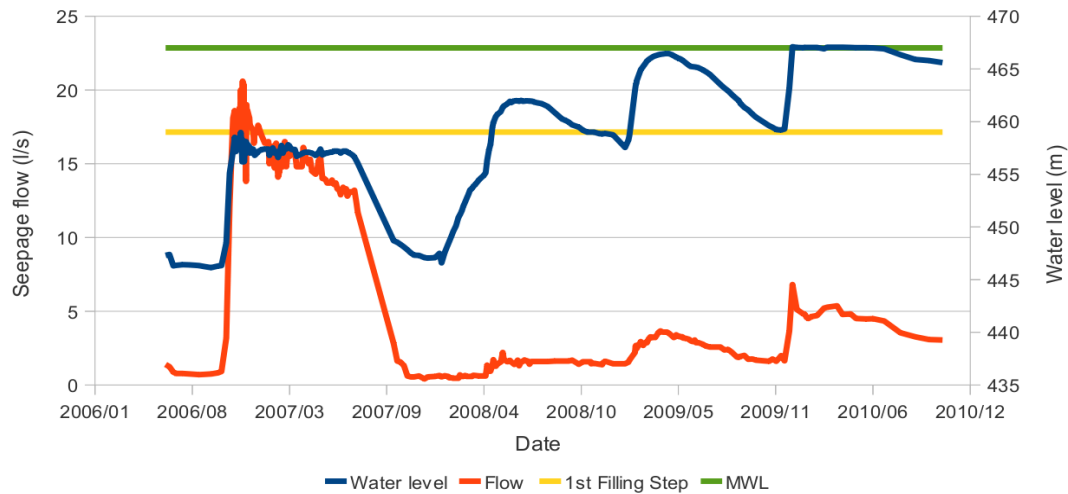
Figure 6: Water level and seepage flow against date

Figure 6 plots the reservoir's water level and the measured flows against the date. As can be seen from the figure, the flow rates recorded in December 2006 and January 2007 were even higher than 20 l/s, but for the first filling step instead than at the MWL as forecasted by the model.

According to this model, the forecast for the MWL is (perhaps optimistically) roughly 30 l/s. This situation posed two serious issues. The first was safety-related, because with that amount of flow the dam foundations could experience erosion problems. The other issue was related to the storage itself. According to the figures, with no indraught, the reservoir would lose almost all of the stored water in one year time.

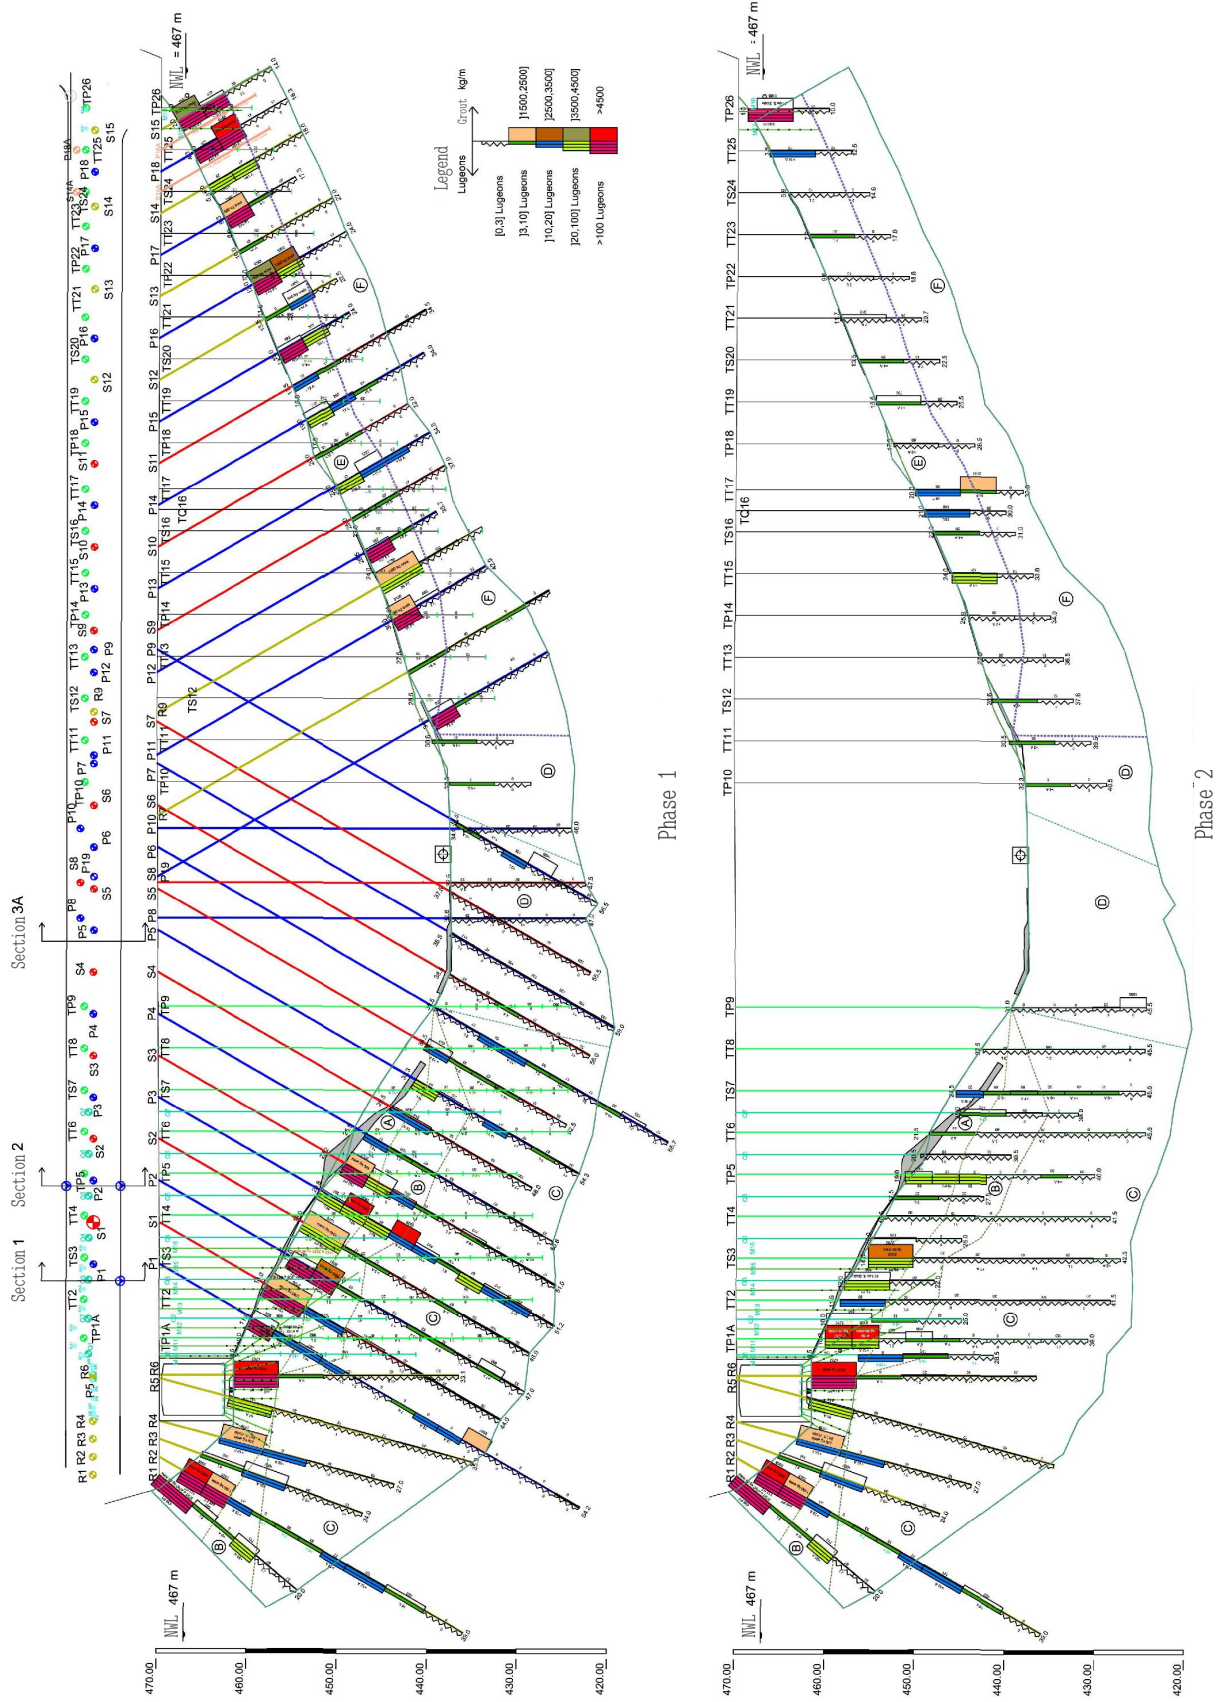
Figure 7: Results of the waterproofing reinforcement injections, 1st and 2nd phases

The treatment by injection of the curtain in the dam's foundations was carried out over 170 m of length, between the right and left abutments, with a height ranging between 15 m at the bottom of the valley and left abutment and 30 m on the right abutment. The total area of the curtain created by this treatment was 3200 m², including the area under the spillway (Figure 7).

The most permeable zones, where higher intakes of cement were observed and/or it was difficult to achieve the prescribed pressure or refusal, were zones A and E and, to a lesser extent, zone B, totalling 30% of the curtain. The remaining 70% was related to zones C, D and F, with low to moderate permeability, but with high grout consumption, which includes the lower horizon of the curtain, and corresponded to about 30% of the overall treated area.

The injections were made by the successive approximations method. Initially the treatment consisted of injections via the primary and secondary holes provided for in the project and still some holes to the reinforcement of the abutments, where a lot of uncompressed solid rock with open joints was detected.

Given the difficulties in obtaining refusal and the high consumption of cement, resulting from the poor quality of the rock foundation, it was decided to continue treatment with a second phase of injections with tertiary and quaternary holes in the most critical zones, near contact with embankments and those identified by the geotechnical zoning.

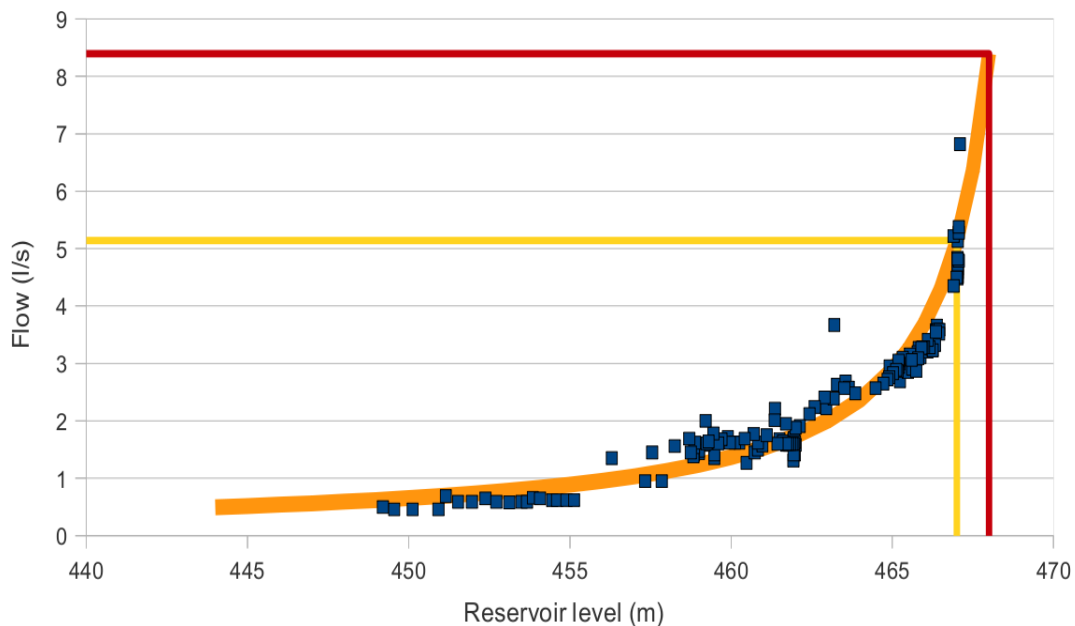
Figure 8: Valtorno dam seepage flow measurements and model

Figure 8 presents all the readings taken following treatment and the attempts to adjust the model with the hyperbolic progress data available. The curve obtained can be expressed by the equation:

According to the variations observed in the flows, as a result of the water level in the reservoir, it seems that for the higher levels, the existing cracks in the foundation opened allowing the passage of a higher flow rate, and outpacing a linear relationship between the two quantities. For lower levels, the proportion seemed to remain the same.

According to the results obtained, it seems that although the foundation treatment of the Valtorno dam may be considered successful, its behaviour at higher reservoir levels is still of some concern. The type of behaviour observed suggests that the flow significantly increases with a rise in reservoir level. This possibly means that some joints open with the increased pressure, thus increasing the water flow.
