# The erosion of granite surfaces. The Cathedral of Évora as example

D. Costa

*National Laboratory for Civil Engineering (LNEC), Lisbon, Portugal*

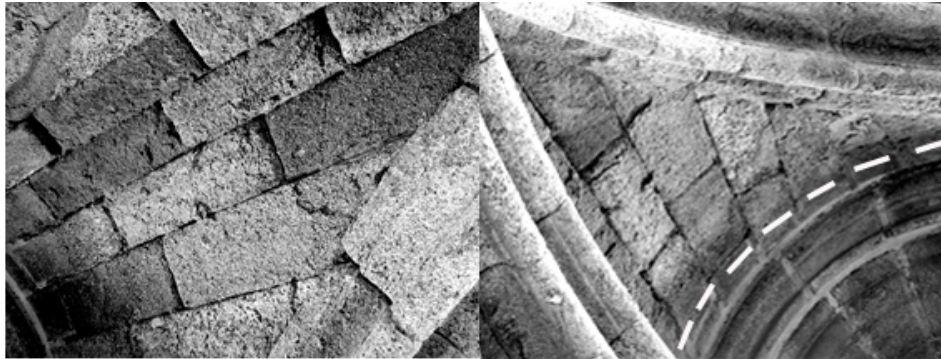
One of the most significant places in the monument is the lantern tower (zimbório). The interior surface is particularly critical concerning the erosion. The extensive rainwater infiltration is the major source of moisture. Incompatible materials widely used here, particularly cement-based mortars, are also important onsite decay factors. Originally, the masonry was covered by renders and a calcitic mortar was used to mimic the limits of the blocks. Meanwhile, the erosion partially removed the render and the blocks are now uncovered in large areas. Figure 2 illus-

trates the weathering of the granitic masonry in a place where the stone is now mostly uncovered.

Figure 2. Extensive sand disintegration and erosion in the internal vault. The render is preserved on the right (zone delimited by dashed line).

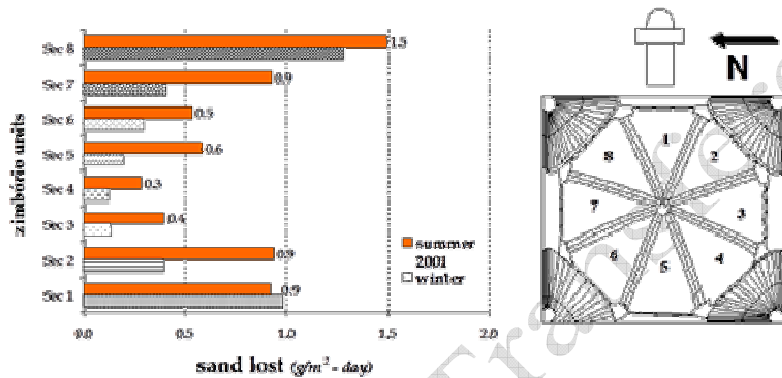
Taking as an example one of the periods monitored (the year 2001), very high material loss were determined in some sectors, reaching  $1.5 \text{ g/m}^2 / \text{day}$  during the summer period. In the areas where the render is still partially preserved ("sec 3", "sec 4", "sec 5" or "sec 6" in Figure 3), the quantity of detached material is lower, around  $0.3\text{-}0.6 \text{ g/m}^2 / \text{day}$ . Consistently, the quantity of material detached during the winter is lower than in the summer.

Figure 3. Erosion rates determined for the different sectors of the zimbório internal vault.

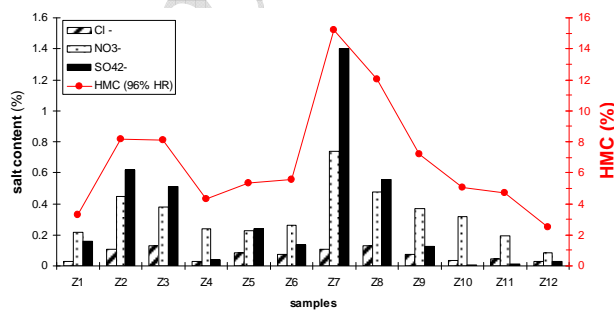
Figure 4. Evaluation of the salt content in decayed granitic samples from the zimbório; hygroscopic moisture content determined at 96% RH (HMC, line) and soluble salts (anions) determined by IC (bars).

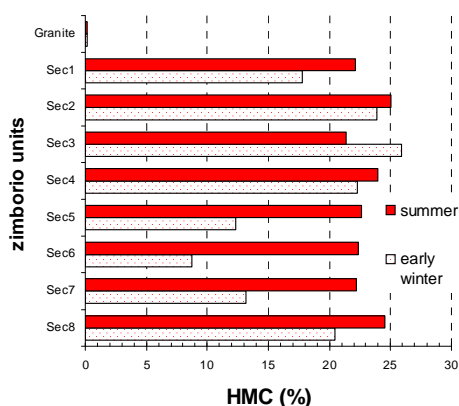
Figure 5. Hygroscopic moisture content (HMC) of debris collected in summer and winter of 2001.

The hygroscopic moisture content of the debris (Figure 5 shows some results) confirms the high amount of hygroscopic salts present as subflorescences (up to 3-4%, in the summer).
