Case-studies in plastering and rendering mortars. Sampling and testing for salts

Teresa Diaz Gonçalves

Lecture contents

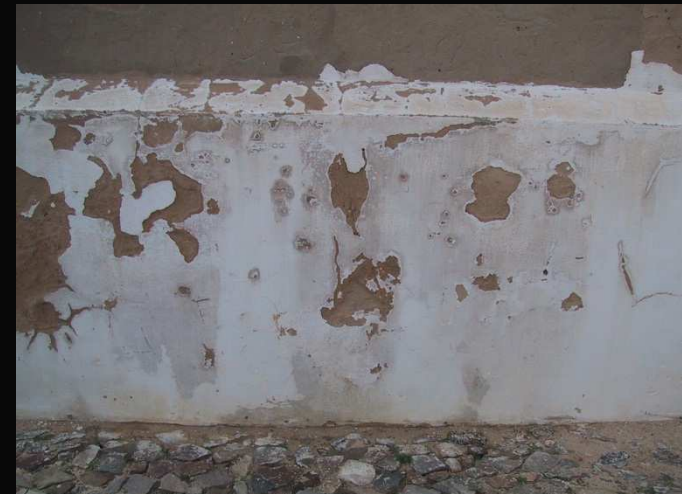
Damage (2004):

- cracking, sanding of the render, erosion
- 60% of the surface damaged
- reached more than 4 m height
- mainly at the walls middle height

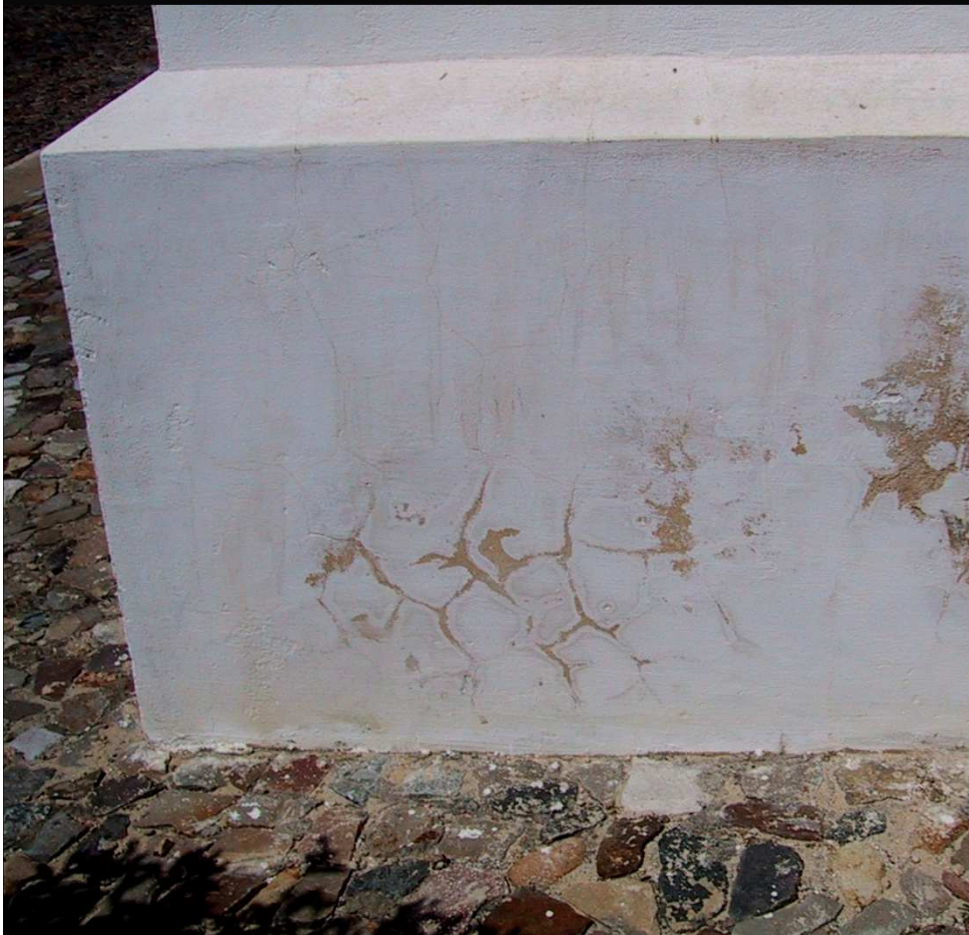
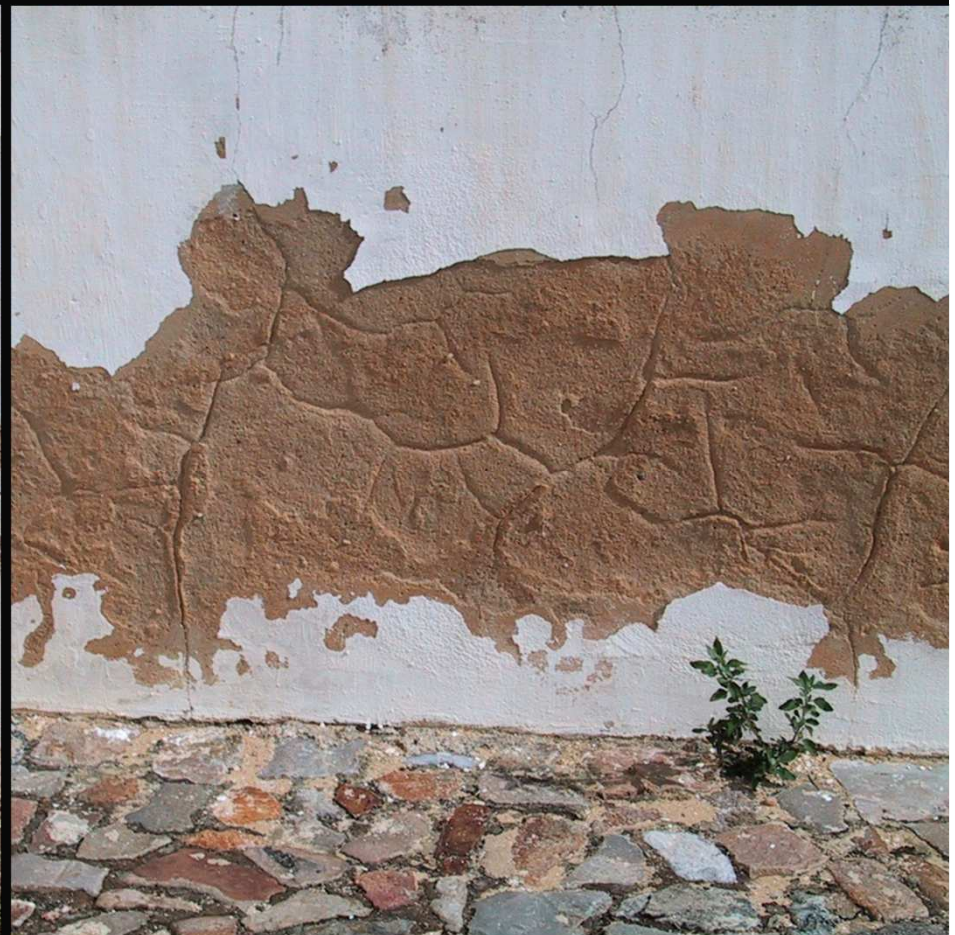
NE (rear) façade

damage seems to start at the cracks ...

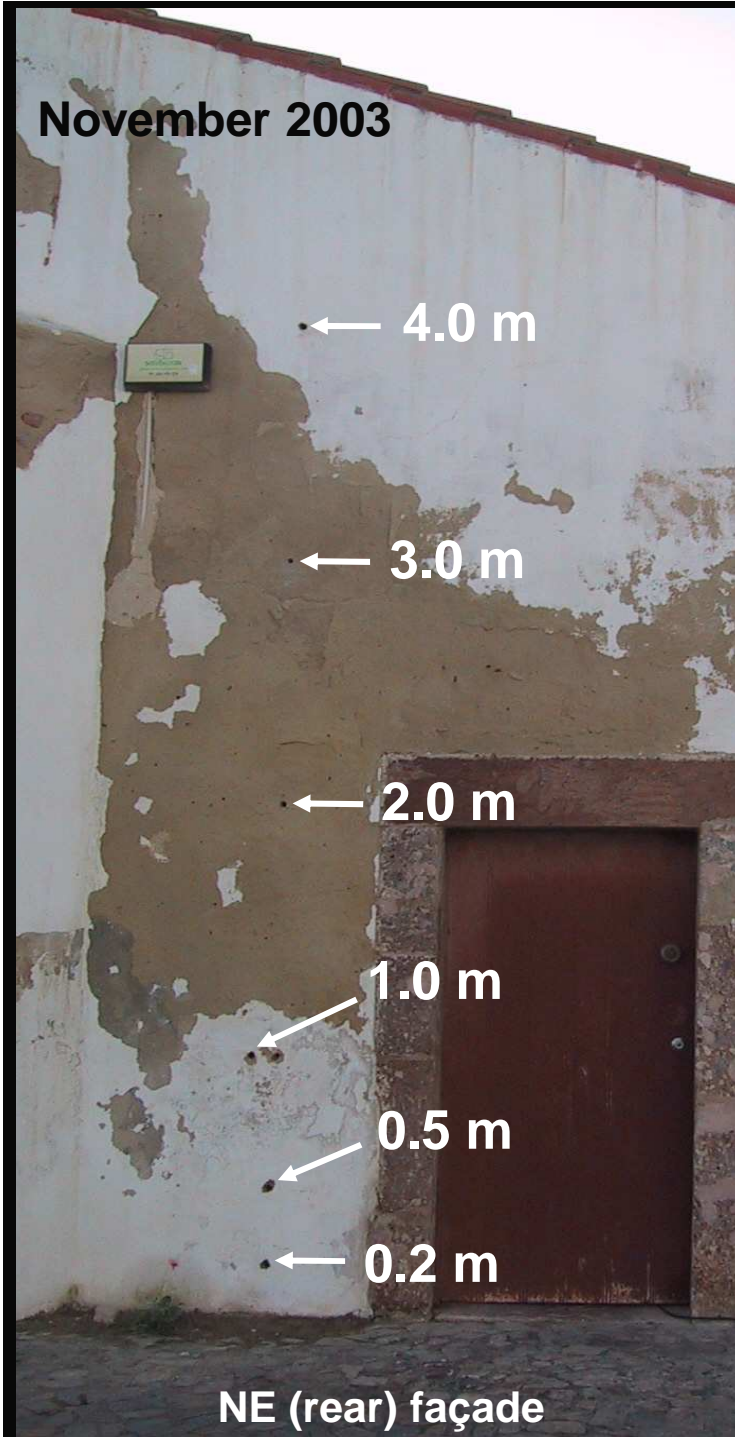
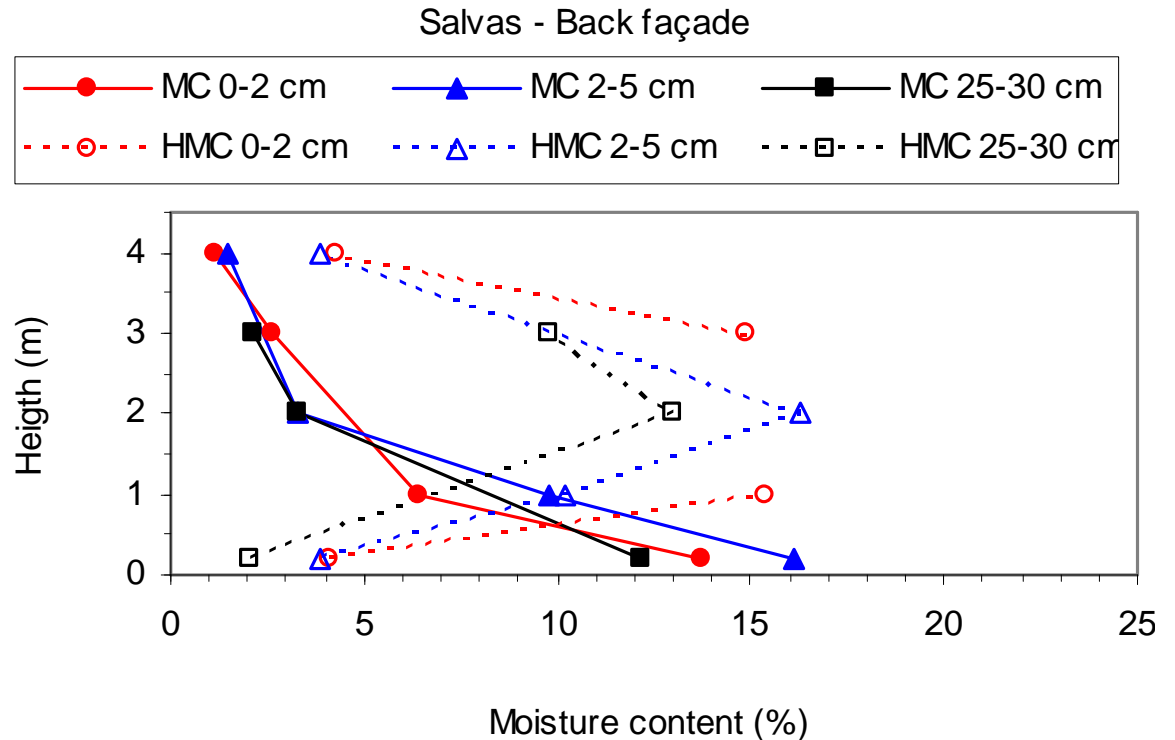
Salvas - Back façade

- MC => rising damp seems very significant:
 - at the base of the wall, the MC is very high (and much higher than the HMC)
 - MC decreases with the distance to the pavement
- HMC => the stronger accumulation of salt occurs at around 2m from the pavement
 - close to the ground the moisture content is very high => stage I conditions => efflorescence (washed out ...)

- Prevent the ingress of chloride => hardly feasible ...
=> **Prevent rising damp** (prevents also the access of the nitrate):
 - investigate possible contribution of the old fountain
 - damp proof course ?
- Use a plaster that allows drying of the wall (salt transporting)
- Use a paint with good adherence (some surface decay is still expected) ... silicate?

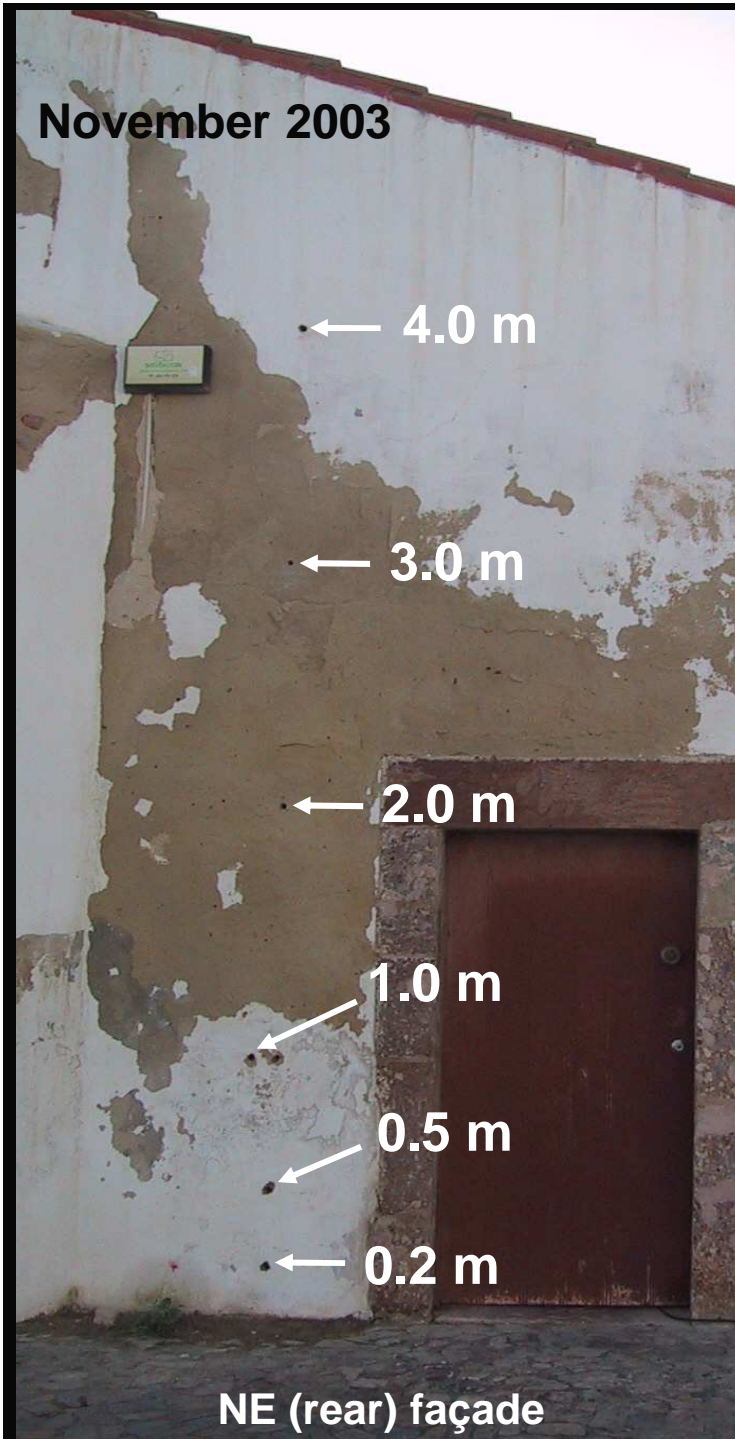
NE (rear) façade

In-depth analysis at the lower drilling hole
(0.2 m from the pavement)

- both the MC and the HMC are constant inside the wall
- the MC is high and much higher than the HMC

Features characteristic of rising damp...

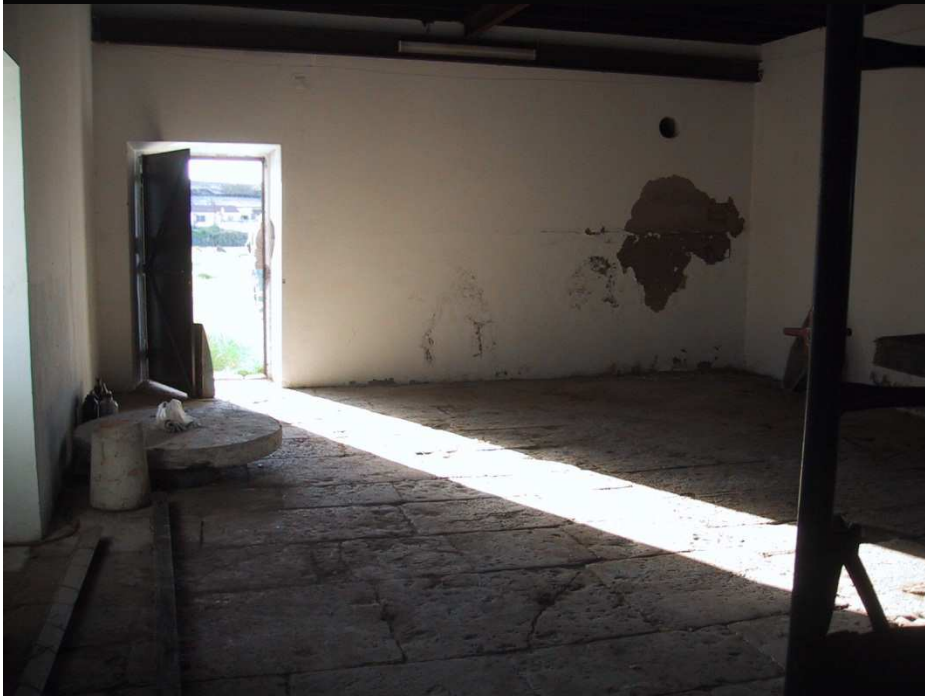
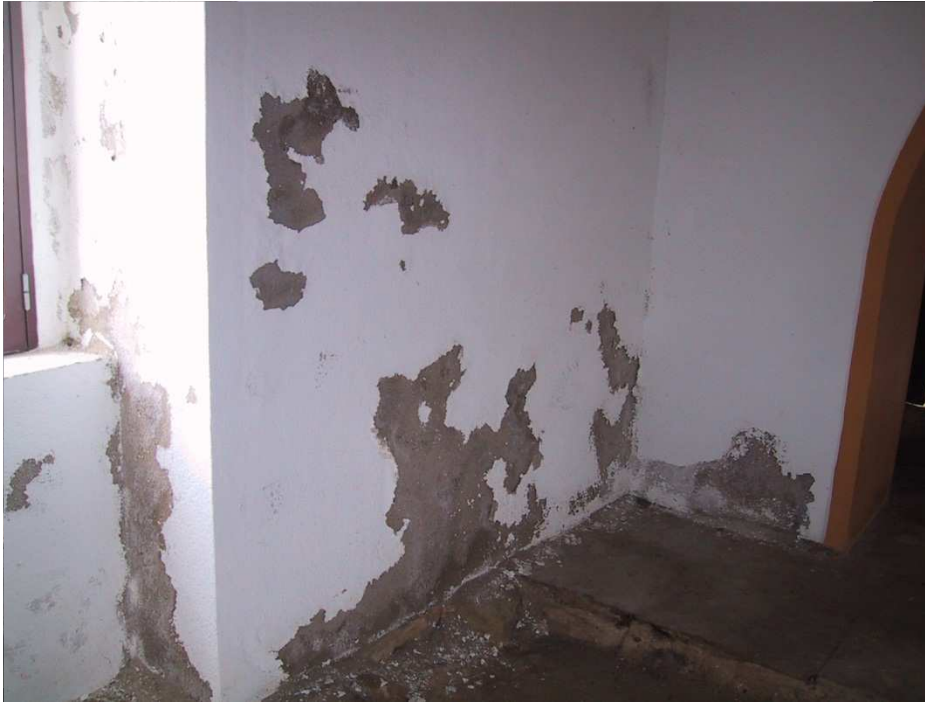
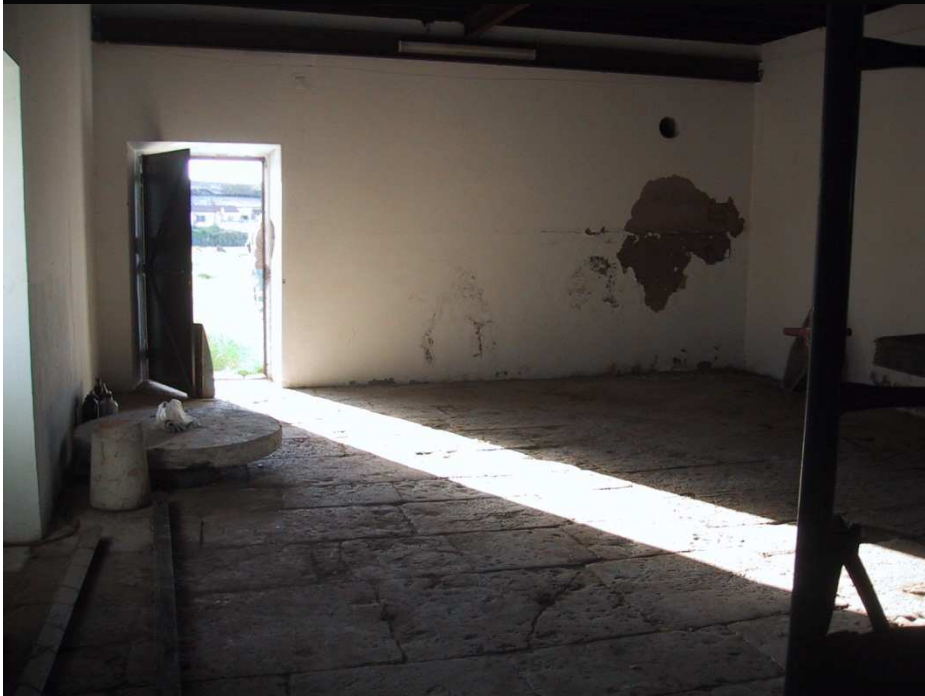
Damage (2002):

- efflorescence, peeling of the paint, sanding of the plaster – in the interior
- affects mostly the (new) plaster

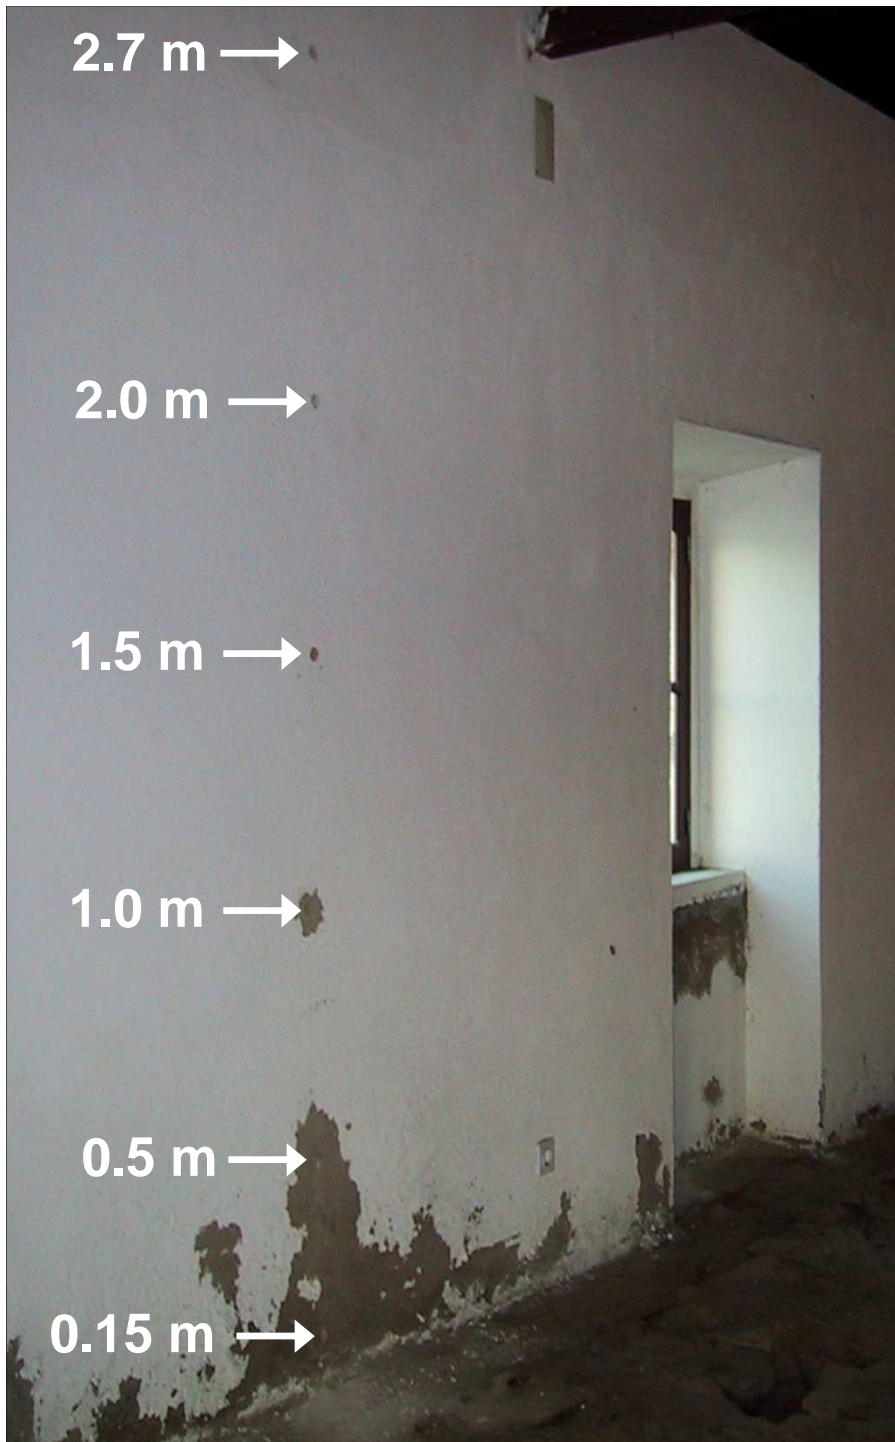
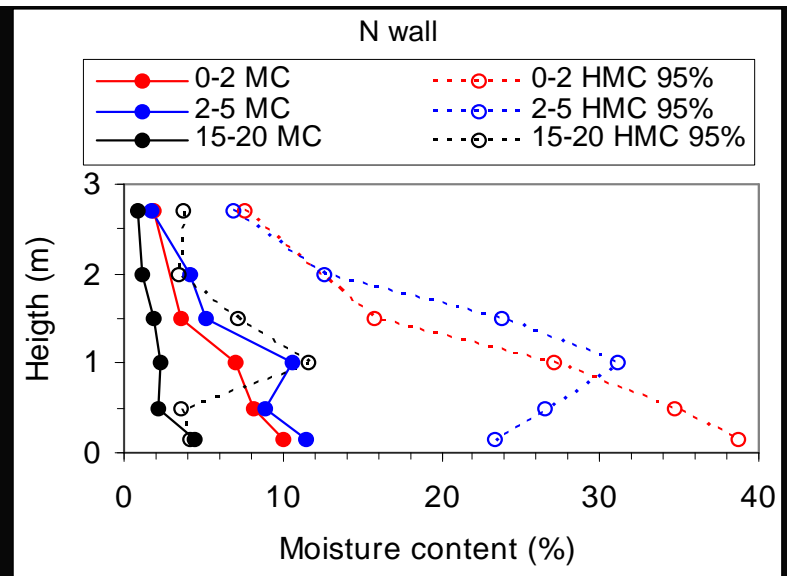
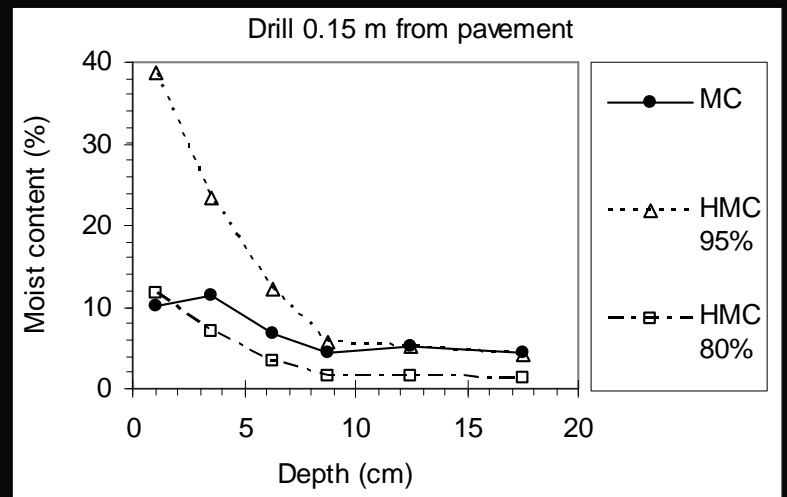
the MC is low inside the wall:

=> rising damp is not the main problem, despite the direct contact of the mill foundations with the river water

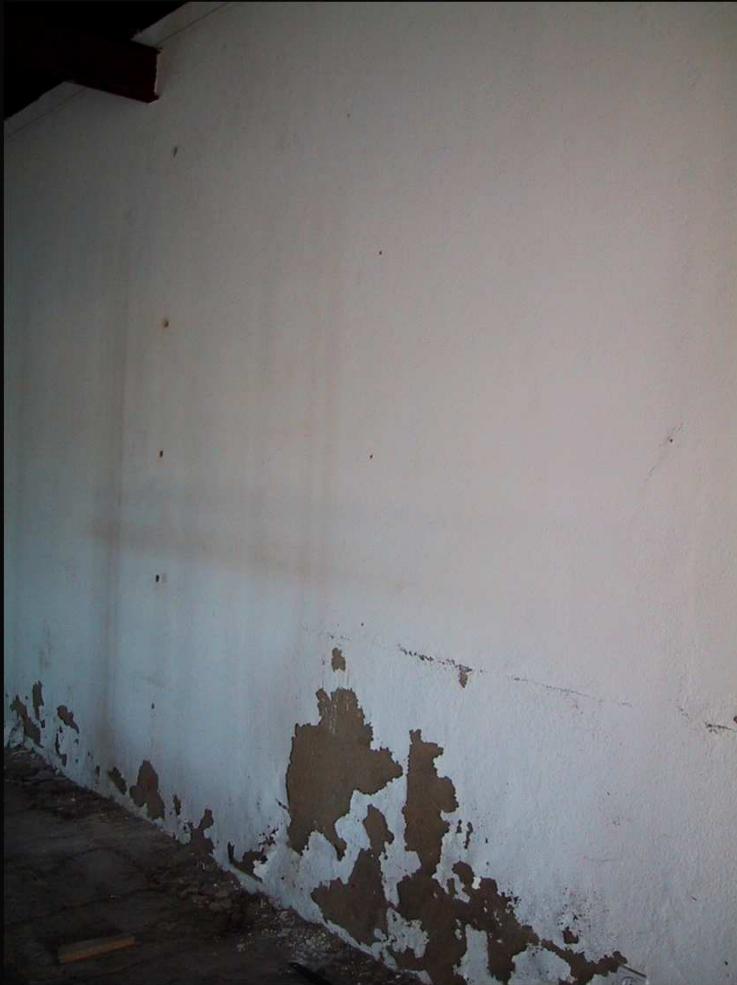
Salt damage:

- close to the pavement

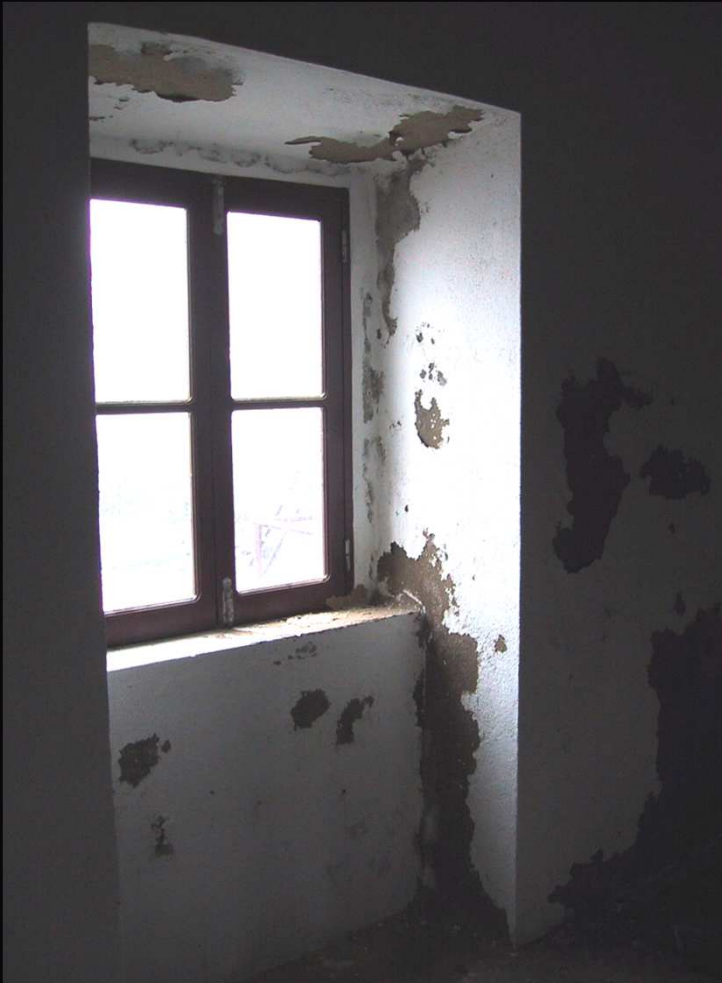
Salt damage:

- close to the pavement
- around the NW windows

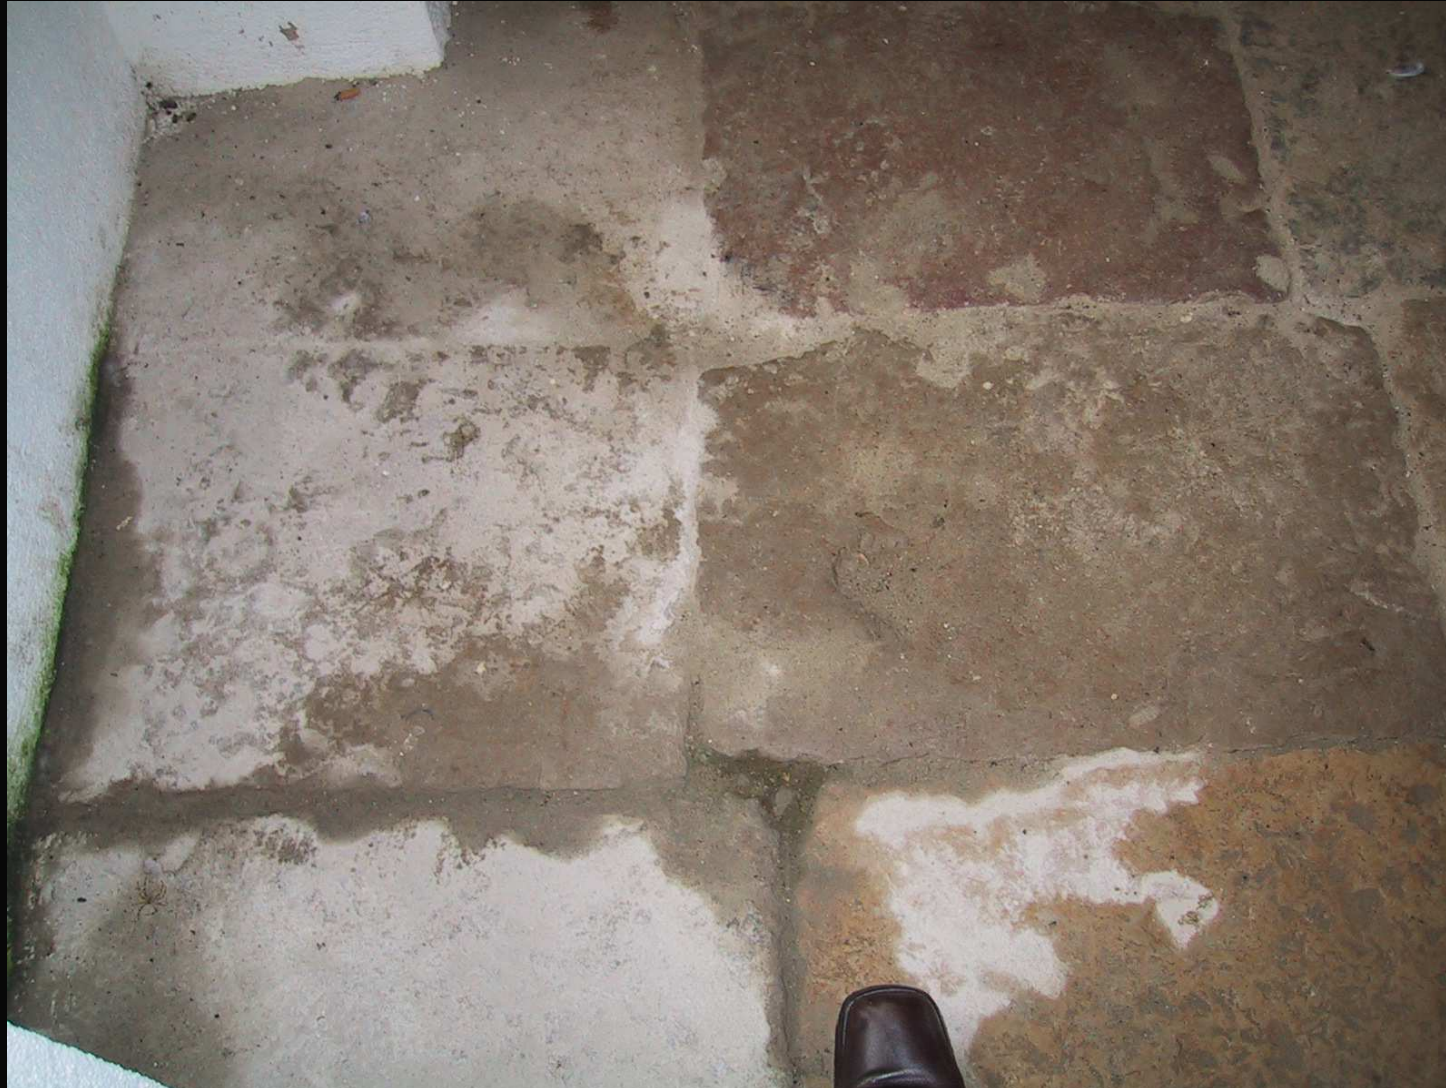
November 2002

Cold /wet day

Sun suddenly appeared

Air temp raised rapidly

Wet spots start
appearing
(condensation...)

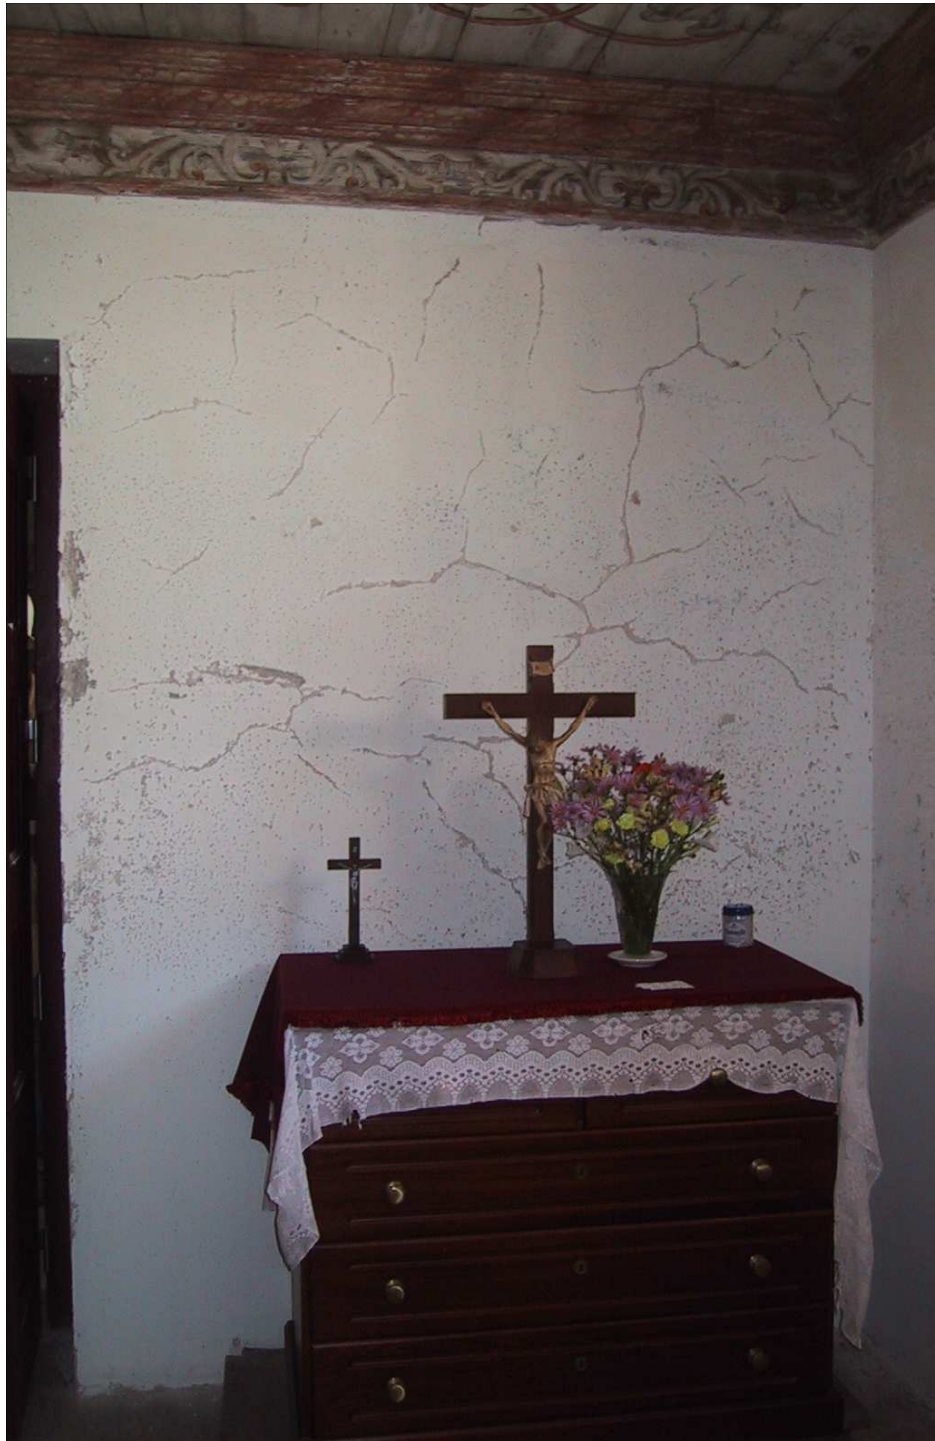
Damage (2003)

- few months after the works ended...
- affects 50% of the plastered area
- cracking + efflorescence
- affects upper part of walls (1.0/1.5 - 2.7 m)

Evolution of damage:

- 1) efflorescence develops at the interface plaster/paint
- 2) the crystals push the paint layer and cause its rupture
- 3) long needle-like crystals appear + sanding of the plaster

plaster cracks = critical points where the degradation first starts and develops faster

- plaster of low alkali content (no cement-based adhesion layer...)
- do not use hydrophobic paint
 - hydrophobic surface layer => lower evaporation rate (stage II conditions)
 - subflorescence disrupts the paint layer (rather, let the salt go out...)

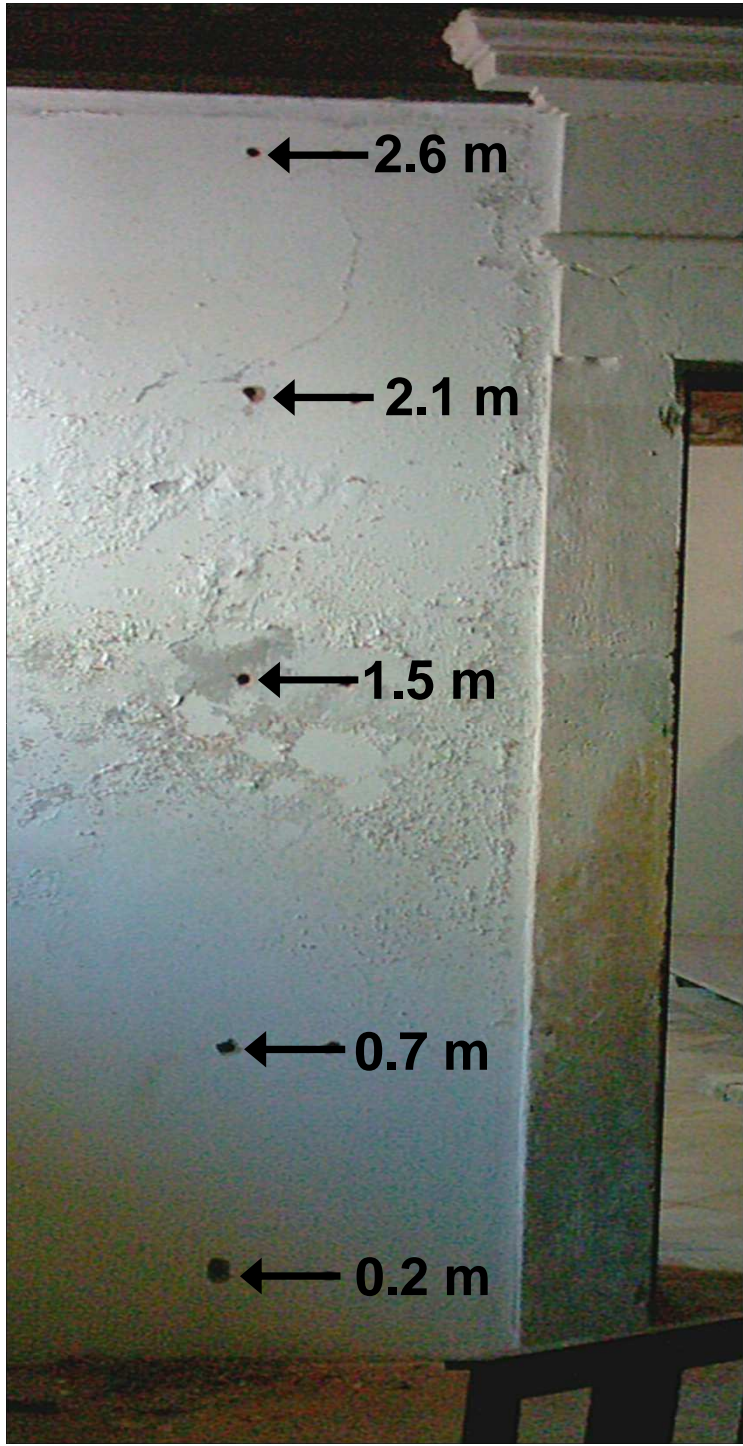
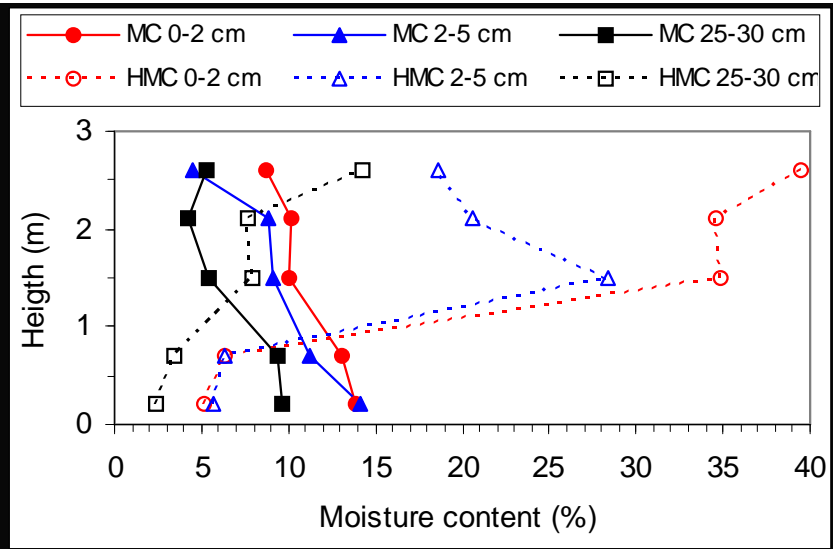
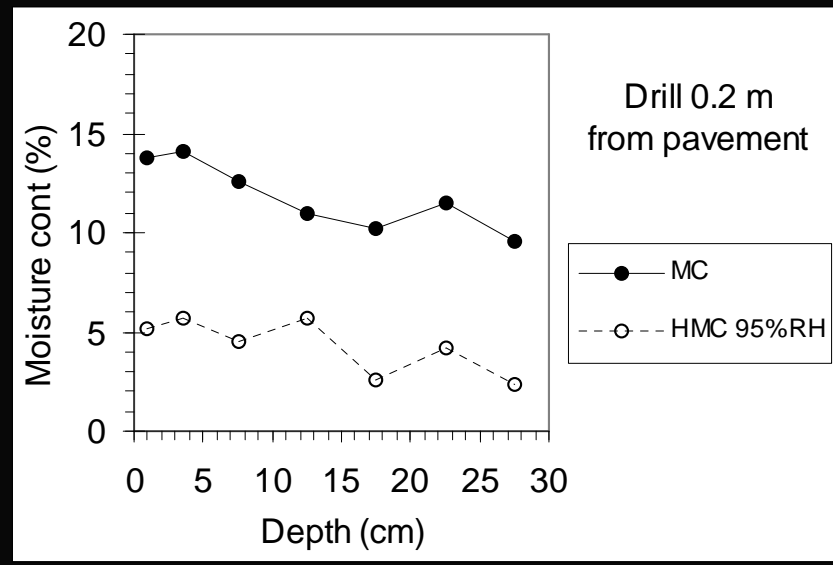
Significant amount of moisture exists inside the walls

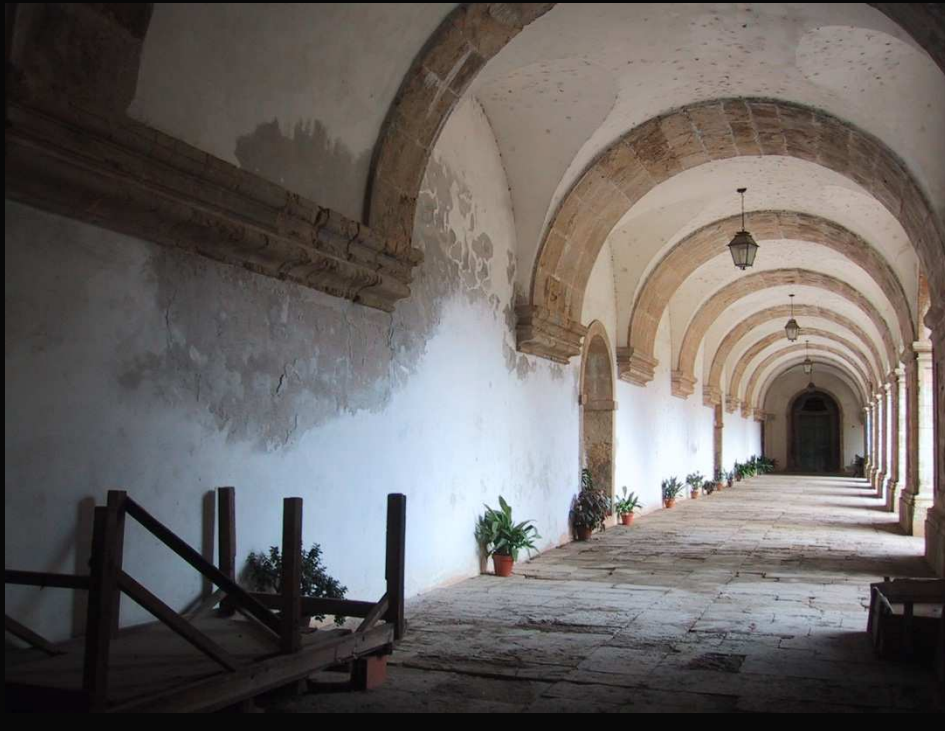
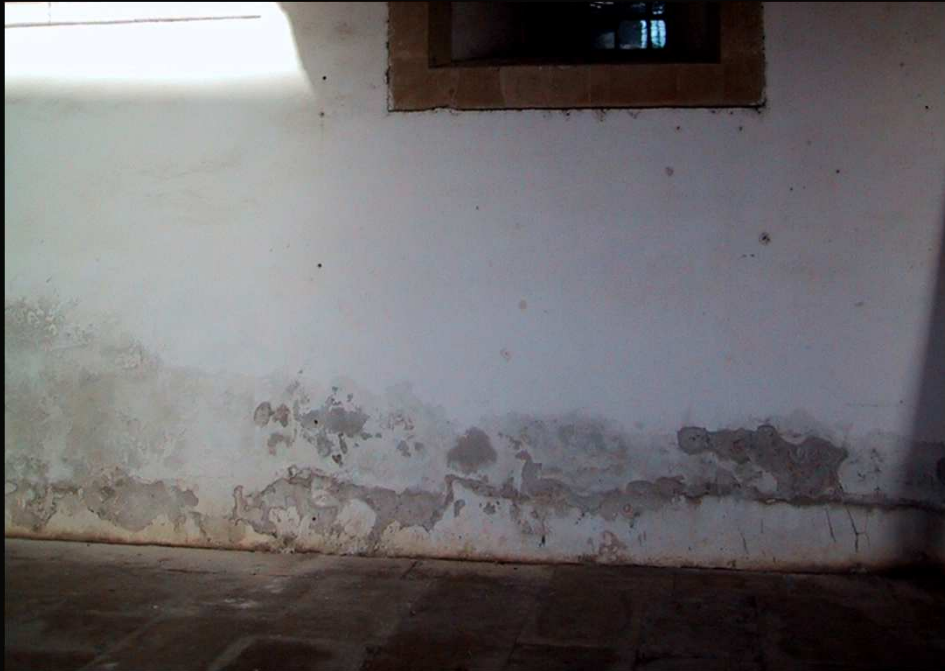
Damage:

- either upper on the walls, next to stone elements
- or close to the pavement

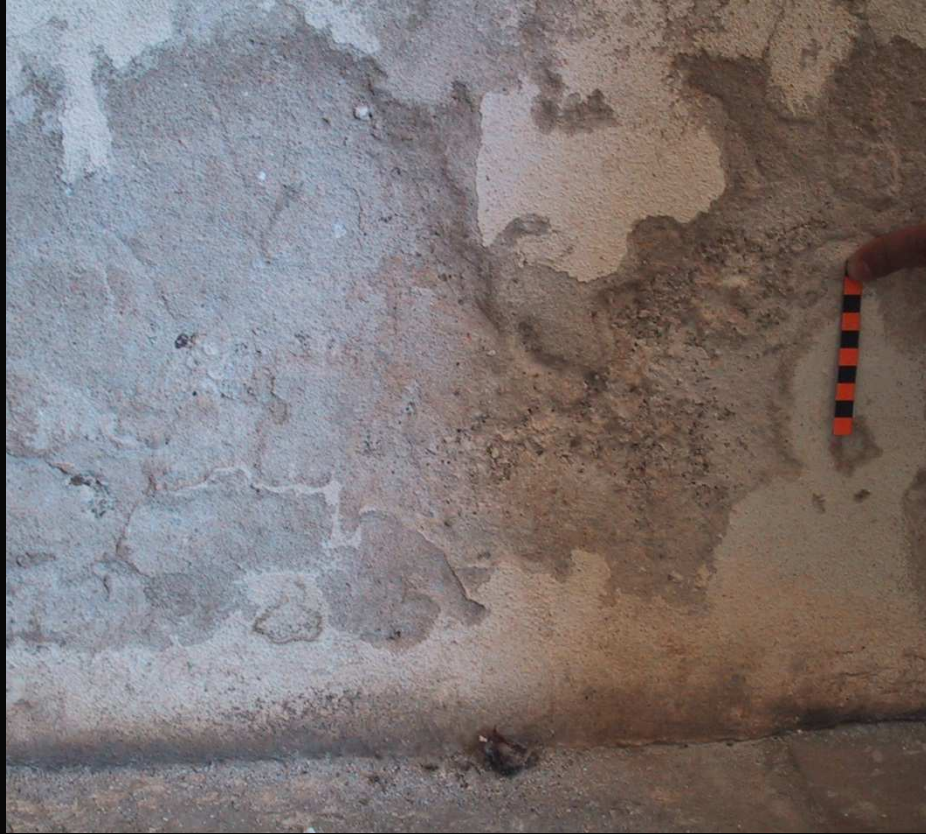
Damage close to the pavement

XDR on sanded surface material (NE wall)

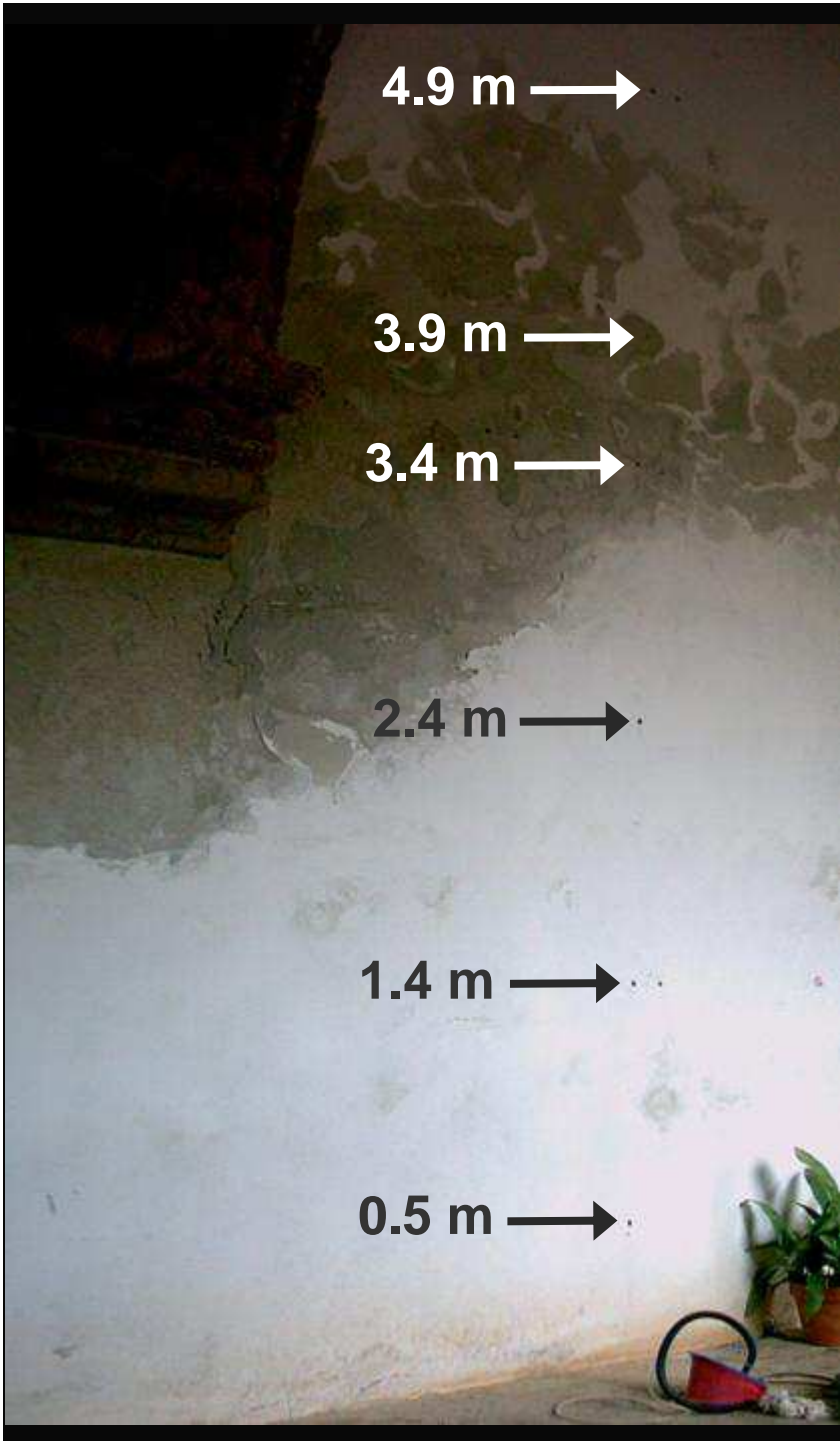
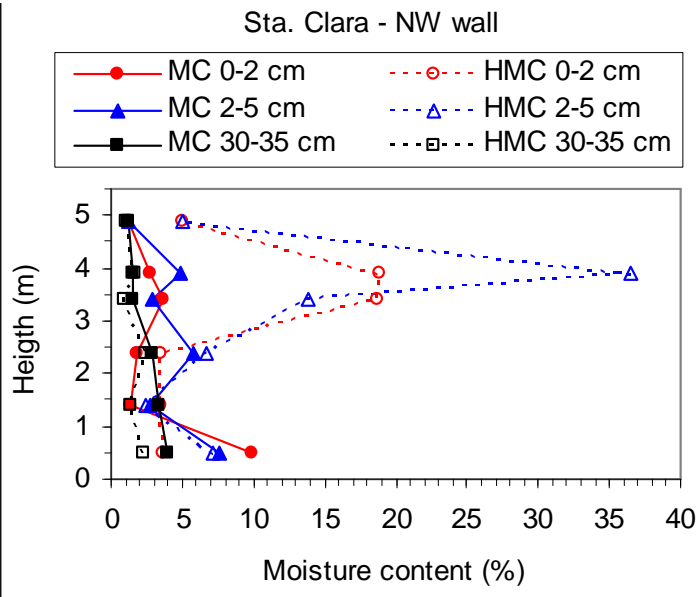
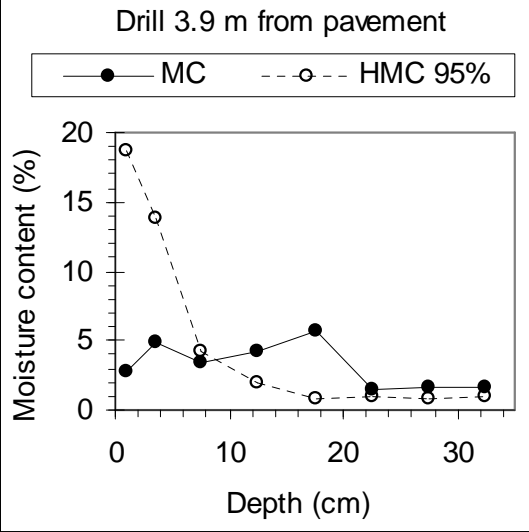
- Rising damp seems limited (< 5% inside)
 - In-depth MC/HMC profile at the level of maximum damage => MC decreases towards the interior of the wall (at the deepest points, MC ≈ HMC)
- => superficial source of liquid moisture is likely

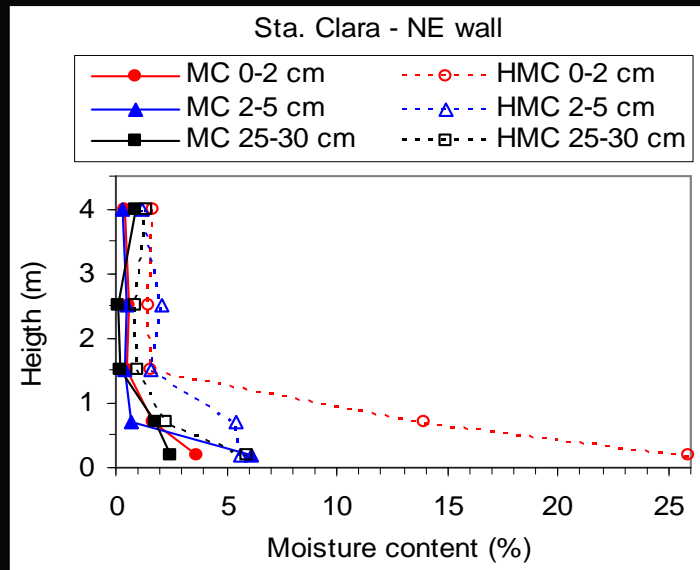
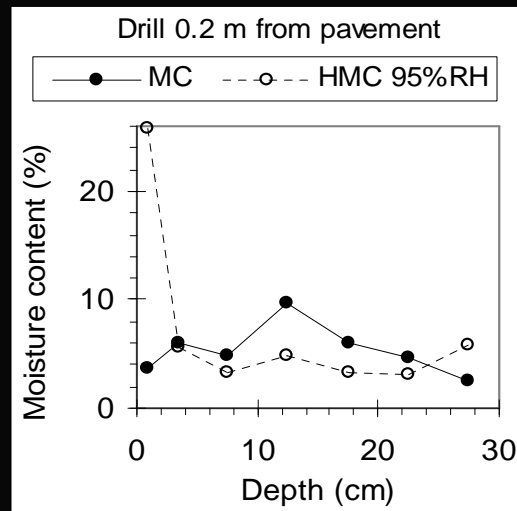
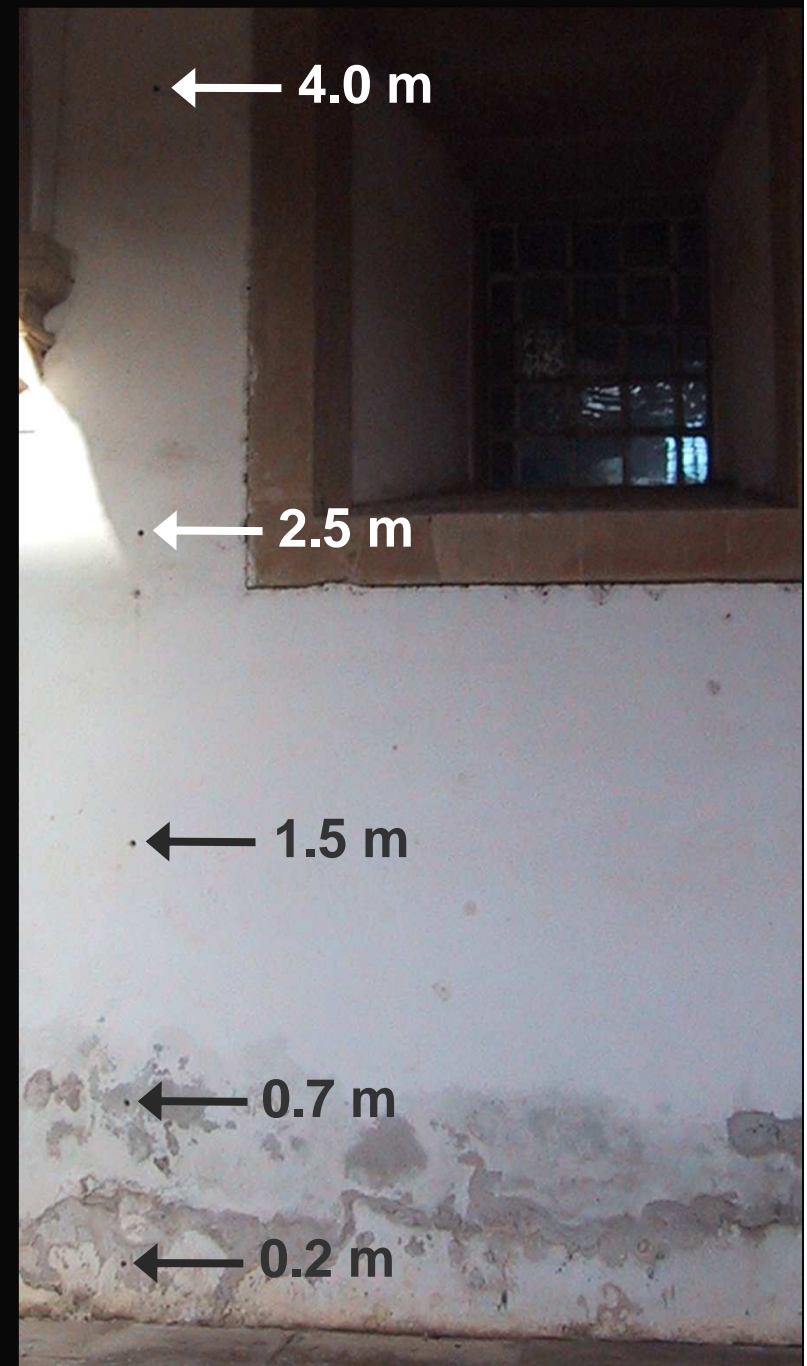
- Rising damp seems low also here
- In-depth MC/HMC at the bottom of the wall => MC decreases towards the interior of the wall (at the deepest point, the MC is lower than the HMC)

=> superficial source of liquid moisture is likely also here
