The reshaping during construction of the right abutment foundation of the New Alto Ceira Dam in Portugal

João Cunha (1); Noemi Schclar (2); Jorge Neves (3); Nuno Antunes (4)

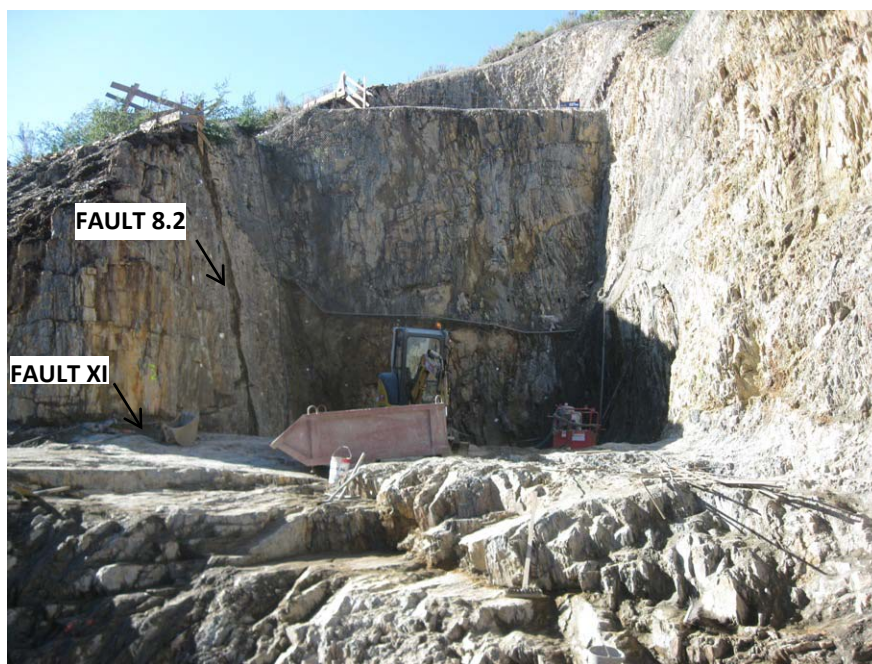
Figure 7 - Right abutment after complementary excavation

In the dam construction phase, as referred in item 2.3, two important sub horizontal faults with clayey gouge of centimetric thickness were detected, one located in the middle level of the dam foundation in the left bank and the other about 3 meters below the right abutment, parallel to its foundation surface, raised concerns about the dam's stability.

These two actions were immediately implemented. The first one consisted of a complementary study (LNEC, 2011) which is further presented in item 5. For the second one, excavation works were retaken. Figures 7 and 8 show the fault configuration on the right abutment foundation after the complementary excavation was finished. The complementary excavation comprised a volume of 1000 m³.

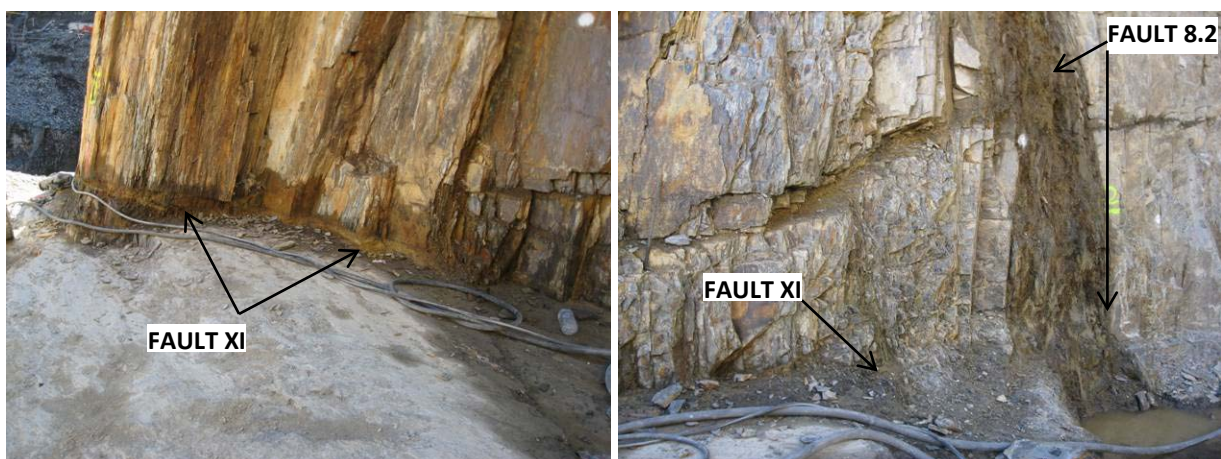
Figure 8 - Detail of discontinuities in the right abutment foundation

The unfavorable geometry and clayey gouge infilling's low shear strength of these faults led to the analysis and foundation redesign described below, due to its possible influence on dam's stability conditions, particularly at the intersection of sub horizontal and sub vertical geological faults that could, eventually, allow the formation of sliding wedges.

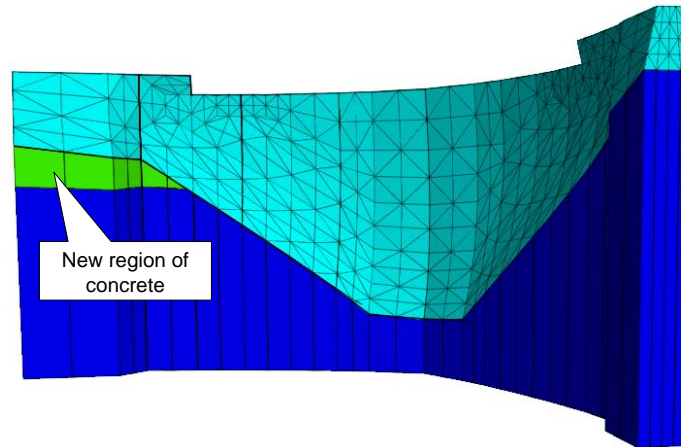
Figure 10 – Definition of the foundation region to be replaced by concrete

to obtain the desired model dimensions. To simulate the replacement of rock mass foundation by concrete, a new region located between the dam-rock interface and the sub-horizontal fault on the right-bank was defined as shown in Figure 10.

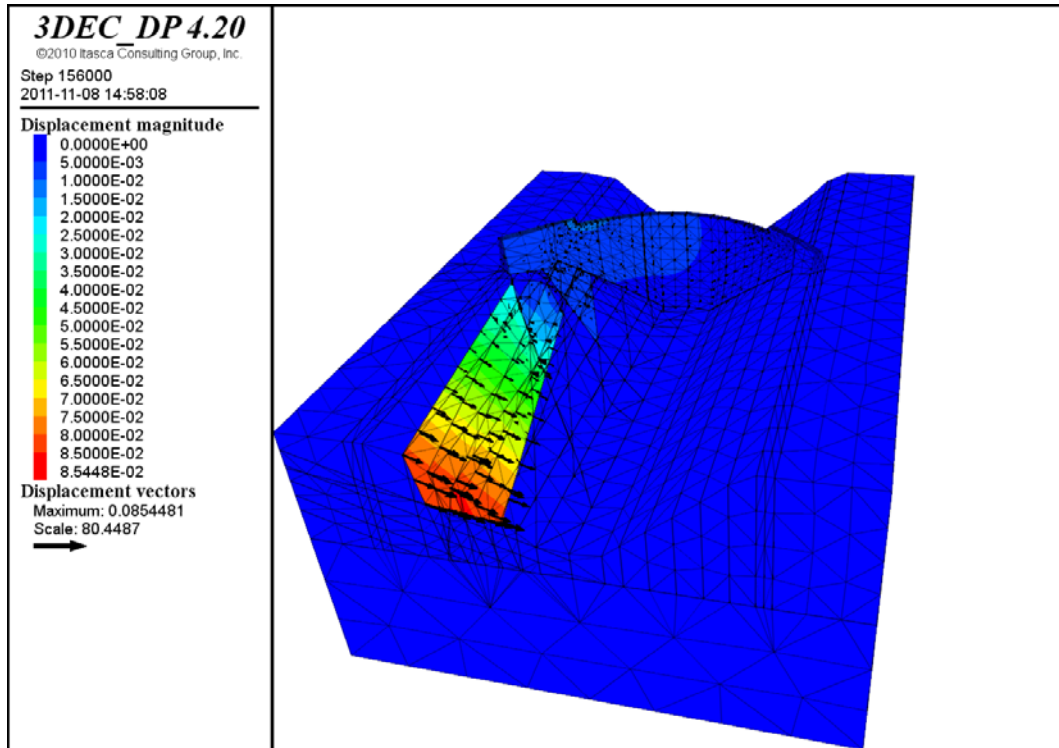
Figure 12- Displacement field for a reduction factor of 1.7

The development of a failure wedge on the right bank, shown in Figure 12, was obtained for a friction reduction factor of 1.7. This failure mechanism concerned only the stability of

the downstream rock mass, while the dam foundation remained stable until a reduction factor of 1.9 was applied.

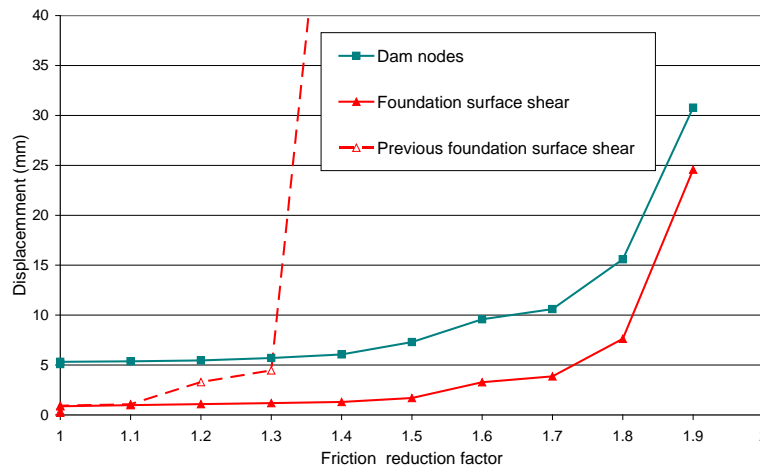
Figure 13 Evolution of model displacements with strength decrease factor

The displacement indicators in Figure 13 (solid lines) show that the joint slip starts to influence dam displacements when the reduction factor exceeds 1.5, and that a clear acceleration can be seen above 1.8. The previous foundation surface shear curve (dashed line) represents the displacement obtained for the model without rock mass foundation replacement by concrete.
