DAMAGE ASSESSMENT AND DIAGNOSIS FORM

Cloister of St. Clara-a-Nova Monastery – Coimbra, Portugal.

LNEC

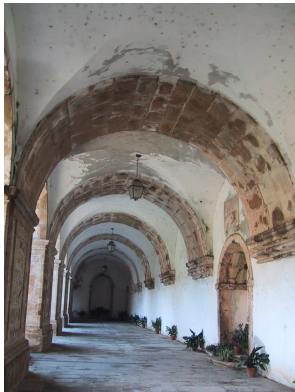
Fig. 7 - Cloister gallery: plaster damaged on vaults and moisture spots on stone (2004-02-05)

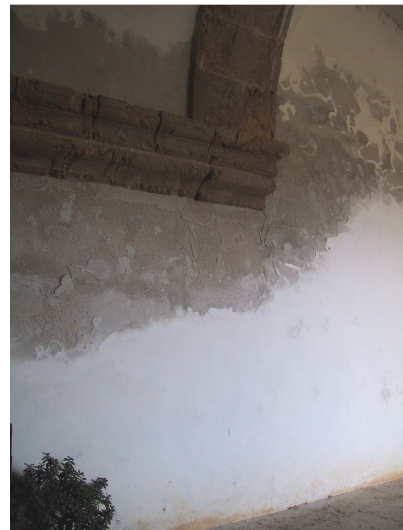
Fig. 8 - Cloister gallery: detail of a damage spot of the render/paint system, next to a stone element (2004-01-08)

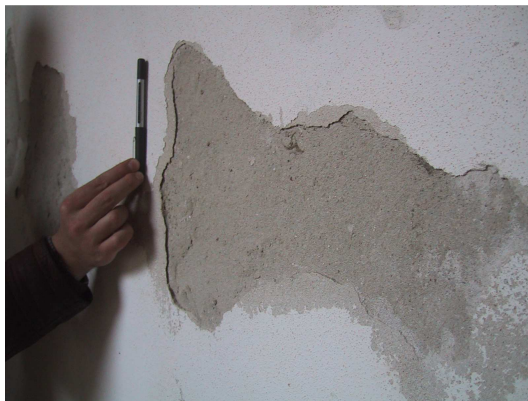
Fig. 9 – Detachment of the render superficial coat (2004-01-08)

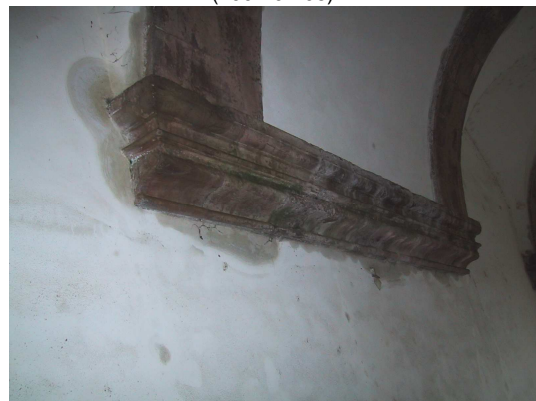
The walls moisture and the HMC profiles point for the existence of two simultaneous sources of moisture and salts: in depth, capillary rise seems to be the only source; at the surface of the walls, an upper-located source seems to exist. Direct observation (fig. 10) indicates that the stone elements are this second source of moisture.

Fig. 10 – Moisture spots on the interface render / stone element (2004-01-08)

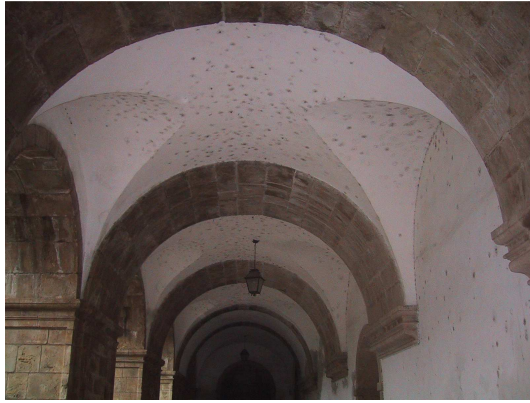
Biological development is present under the form of moss, particularly at the base of the walls. Another form of biological development, not yet clearly identified, appears upper on the walls (more or less above 1.5 m) and on the vaults. When removed, this last biological form leaves a little (around 2 mm) hole on the wall, damaging the paint.

Fig. 11 – Unidentified biological development on the upper part of the walls and on the vaults render (2004-01-08)

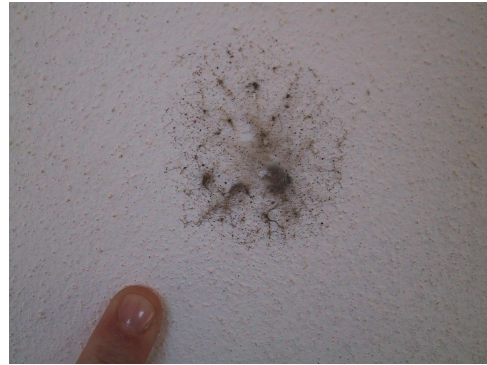
Fig. 12 – Detail of the unidentified biological form (2004-01-08)

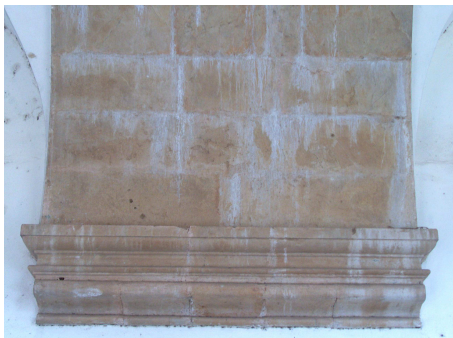
Fig. 13 – Efflorescences spread from the joints of stone elements (2003-11-27)

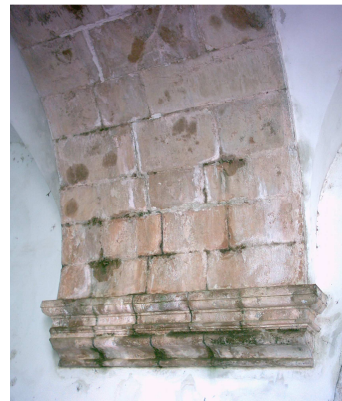
Fig. 14 – Efflorescences, moss and moisture spots on stone (2004-02-05)

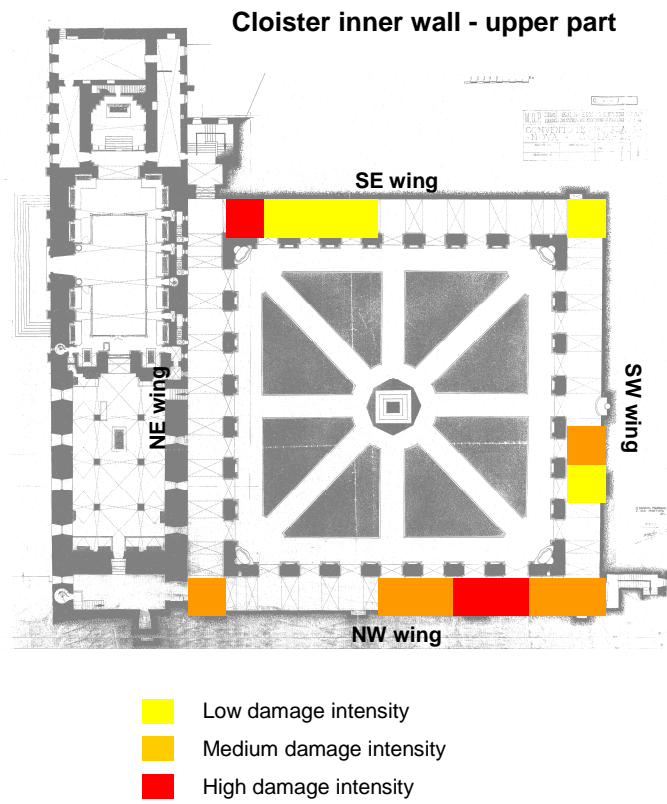
Fig. 15 – Chart of damage intensity on the upper part of the cloister inner wall

A direct correlation between the fact that two of the cloister walls are semi-embedded and salt damage intensity was not found (fig 15).

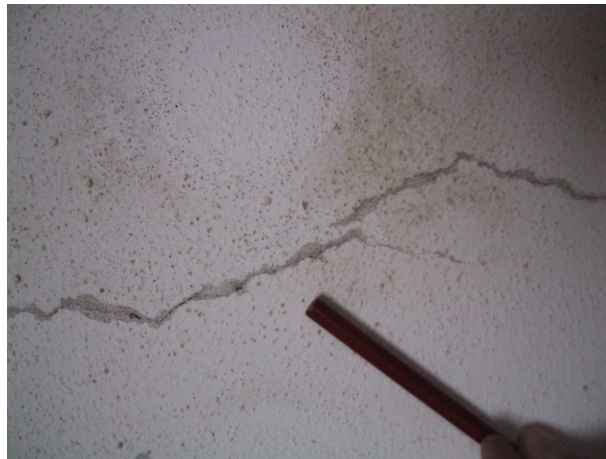
Fig. 16 – Often damage seems to start at cracks

Visual observation of the damaged areas (see Pictures of Damaged Areas), indicate that salt damage starts at the mortar cracks (see fig. 16) or at dry moisture spots (fig. 17).

The new renders should be resistant to cracking, namely to cracking due to the drying shrinkage.

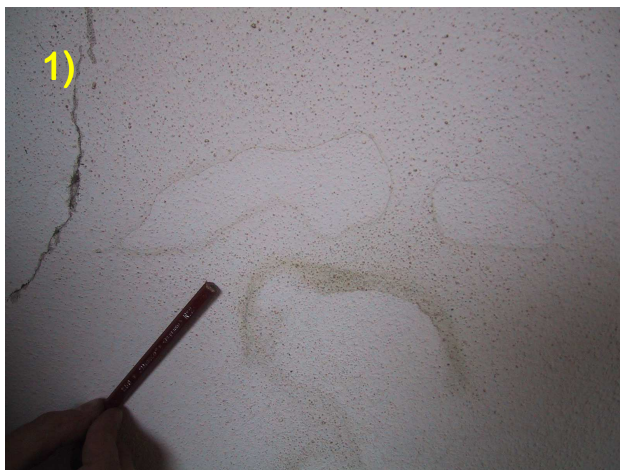
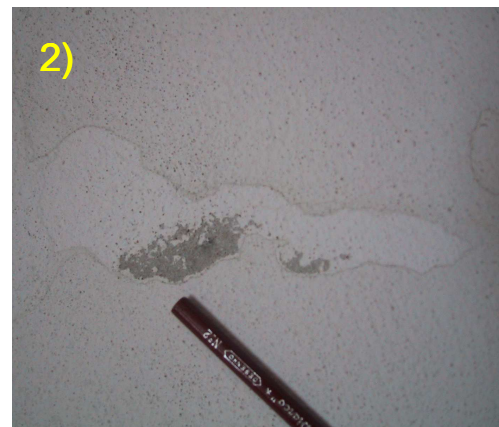
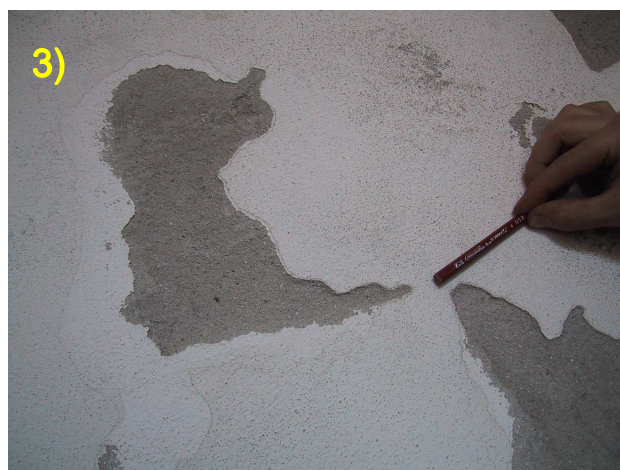
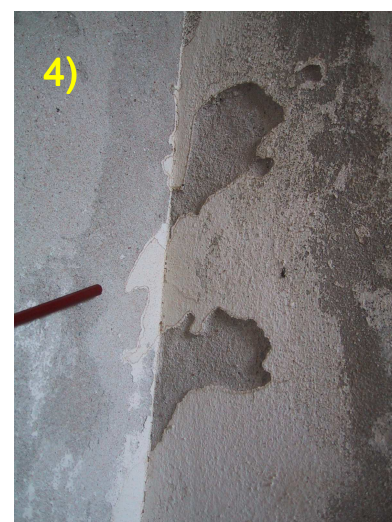
Fig. 17 – Evolution of damage starting from dry moisture spots. The dark lines may represent a microfissure

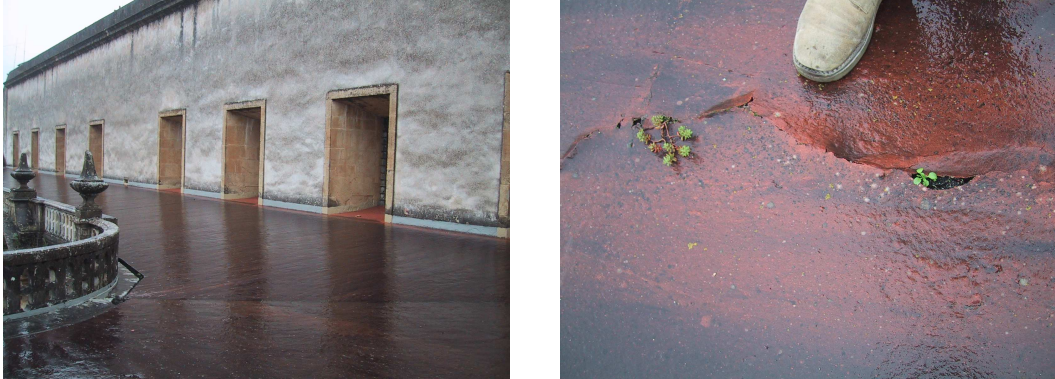
In the same day, water infiltration through the terrace roof and accumulation of water on large puddles at the cloister building first floor pavement was directly observed. The outer roof coverings are blistered and cracked.

Fig. 19 – Damaged roof covering (2004-01-08)

Solve the infiltrations of water from rain, by repairing the roof of the cloister building. For permitting a certain drying of the walls, one summer, at least, should pass after these repairs, before the execution of the new cloister render.

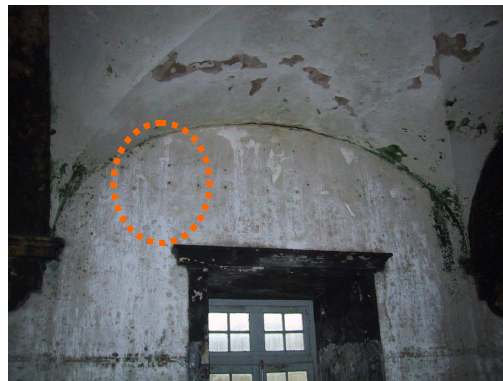
Fig. 20 – Infiltration of water from the rain through the roof and accumulation on the second floor pavement (2004-01-08)

On the vaults, penetration of water from the upper floor (first, the water from the rain enters through the cloister building roof, and then it accumulates on the second floor pavement and passes to the ground floor) seems a consistent hypothesis.

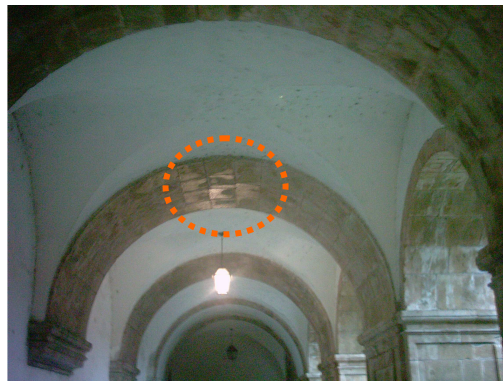
On 2004-02-05, a sunny day that followed several cold rainy days, spots of liquid water were observed on the stone surfaces of the walls of the cloister ground floor. These places are protected from the rain. This leads to the hypothesis of those water spots being due to condensation.

Fig. 21 – Liquid water on the vaults and pavement stones (2004-01-08)
