DAMAGE ASSESSMENT AND DIAGNOSIS FORM

Name of the building – Location St. Sebastian Church – Almada
Type of damage – decay pattern <ul style="list-style-type: none">• Detachment of paint coats• Sanding and crumbling of original lime-plasters and lime-renders• Detachment of cement plasters and renders, which correspond to localized repairs• Sanding and crumbling of the masonry bedding lime-mortars• Scaling of the ceramic bricks, which correspond to localized repairs to the original masonry
Materials concerned <ul style="list-style-type: none">• Ancient lime-plasters and lime-renders• Ancient paints at both the exterior and the interior of the church• Cement plaster and render repairs• Ordinary masonry made of argillaceous lime-mortar and soft sandstone
Tests performed <ul style="list-style-type: none">▪ Moisture and hygroscopic moisture content (HMC) profiles at two walls for estimating moisture and salt content distribution▪ Ion chromatography on six superficial samples▪ For estimating the relation between the amounts of moisture transported through the masonry bedding mortar and through the masonry stone:<ul style="list-style-type: none">▪ Water absorption at low pressure (pipe me

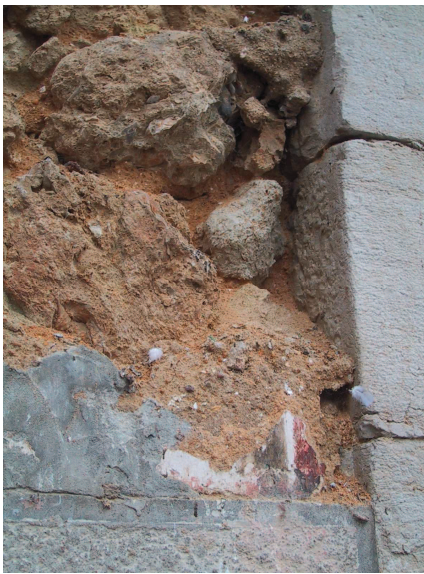
Fig. - Sanding and crumbling of the masonry bedding lime-mortars

The high damage state of the lime-mortars seems to be due, in a great extent, to their low mechanical resistance (which results in a very low salt resistance) and very high absorption (which make them the main way for the solutions to circulate and the place where the salts preferentially crystallize).

The new plasters and renders should prevent crystallization from occurring inside the weak substrate lime-mortars, which easily deteriorate. These new plasters and renders should mainly:

- Provide a good hydric continuity with the underlying lime-mortars;
- Possess a very absorbing base layer, which should be able to quickly absorb the solutions supplied by these lime-mortars.

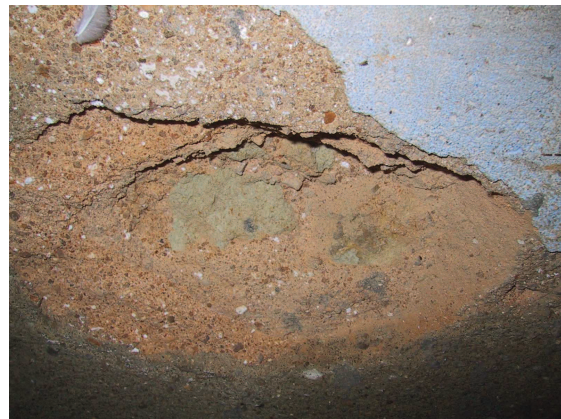
Fig. - Sanding and crumbling of the masonry bedding lime-mortars; detachment of a cement render repair

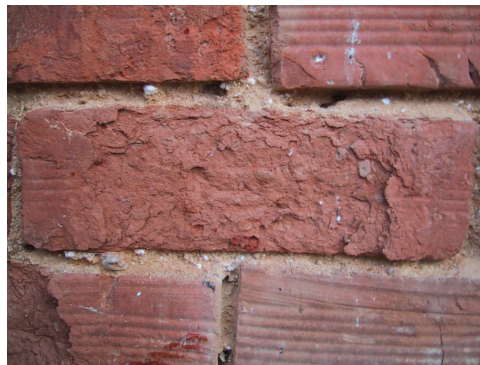
Fig. - Scaling of ceramic bricks at a masonry repair

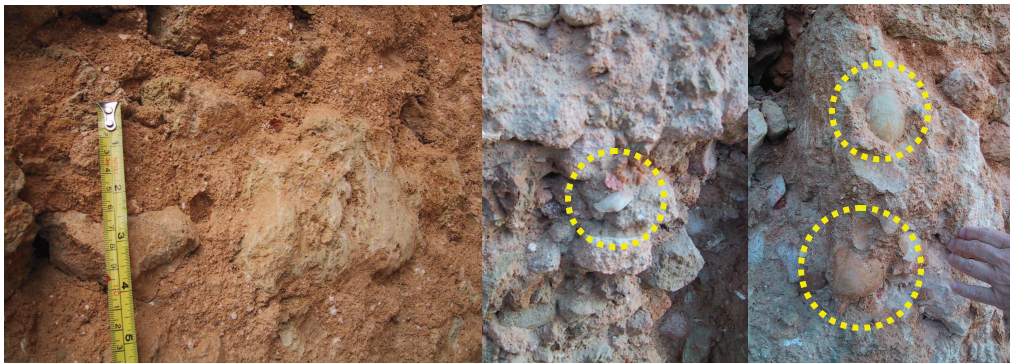
The original masonry of S. Sebastião Church is the so called “ordinary masonry” (made of irregular stones and a bedding lime-mortar), which is, from far, the most common one in Portuguese ancient buildings. In S. Sebastião Church, the bedding mortar is a very weak and absorbing argillaceous lime-mortar. The masonry stone is a sandstone and a shelly limestone from the nearby cliffs of the Tagus river mouth. They are very porous and absorbing stones, which includes many vestiges of marine life forms (shells and fossils).

Fig. – Ordinary masonry of S. Sebastião church; shell and fossils incorporated in the stone elements

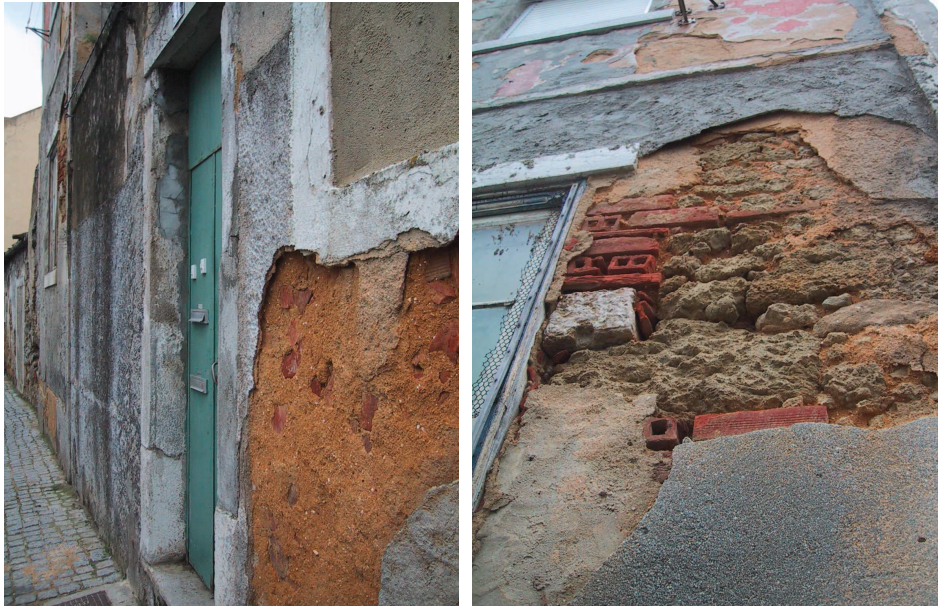
Salt damage is a common problem at the whole ancient Almada. The following pictures show some common damage patterns: peeling of paints; detachment of new renders from the ancient supports (lime renders or ordinary lime/stone/brick masonries); powdering and crumbling of the lime-mortars (lime-renders and bedding lime-mortars of ancient ordinary masonries), which are left exposed.

Fig. – Damaged building surfaces at ancient Almada
(sanding and crumbling of lime-mortars; detachment of cement renders)

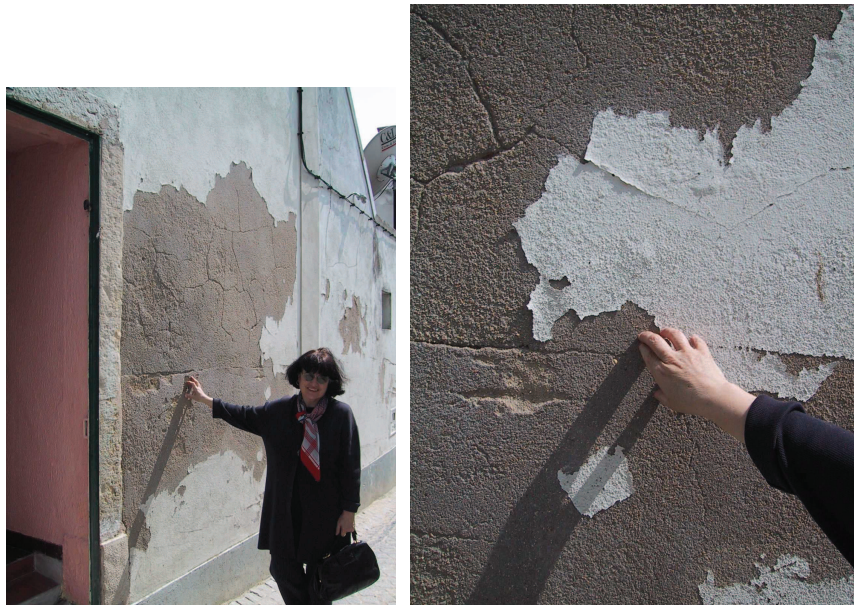
Fig. – Damaged building surfaces at ancient Almada (peeling of paints)

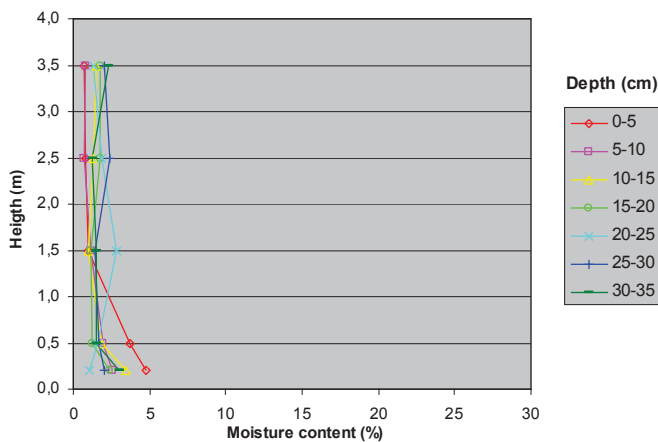
Fig. – Moisture content profile of the exterior wall

Capillary rise seems to be the main source of moisture. At the exterior (this wall is without render until about 2.7 m from the ground), some direct absorption of water from the rain may also exist. Moisture contents are not, however, very high (a maximum of around 6.5% was measured at the interior, on the base of the wall).

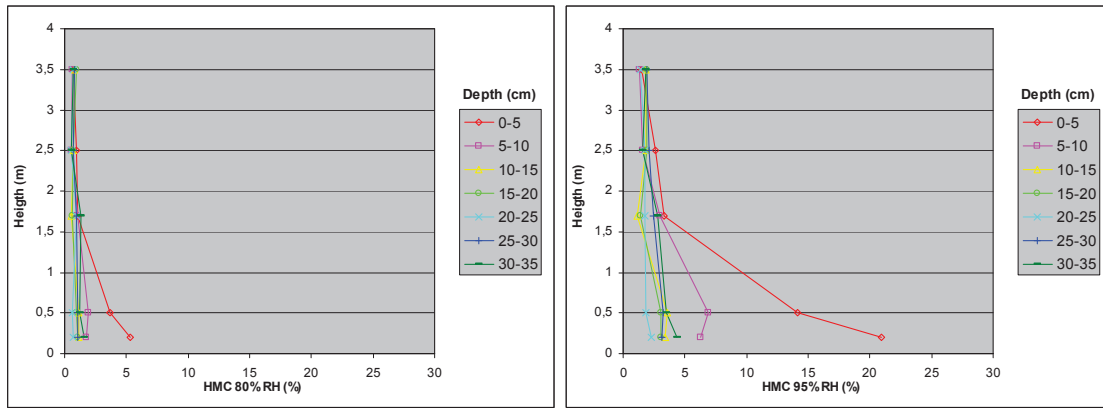
Fig. – Exterior wall: HMC at 80% (left) and at 95% RH (right)

The materials salt content shows a general decrease with the distance from the ground, as indicated by HMC and ion chromatography. At the exterior, it seems to be irrelevant above 1.5 m. At the interior, the salts content is still relevant at the maximum height sampled (3.0 m). HMC points to an expected tendency for a superficial deposition of salts. Salts content at the interior seems significantly higher than at the exterior of the chapel.

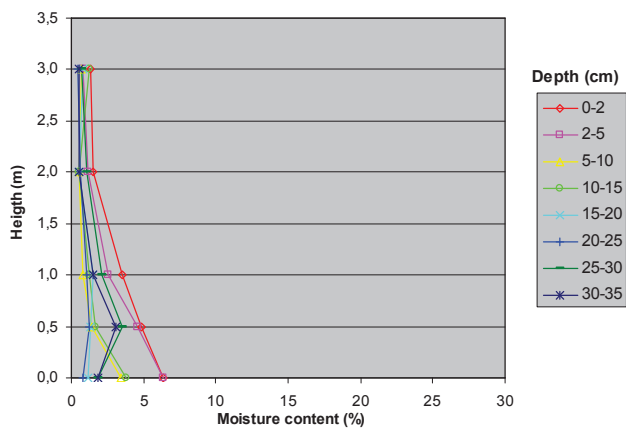
Fig. – Moisture content profile of the interior wall

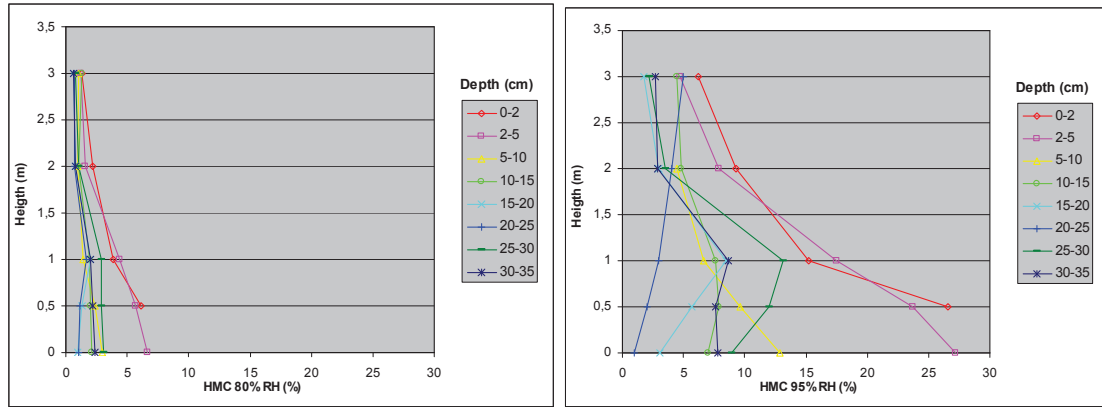
Fig. – Interior wall: HMC at 80% (left) and at 95% RH (right)

Note: After 4 weeks inside the chamber at 20°C and 95% RH complete stabilization of the samples mass doesn't seem to have been totally reached yet. When stabilization is reached, the HMC 95% chart will be corrected; for the present form, this preliminary chart, which is "on the security side" was used.

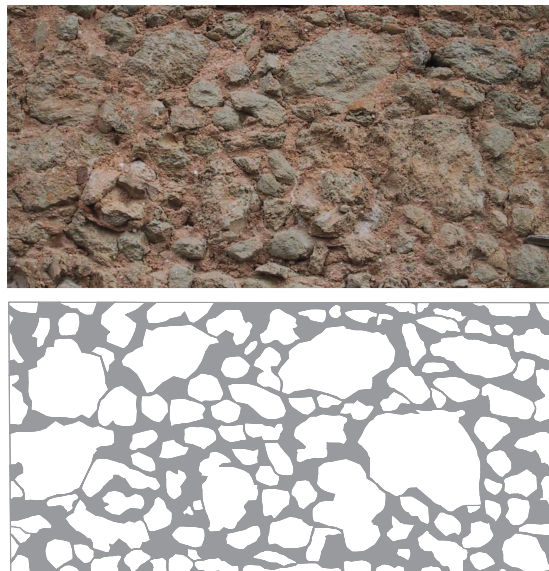
Stone: Area = 66% => As = 1.94 Am
 Mortar: Area = 34%

Fig. – Graphic estimation of the relation between the superficial areas of the bedding mortar and the masonry stone

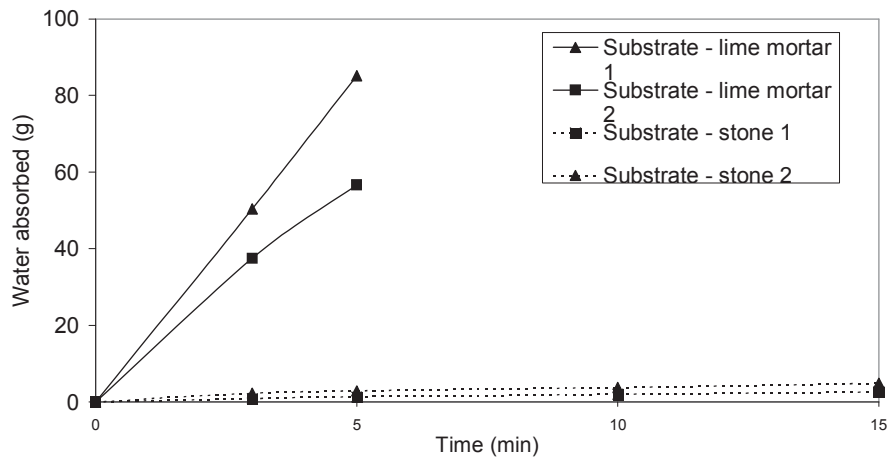
Fig. - Results of the water absorption tests

The mortar absorbs around 95% of the total amount of the water absorbed by this masonry, in its current surface. The stone absorbs only around 5%.
