DAMAGE ASSESSMENT AND DIAGNOSIS FORM

Alhos-Vedros tide-mill – Alhos-Vedros, Moita, Setúbal, Portugal

LNEC

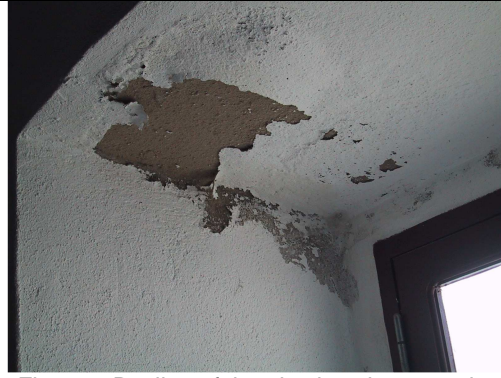
Fig. 12 - Peeling of the plastic paint around a northern window of the mill ground floor

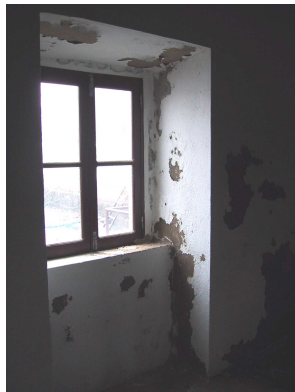
Fig.13 - Damaged (northern) wall and pavement of the mill ground floor

Therefore, three test panels are suggested to be executed in the interior, at the mill ground floor, on presently degraded areas of the north wall. They should cover the entire height of the wall and have, at least, 2 m width. Each panel should be vertically divided in two equal strips: on one side, the plaster should be left unpainted; on the other side, the selected paint should be applied. The recommended constitution for each panel is presented in table 3.

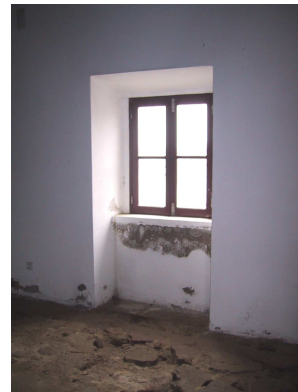
Fig. 14 - Puddles of liquid water – southern window on the mill ground floor

On the other hand, the existence of water flow marks coming from the ceiling and windows, as well as the presence of puddles of liquid water and of algae/moss below the south windows (damage pictures 7 to 11) point to the existence of significant water infiltration through the roof and windows.

The repair of the roof and the windows, in order to make them watertight, is obviously urgent.

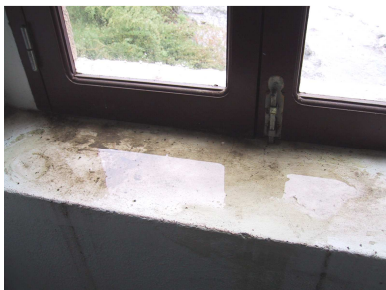
Fig. 15 - Algae/moss – southern window on the mill ground floor

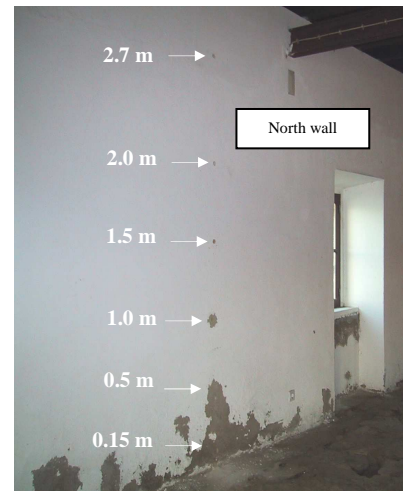
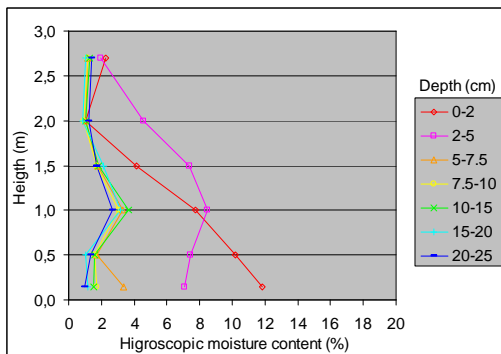
Fig. 22 – N wall: HMC at 80% (left) and at 95% RH (right)

The HMC profiles point to decreasing total salt contents with the distance to the pavement. An accumulation of salt in the superficial coats of the N wall is also visible. From the comparison of the 80% RH and the 95% RH profiles, chlorides seem to be relevant but other salts also seem to exist, with a very high relevance.

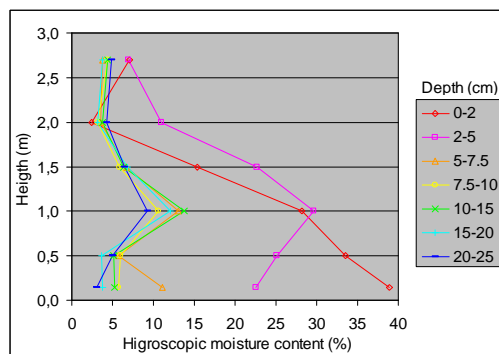
Fig. 23 - Moisture content profile of the South wall (samples collected in Nov. 2003)

The direct contact of the building foundations with the river water favours capillary rise. The preferential location of damage in the vicinity of the ground and the conspicuous presence of halite (table 1 and 2) point to the likely origin of moisture in the tide-water rising from the building foundation. In both the south and the north walls, the moisture profiles (fig. 2) show a clear decrease of moisture content towards the upper zones, fact that proves this origin.

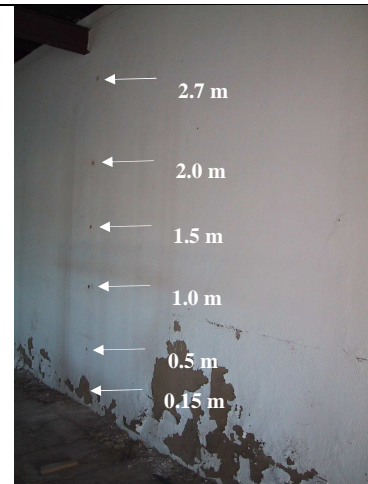
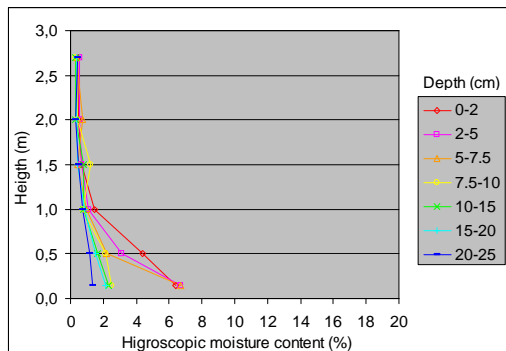
Fig. 25 – S wall: HMC at 80% (left) and at 95% RH (right)
