## THERMAL IMAGING OF CONCRETE DAM SURFACES TO SUPPORT THE CONTROL OF THE EVOLUTION OF PATHOLOGIES

Maria João Henriques\* and Pedro Ramos†

\* Laboratório Nacional de Engenharia Civil (LNEC)  
Av. do Brasil, 101, 1700-066 Lisboa, Portugal  
e-mail: mjoao@lnec.pt, webpage: <http://www.lnec.pt>

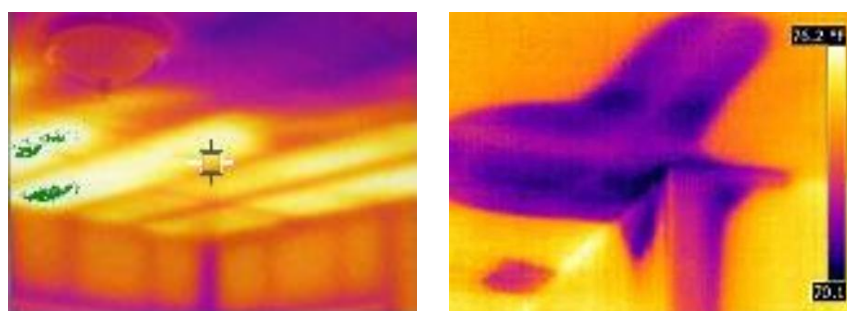
Figure 1: Thermal images from ceilings in two buildings. The first ceiling reveals insulation deficiencies, the second water seepage.

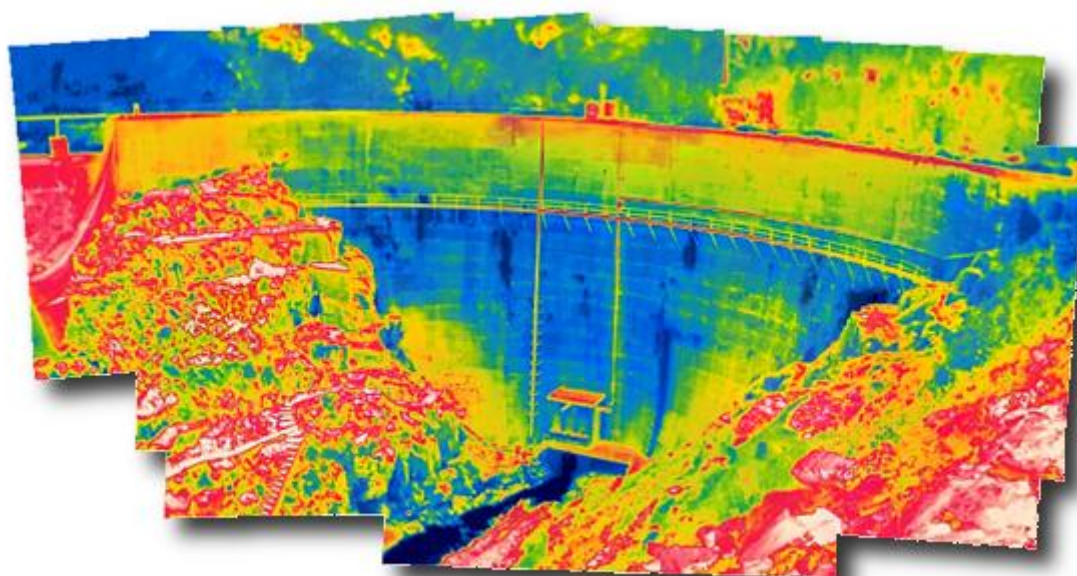
The Alto Ceira dam is an arch dam that presented, as a result of alkali-aggregate reactions, an abnormal behaviour which led to the need of its demolition. This one started two weeks after the thermal survey. The dam surface was heavily covered with cracks and seepage was presented in several areas.

Figura 3: Thermal panoramic image of Alto Ceira dam.

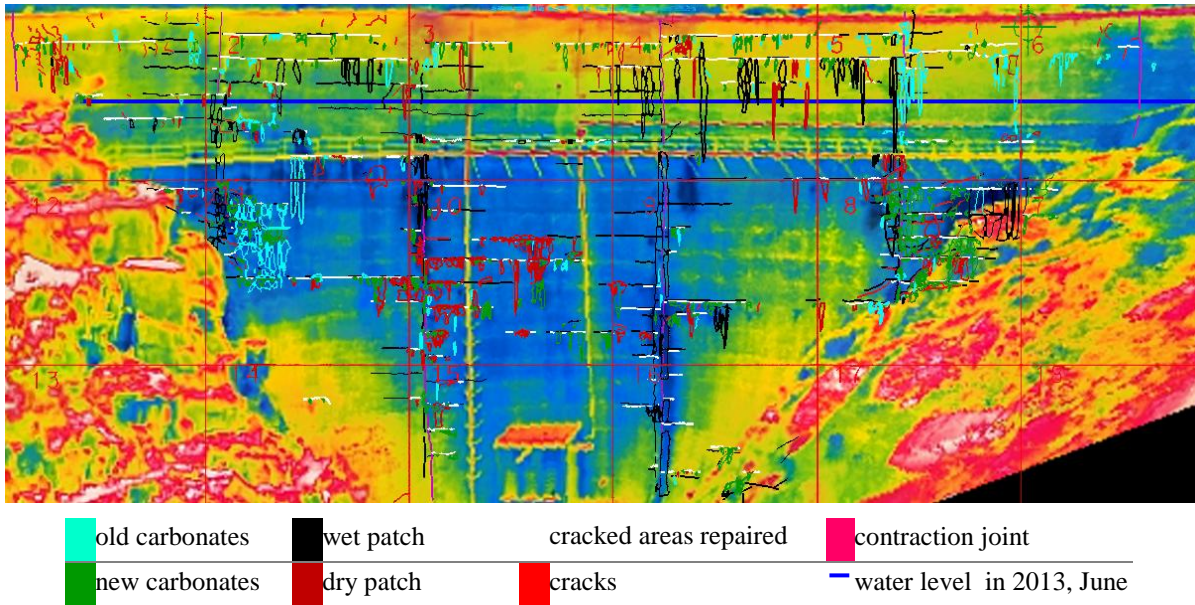
Figure 4: Occurrences, surveyed in 2001, overlapping the thermal panoramic image of Alto Ceira dam

On the thermal imaging one can noticed that many of the areas that in 2001 were “wet patches” are, on the thermal images, cooler zones. At the top of the wall the thermal survey didn’t detected cold areas. This is normal because the water level in the reservoir was 4 m below the maximum level; in 2001 this level was near the maximum. And it can also be noticed that there are cold areas (thermal survey of 2013) that don’t have any match with the wet areas of 2001.

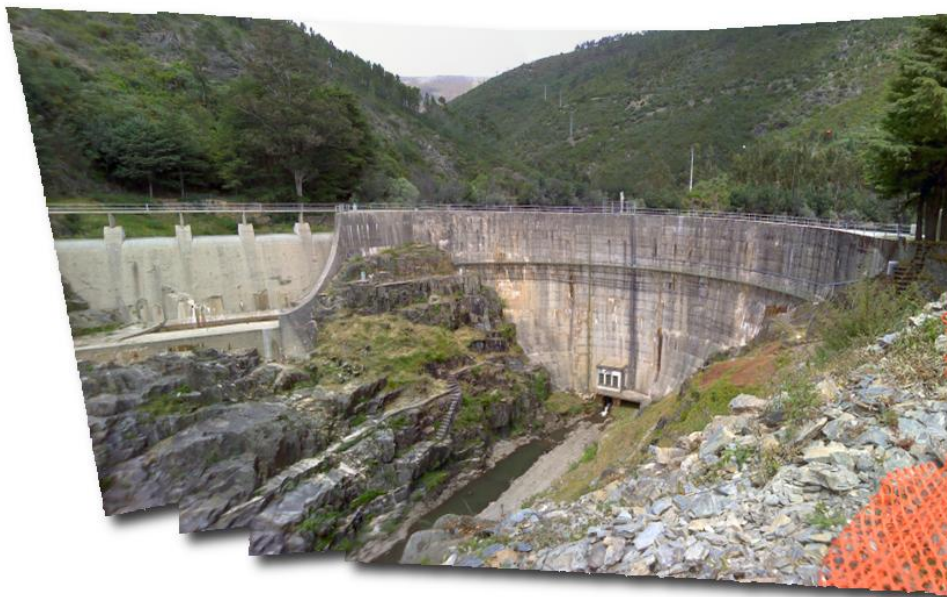
Figure 5: Panoramic image of Alto Ceira dam

In the visible image of the dam (Figure 5), one can noticed several white patches on the downstream face. These are deposits of carbonate. Because they are white is impossible to know if there is still a transfer of water. On the other hand, is possible to detect if the concrete is wet because its colour becomes darker. It is important to noticed that some of the long darker strips, for instance along the central cantilever, are dirty areas, some due to fungus. Using thermal images is easy to notice if in the white areas there is still a transfer of water. Overlapping thermal data (as in Figures 7 and 8) on a

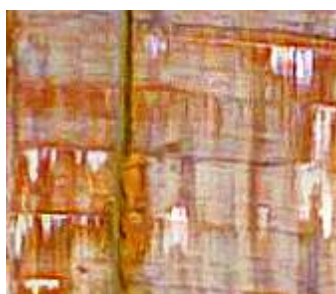
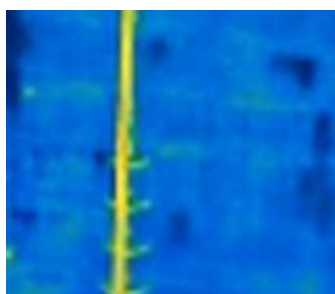
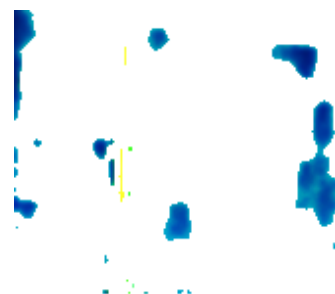
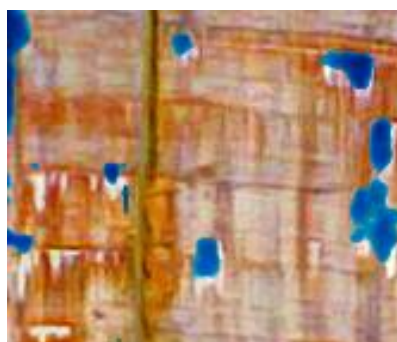
normal, “visible”, photo (as in Figure 6) makes it possible to notice the areas where the water is not flowing because the cracks are filled (see Figure 9).

Figure 6: Photo of the downstream face with colour enhancement.

Figure 7: Thermal image of the same area.

Figure 8: Cooler areas (dark blue areas of Figure 7).

Figure 9: Overlapping of the image of Figure 8 on the image of Figure 6.

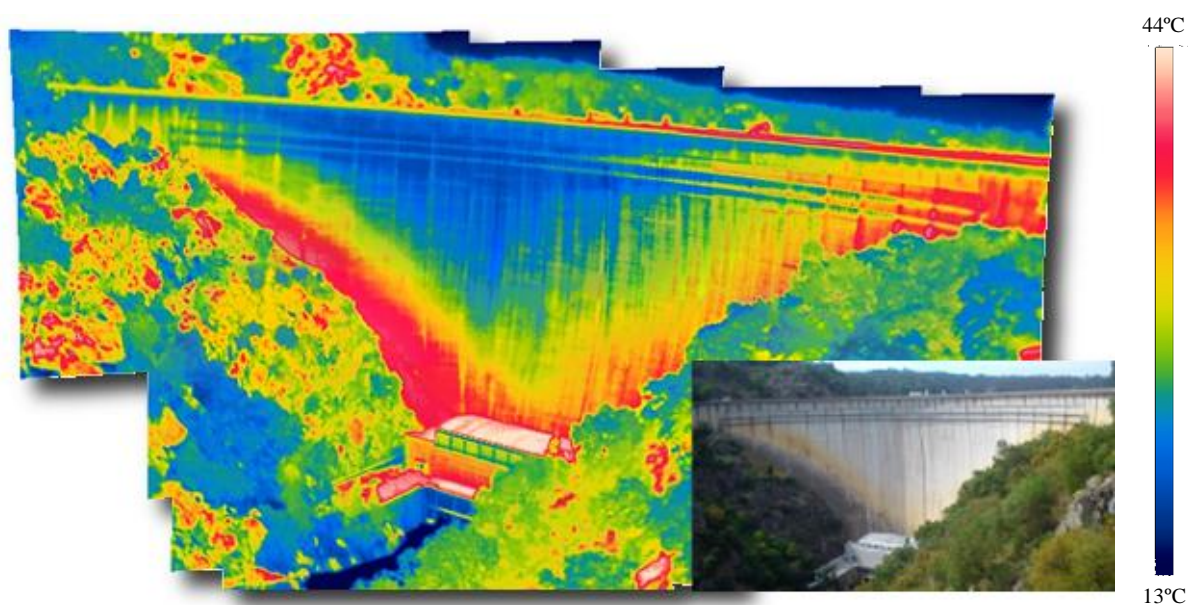
Cabril dam is also an arch dam that faces some structural problems that originated a significant horizontal cracking in the upper areas of the downstream face. On this face there were placed two catwalks to allow the access to the most damage area.

The thermal survey was conducted in four minutes (17 images) from the left bank, near the crest height, about 340 m away the centre of the dam. At that time of the day, half dam was shaded by the right bank. The thermal panoramic image and the normal image are presented in Figure 10. On the visible image one can see long vertical strips, of a darker material, which is also, in the thermal image, hotter than the clean concrete. These lines are related with the draining of rain water from the crest. One can also notice, in the thermal image, a large hot area on the abutment, parallel to the foundation, area that in the normal photo is dark. Above this one is a yellow/brownish area that has an intermediate temperature.

Figure 10: Cabril dam: thermal panoramic image and the normal image.

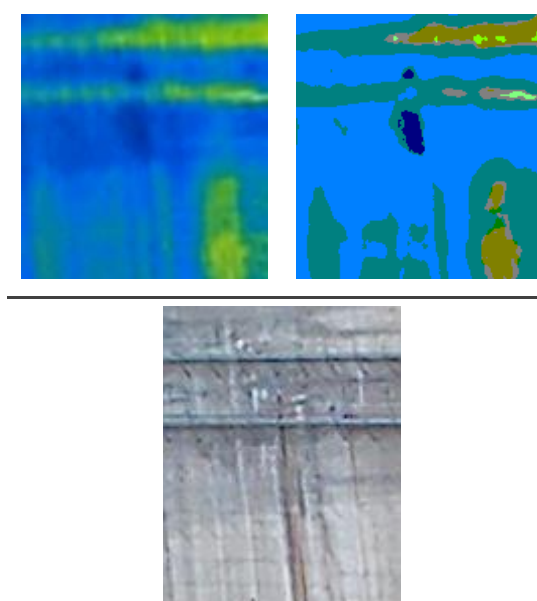
Other small features on the downstream wall affect the temperature of the surface and for this reason are also visible in the thermal image. The most important is a colder area near the lowest catwalk. In Figure 11 are presented two thermal images of the area (in the second there was an enhancement of the colours made in GIMP, an image manipulation program) and the visible image. In this image, one can noticed that there are some white deposits of carbonates. In these images it is also visible the shade of the catwalk.

Figure 11: A detail of the thermal image and of the normal image.

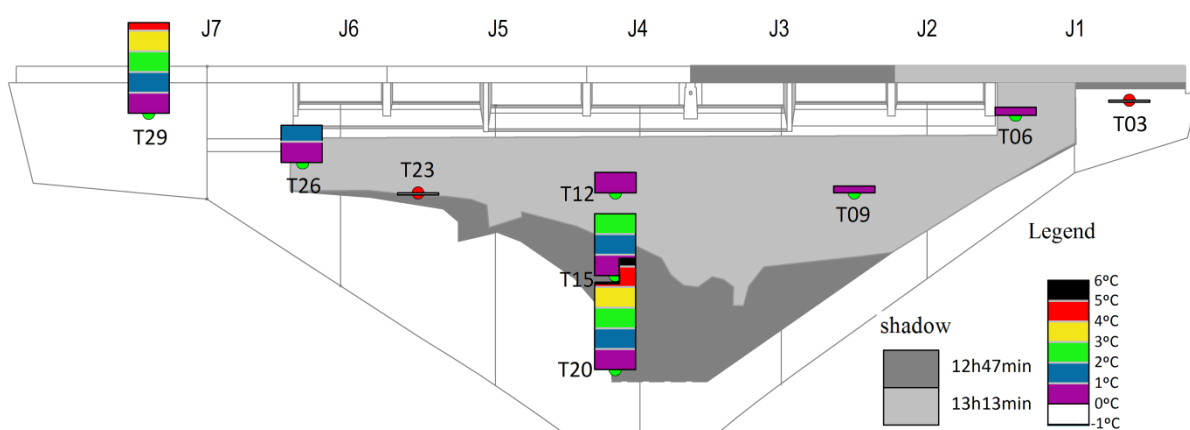
Figure 18: Differences between “thermal image” temperature and “thermometer” temperature.

It is important to remind that each thermometer (a Carlson Resistance Thermometer) is a few centimetres deep and for this, and also because the thermometer has a slow response time (equivalent to the concrete), changes of the temperature of the surface will be sensed by the thermometers some time after the concrete surface has been heated. In fact, with only one exception (on T03), the largest differences happened in the areas where the sun light struck on the downstream face. The small difference detected in T03 area can be explain by the orientation of the wall: not only the sun rays started to strike only 20 minutes prior the photos were taken, but also the angle of incidence was small. On T15 and T20 areas the rays were almost perpendicular to the wall.

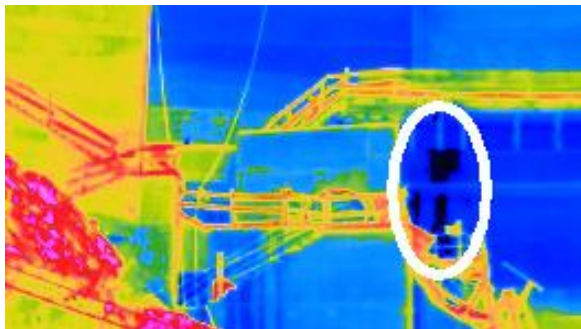
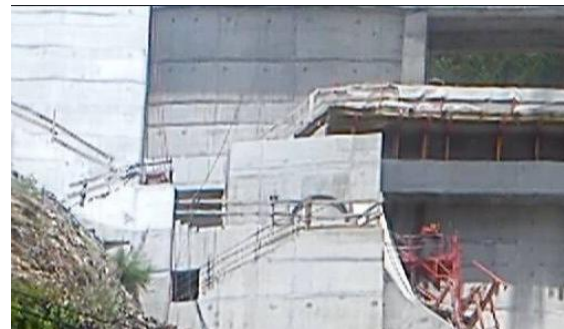
Concerning the five thermometers in the shadow, the differences are small, with the exception of T26. But even this one can be explained. Near the area of thermometer T26 was installed a tube to carry water from upstream to downstream, water needed for construction works that were going on near the foundation, on the downstream side. This tube had losses and for this reason some areas of the surface were wet. In Figure 19 one can easily notice these areas because they are cooler, since their colour is dark blue. Some of these areas can't be detected in the visible image, presented in Figure 20. The wet concrete of the surface was cooler and, by heat transfer, the concrete around T26 was also cooler, as can be noticed in the graph of the Figure 19, where the temperature measure by the thermometer T26 is compared with the temperatures measured by other thermometers. In this graph is also included the "air" temperature measured by a thermometer placed a few meters away from the dam.

Figure 19: Colder concrete near T26.

Figure 20: Visible image of the same area.
