# Influence of Exposure Conditions and Particulate Deposition on Anodized Aluminum Corrosion

Isabel Rute Fontinha \* and Elsa Eustáquio

Laboratório Nacional de Engenharia Civil, Avenida do Brasil 101, 1700-066 Lisboa, Portugal

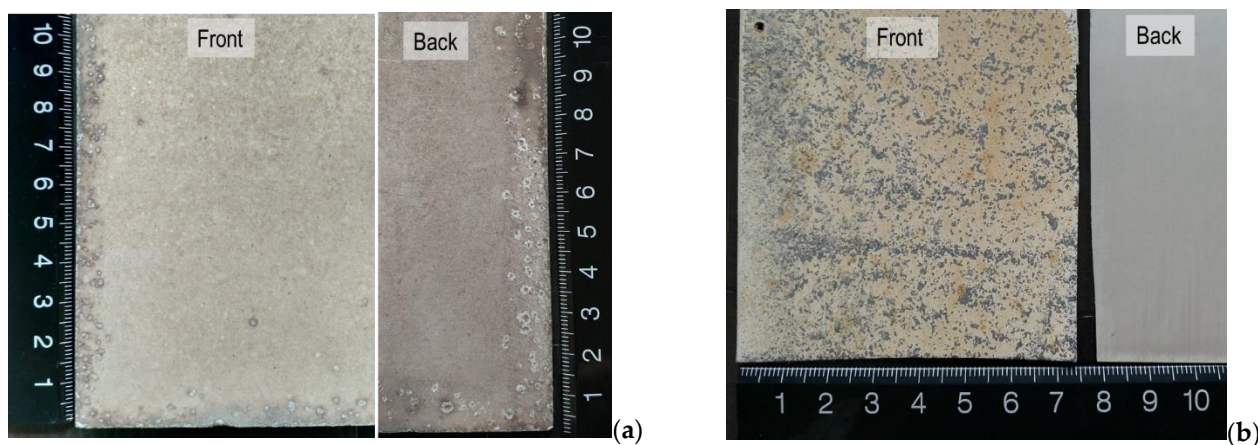
**Figure 3.** Details of the visual aspects of the front (exposed) and back surfaces after ten years of exposure at the test sites: (a) Barreiro (industrial–marine); (b) Rodão (industrial).

After ten years of exposure in the industrial–marine test site at Barreiro, the anodized aluminum specimen surfaces (both faces) acquired a reddish-grey hue (this was observed for all the exposed materials, as can be seen in Figure 2) and showed deep pits mostly on the edges and back faces, and the coating surfaces were slightly rough to the touch (Figure 3a).

At Rodão, after ten years of exposure, the anodized aluminum specimens' upward surfaces became yellow with dark-grey spots and were extremely worn and rough. However, the back surfaces retained practically the original aspects (Figure 3b).

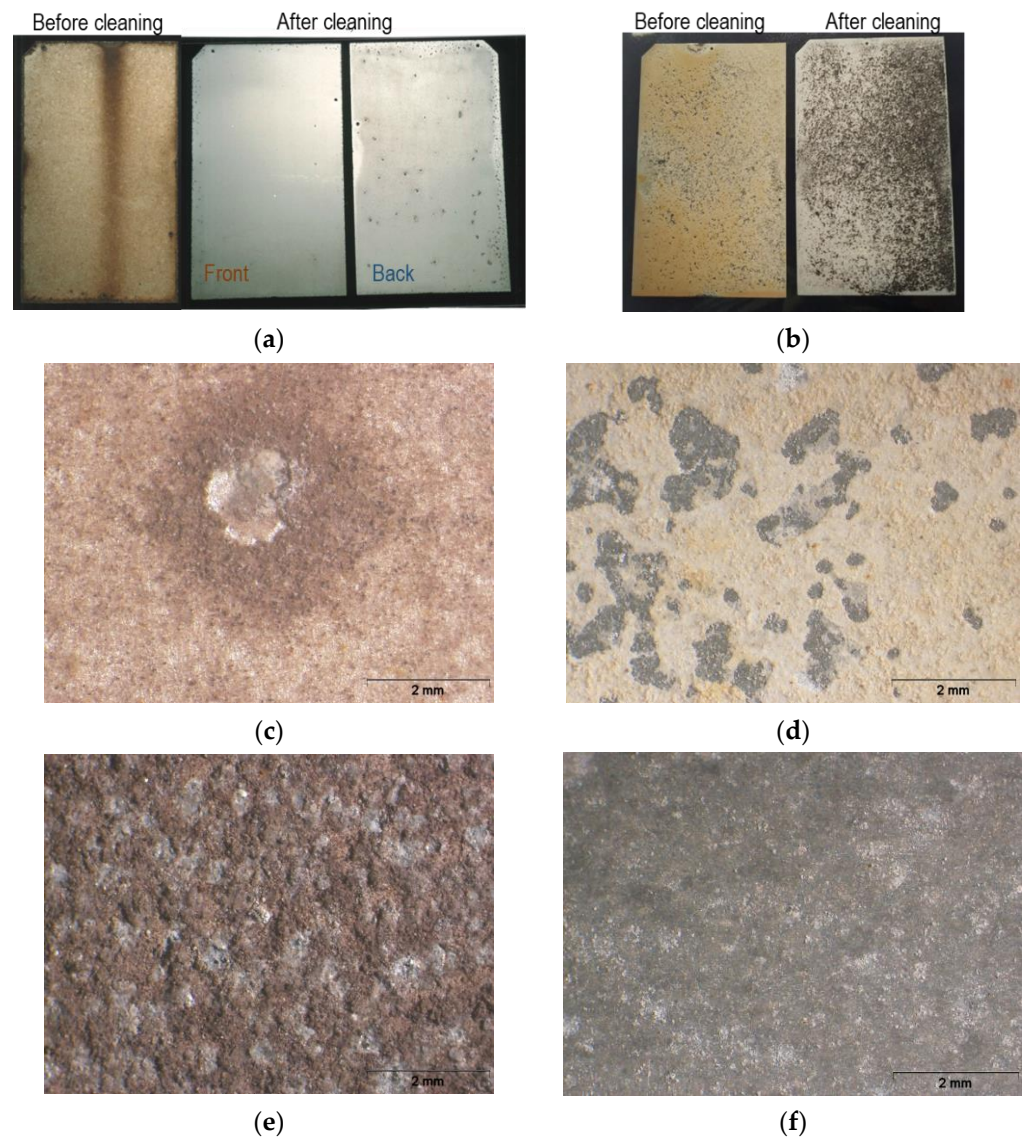
In relation to the type of degradations processes that occurred, it was observed that the specimens exposed at Barreiro showed only pitting corrosion (Figure 4a,c), typical of the kind of atmosphere to which they were exposed—that of an industrial site with marine influence (Table 1). Pitting corrosion was more intense and extensive on the back faces, which were also dirtier. Some superficial attack of the anodic coatings might have occurred as well. It should be noticed that the bare aluminum specimens exposed at this site suffered generalized pitting corrosion (Figure 4e).

**Figure 4.** Test specimens exposed at Barreiro (on the left) and at Rodão (on the right): (a,b) visual aspects before and after cleaning (*Steps I and II*); (c,d) OM images of the anodized aluminum front surfaces after 10 years' exposure and (e,f) OM images of the bare aluminum specimens' front surfaces after the same time of exposure.

The anodized aluminum specimens exposed at the Rodão test site showed generalized dissolution of the coatings on the front surfaces and possible uniform corrosion of the aluminum substrates at the black spots (Figure 4b,d), which were of the same kind as those observed on the front surfaces of the bare aluminum specimens exposed (Figure 4f).

Anodic coating thickness influenced the length of time required for the test specimens to show pitting corrosion. For the lowest range (15  $\mu\text{m}$ –18  $\mu\text{m}$ ), this took three years, while the specimens with anodic coatings with thicknesses above 30  $\mu\text{m}$ , after ten years' exposure, only showed pitting at the edges of the front faces, although pitting had already occurred on the back faces. Pitting corrosion occurring at the edges of the plates was associated with small cracks that developed in these zones, probably due to the cutting that was performed to obtain the plates; therefore, they should be discounted. The maximum pit depth measured was 337  $\mu\text{m}$ .

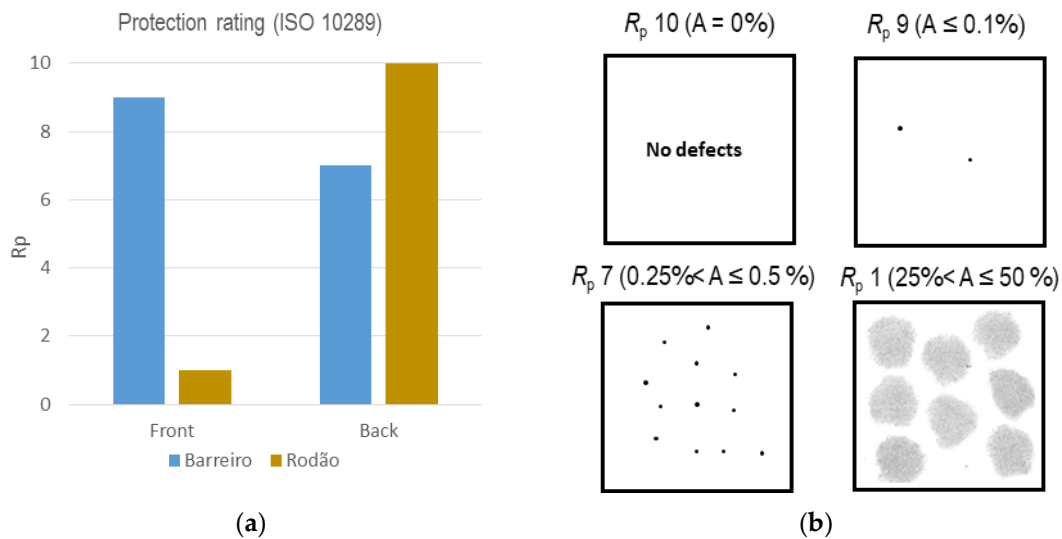
of the coatings of the specimens exposed at both test sites were plotted in the chart shown in Figure 5a. The correspondent image charts used for the classifications are included in Figure 5b. An “ $R_p$ ” of 10 means that no corrosion pits or any relevant type of coating damage was observed on the surface under evaluation.

**Figure 5.** Evaluation of anodic coating protection performances after 10 years’ exposure at both test sites: (a) average (considering all thickness ranges) protection ratings,  $R_p$ ; (b) correspondent standard corrosion-affected areas and dot charts used (scale: 1:2).

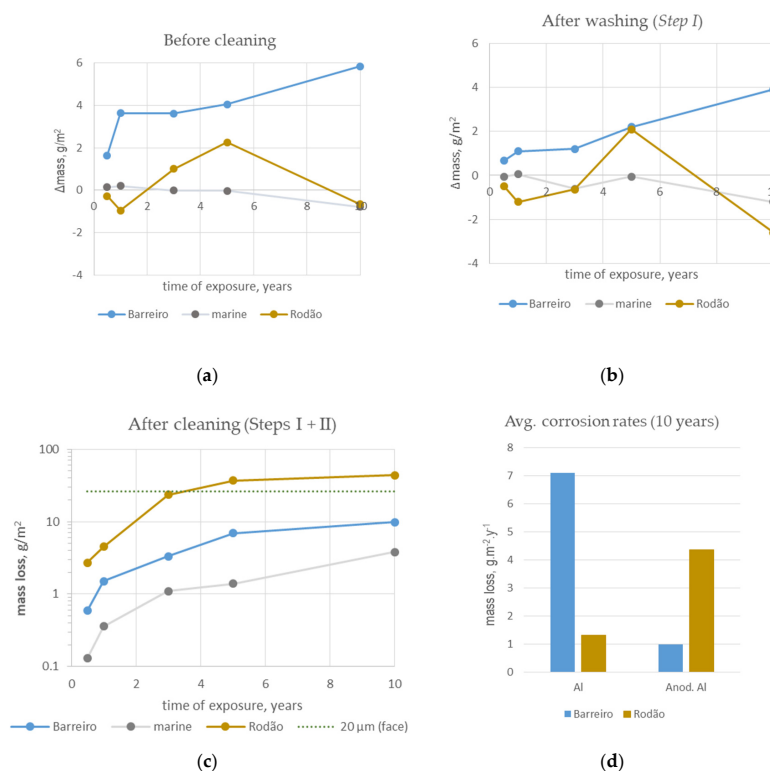
**Figure 6.** Mass variations with exposure: mass changes after (a) exposure, before cleaning and after (b) washing (*Step I* cleaning procedure); (c) mass loss after washing and cleaning in nitric acid (*Steps I + II* cleaning procedure); (d) comparison of anodized aluminum and bare aluminum corrosion rates calculated based on the mass losses obtained after ten years of exposure.

Note that the mass loss values plotted in Figure 6c are in the logarithmic form. A dotted line representing the mass loss associated with the dissolution of a  $20\ \mu\text{m}$ -thick anodic coating on one face was added to this graph to better perceive the degradation level.

Based on the mass losses obtained for the anodized specimens exposed at the Barreiro and Rodão sites, a “corrosion rate” for anodized aluminum was calculated for comparison with that of the bare aluminum specimens exposed at the same test sites. The results obtained for ten years' exposure are presented in the chart in Figure 6d.

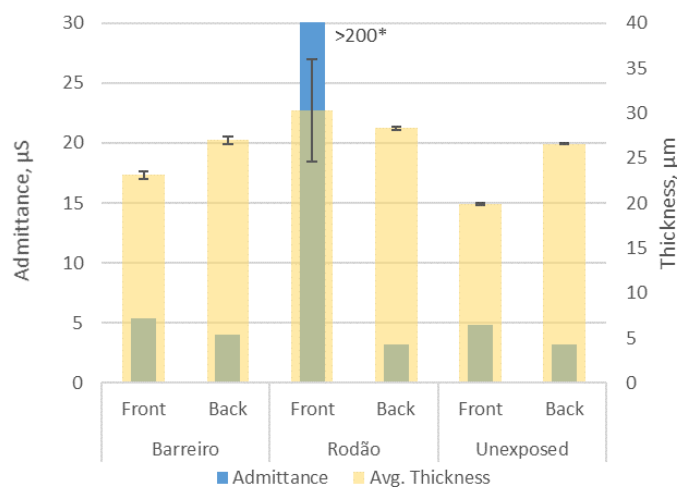
**Figure 7.** Admittances and thicknesses of the anodic coatings of the Barreiro and Rodão test specimens after 10 years of exposure and of an unexposed test specimen. The error bars plotted represent the standard deviations for anodic coating thickness measurements. \* This result exceeds the measuring limit of the apparatus used.

Except for the anodic coating on the upward surface exposed at Rodão, the admittances of the anodic coatings of the exposed and unexposed specimens were similar (Figure 7) and low, ranging from 3 to 6  $\mu\text{S}$ . These values are to be expected for aged coatings of good integrity [35] and implied that, besides the corrosion pits, the damage caused to the anodic coatings of the specimens exposed at the Barreiro test site was superficial and would not have affected integrity. On the other hand, the high admittance value ( $>200 \mu\text{S}$ ) obtained for the upward face of the Rodão specimen confirmed that the anodic coating on this surface would be damaged in depth and far more degraded than those of all the others, namely, the ones on their back faces. These aspects were clarified by the following SEM observations.

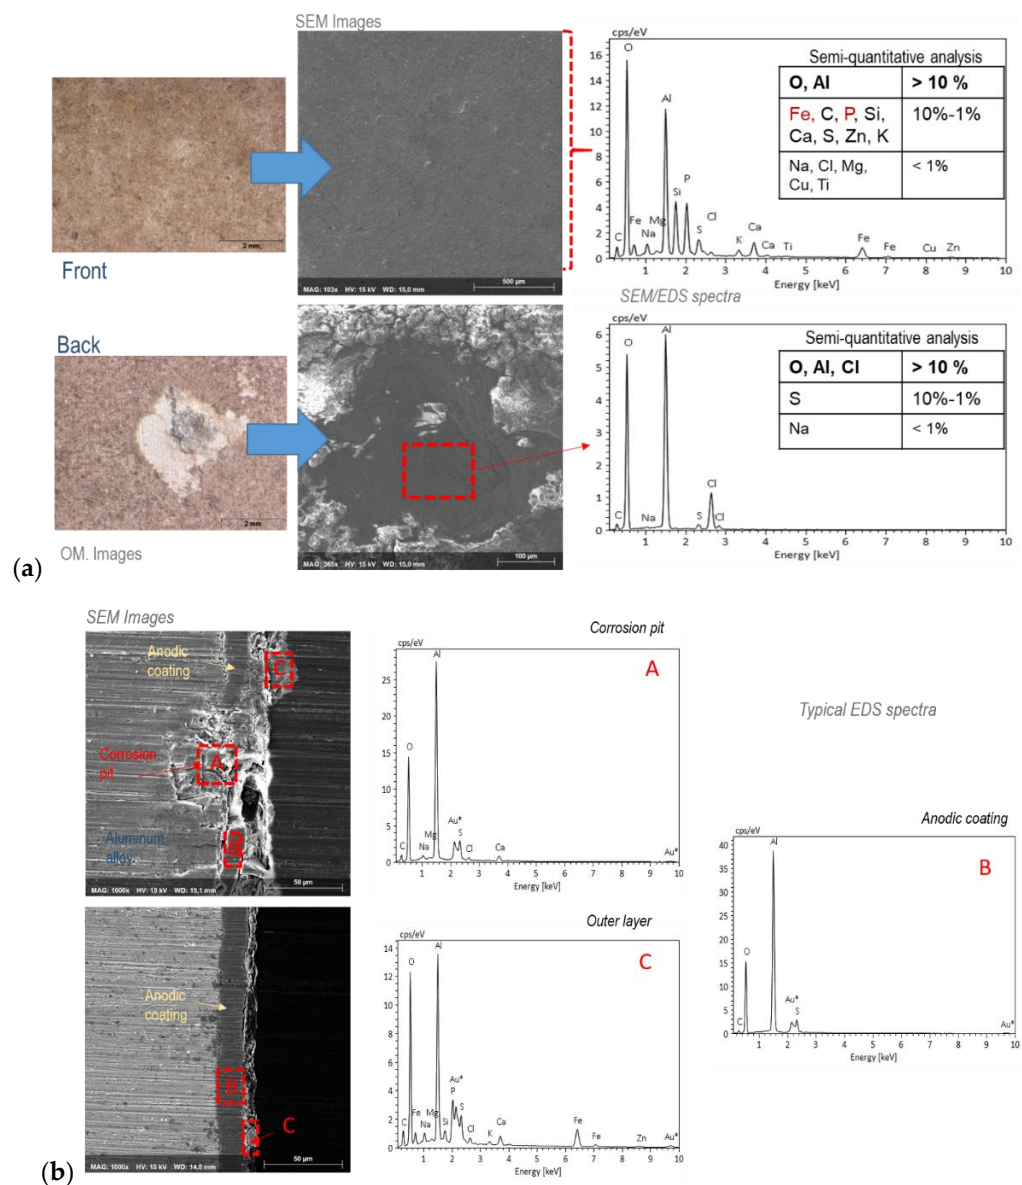
The SEM images of the anodic coating cross sections indicate the extent of anodic coating degradation. At the Barreiro test site, the coating was punctually disrupted at the corrosion pits, but outside these zones was only superficially damaged (Figure 7b). At Rodão, these observations (Figure 9b) evidenced the high degradation that occurred in the anodic coatings of the upper surfaces of the test specimens, sometimes affecting all coating thicknesses, though the anodic coatings on the back faces were still in very good condition. These findings are in agreement with the results of the admittance test.

**Figure 8.** (a) Surface and (b) cross-sectional morphologies and analyses of the anodized aluminum test specimens exposed at the Barreiro test site after 10 years of exposure. The OM and SEM images were obtained from zones with and without corrosion (pitting) of the aluminum substrate; the EDS spectra and the respective semi-quantitative analysis results shown are relative to the signaled zones in the SEM images.

The EDS analyses carried out on the surfaces of the anodized test specimens exposed at Barreiro (Figure 8) revealed that, besides the elements oxygen, aluminum and sulfur, which occur naturally in the coatings, there was a significant presence of chloride (inside the pits). Outside the pits and, in general, all over the Barreiro specimens' surfaces (both faces), chloride was present in reduced amounts, and the most significant elements detected were iron, carbon, phosphorus and silicon. Calcium and sulfur could be found as minor contents, along with several other vestigial elements.

Pyrite ash combined with high levels of sulfur dioxide deposition can lead to the formation of extremely acidic solutions on metal surfaces [37]. It would have degraded the anodic coatings and facilitated chloride attack, leading to more intense pitting corrosion on the back surfaces, where the deposition of airborne particles was heavier. Additionally, the presence of soot and other carbonaceous particles, which are considered highly electropositive [2], must have enhanced the corrosiveness of the soiling deposits formed at the Barreiro test site and consequently contributed to its corrosivity with respect to aluminum.

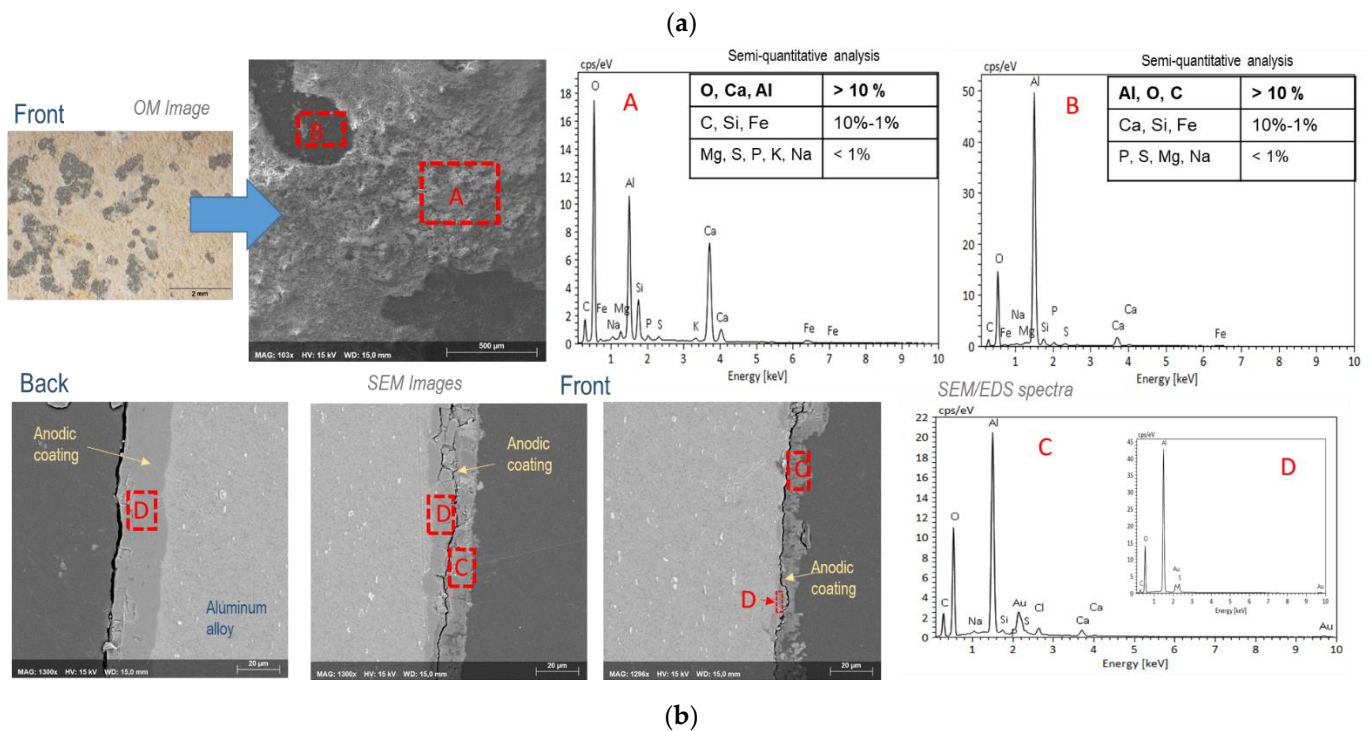
On the exposed (front) surfaces of the anodized specimens exposed at Rodão, the EDS analyses carried out (Figure 9a) revealed significant amounts of calcium and carbon, along with aluminum and oxygen. Calcium content was more relevant in the external "yellow" areas (labeled "A" in Figure 9a) of the damaged anodic coatings, while carbon was more significant in the internal "black" spots (labeled "B" in Figure 9). The other elements

detected in significant amounts in these EDS analyses were silicon and iron, along with several other vestigial elements.

The EDS analyses carried out in the degraded zones of the coatings (labeled "D" in Figure 9b) revealed the presence of the following elements: calcium, carbon, chloride and sodium, in addition to the elemental constituents of the anodized coatings—aluminum, oxygen and sulfur—the only ones present in the intact zones of the coatings (labeled "C" in Figure 9).

SEM observations (Figure 9) of coating cross sections evidenced the depth of the attack of the anodic coatings that occurred on the upper surfaces of the test specimens exposed at Rodão and its relation to the above-mentioned deposited articles. The back surfaces were practically in new condition. This acute difference between the weathering of both anodic coating surfaces of the test specimens clearly demonstrates the detrimental role played by the deposited particles on the anodic coating degradation process. The type of damage inflicted on the anodic coating can only be explained by contact with highly aggressive solutions, most possibly of alkaline nature, such as those that result from calcium product dissolution when these surfaces become wet.
