## CORRECTIVE MEASURES OF THE RIVER BED PROTECTION DOWNSTREAM A DAM FOUNDED IN DEEP ALLUVIA. THE CASE OF CRESTUMA-LEVER DAM

Crestuma-Lever dam, completed in 1985, is located in Douro River. A large design flood of 26,000 m<sup>3</sup>/s involves 8 gated spillway bays with stilling basins directly founded on the alluvial river bed. Regular river bed surveillance downstream of the spillway evidenced unexpected progressive erosion of riprap.

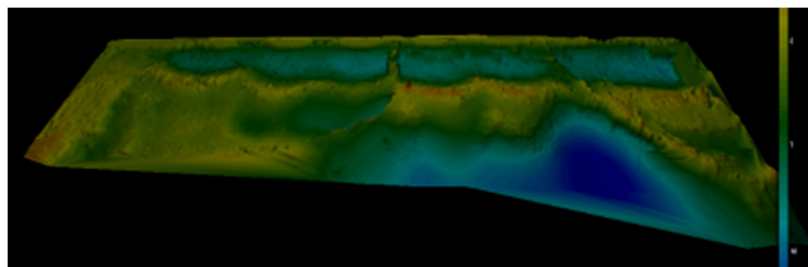
A survey made after the first significant floods of the 1989/90 winter evidenced already the development of an erosion cavity in the initial 10 to 20 m of the riprap and a bar reaching an elevation 1 to 2 m above the original riprap elevation some 30 m downstream of the spillway end sill in three of the eight bays.

A survey made in 1998, after the floods of the winter of 1995/96, evidenced some additional erosion in the vicinity of the spillway and after the floods of 2000/01 surveys evidenced the development of some erosion in the left side of the river and, more significantly, in the central part of it, whereas the right side didn't evidence much change. However, raising more immediate concerns, the transversal profile closer to the spillway evidenced that the previously observed erosion near the spillway was developing further upstream, exposing the spillway downstream cutoff wall. The erosion near the cutoff wall presented an average 4 m depth.

The survey made after the 2006/07 floods revealed that, despite some deviations from previous survey, the overall pattern of the river bed downstream of the spillway was kept, although closer to the dam the erosion of the riprap increased 1m to 2 m downstream of bays 3E, 1D and 5D, and decreased 1.5 m downstream of bay 7E.

Figure 5. Riprap erosion downstream of the spillway in July 2012 (looking upstream).

Underwater inspections with divers were carried out to assess what type of material covered the scoured zone. Special attention was given to the interface between the spillway downstream cutoff wall and the river bed. Visual inspections evidenced that most material in the scour hole was formed by sediments, the protective riprap and underneath filter layers having been damaged across most of the spillway width in the immediate vicinity of its downstream cutoff wall.

After 27 years of systematical observation of the riprap and assessment of need of corrective interventions, a decision was taken in 2011 to replace the damaged riprap. The correction measures involved:

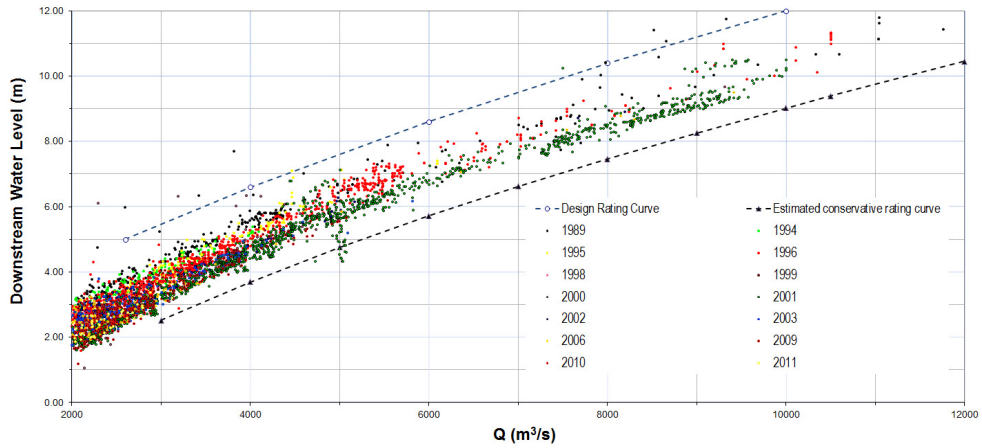
- bathymetry data from 1985 to 2010 evidenced an average lowering of river bed of 4 m downstream of the dam;
- sand mining and navigation channel dredging took place since the dam entered into service;
- operation data regarding the downstream water level and corresponding flow discharges evidenced a deviation from design rating curve.

Tests were made in the model imposing a revised and conservative rating curve, based essentially in the lower boundary of the operation data points, as depicted in Figure 8. Tests were run for the most conditioning range of gate positions in terms of energy dissipation, i.e., considering openings under the gates between 1 and 3 m.

Figure 8. Downstream design and estimated corrected rating curves, and operation observed points.

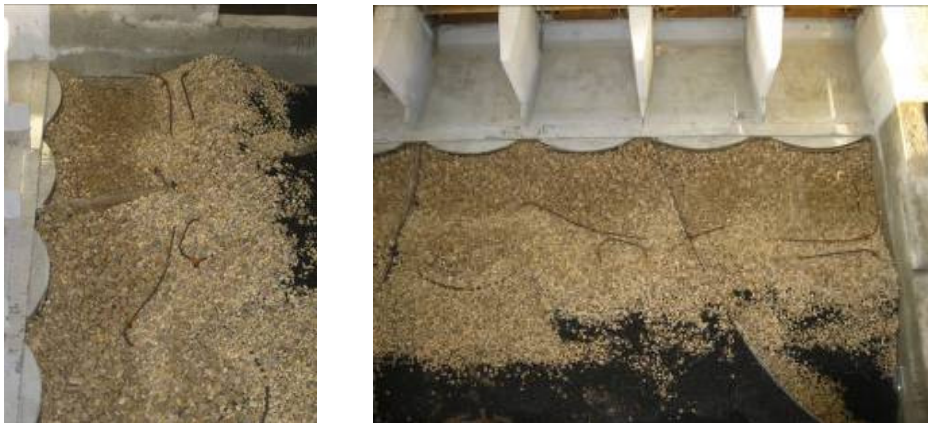
After a simulating two days of continuous operation (prototype), riprap developed an erosion pattern in accordance with the prototype observed pattern of erosion (Figure 9). This indicated that the unfavorable evolution of the river natural rating curve was a major factor leading to the observed erosion.

Figure 9. Riprap erosion reproduced in model assuming a revised downstream rating curve.

The tests carried out in the model evidenced that a considerable increase of blocks diameter was necessary, the mean size having increased from a range of 0.9 to 1.35 m considered in the project to a range of 1.0 to 2.2 m.

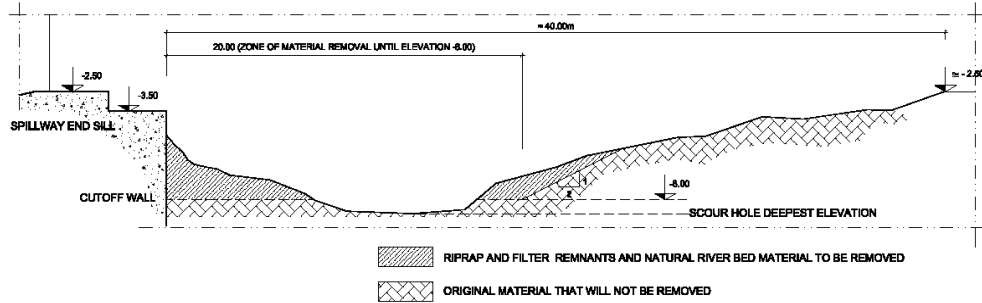
Figure 10. Schematic representation of removal of remnant material from riprap scour hole.

In order to ensure the global homogenous behavior of the new riprap protection, it was carried out the demolition of the damaged riprap, extending from the spillway end sill until the existing bar formed approximately 40 m downstream. Excavation near the cut off wall of the

stilling basin was foreseen until the original river bed was attained and down to elevation -8.00 m, allowing the required thickness to place the first and second layers of filters and the riprap itself (Figures 10 and 11).

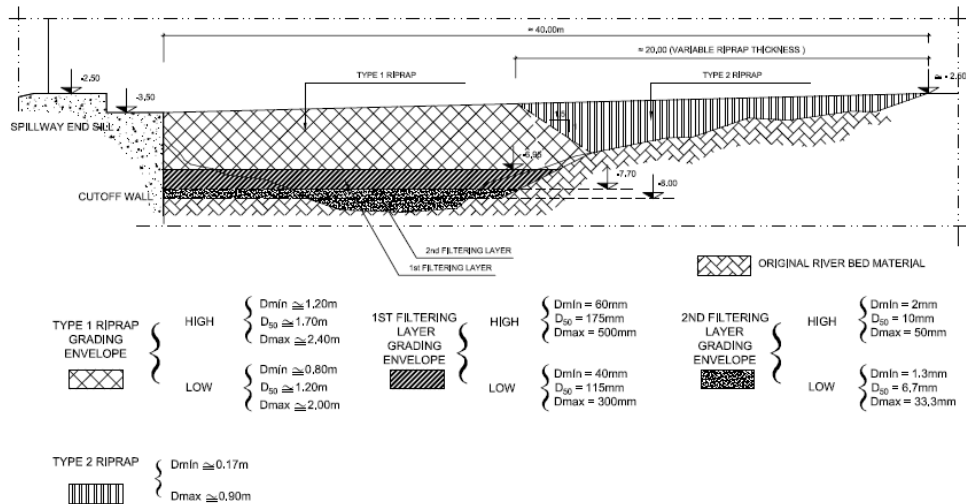
Figure 11. Schematic representation of replacement of riprap and filters for repair of damaged zone.

Based on hydraulic tests results and recommendations of geotechnical nature, a revision of the particle size was recommended for riprap and underlying filter layers (Figure 11).

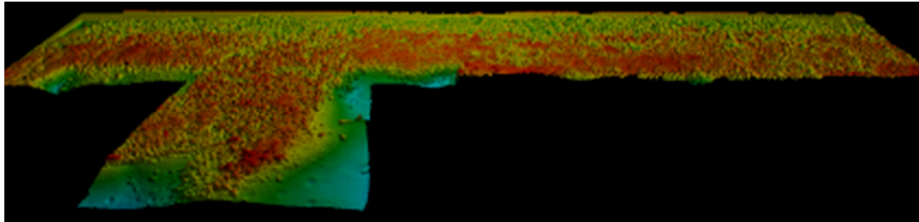
Figure 12. Riprap downstream of spillway after completion of works in Sept. 2013 (looking upstream).

Similarly to what was performed before the repair works, a program for systematic observation of riprap will be set up and implemented, taking as reference the situation evidenced in the most recent bathymetry detailed survey. This bathymetry was made upon the conclusion of the repair works downstream of the dam spillway in September 2013 (Figure 12). The extension of riprap on the right side of the river (left side of figure) resulted from a local additional reinforcement of riprap downstream of bay 3D (refer to Figure 4 for bay identification).
