PATHOLOGY MAPPING IN CONCRETE DAMS THROUGH DIGITAL PHOTOGRAMMETRY AND IMAGE PROCESSING

Dora Roque¹
LNEC

**Maria João
Henriques**
LNEC

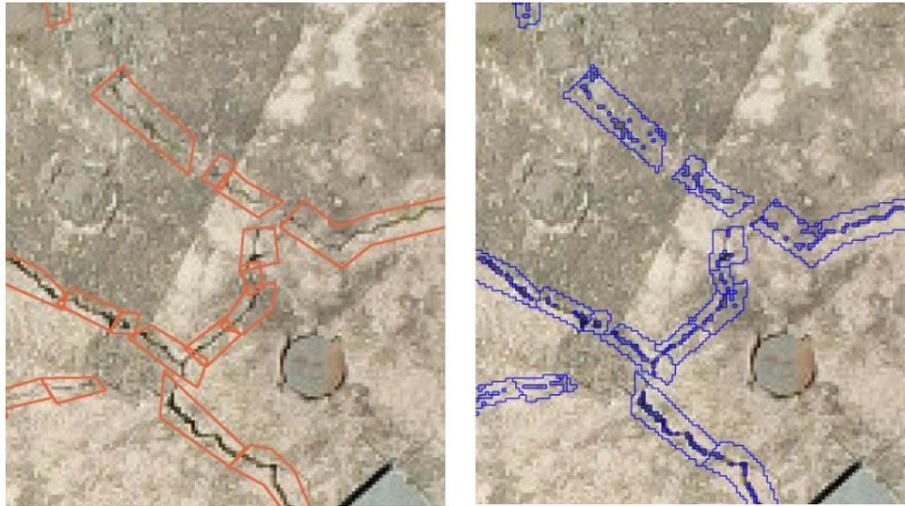
Fig. 4 – Initial crack delimitation (left) and contrast-based crack segmentation (right)

Regarding the dam crest, cracks were the only pathologies considered. As these elements showed high contrast to the surrounding background, the algorithm contrast-split segmentation from eCognition® was used. This strategy required a coarse crack delimitation at an initial phase, which was refined through the separation between bright and dark areas inside the initial delimitation (Fig. 4).

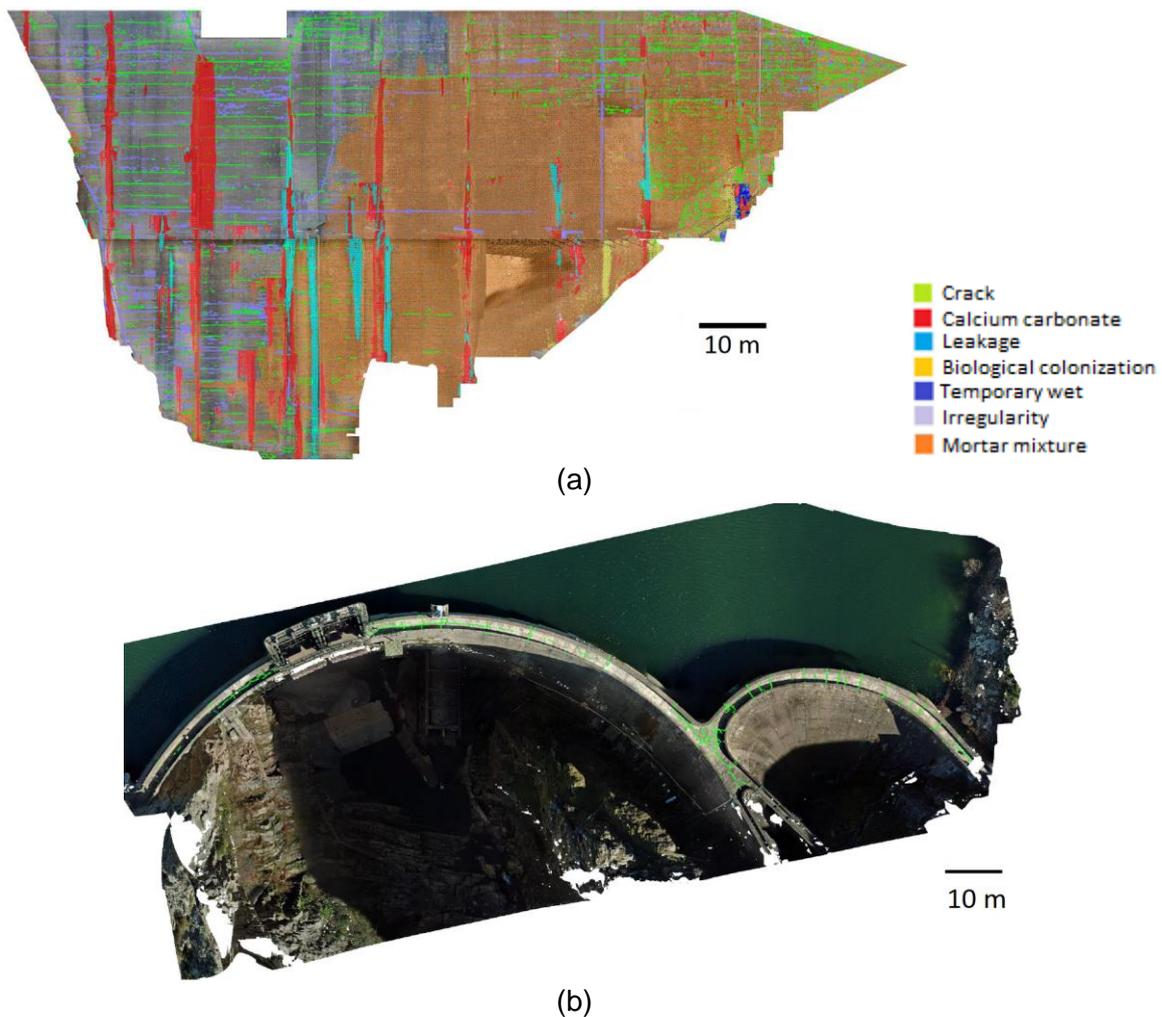
Fig. 5 – Pathology maps for the main body downstream wall (a) and the crest (b)

The cracks with the largest widths were observed in the crest, where one of the cracks presented a width close to 100 mm. Most of the identified cracks, for the four surfaces, presented width values above 2.5 mm. However, this result was influenced by the image spatial resolution, as will be discussed in section 6. Around 60% of the main body downstream wall was covered by the mortar mixture, which did not allow the observation of the dam surface, hiding eventual pathologies. Most calcium carbonate deposits on the downstream wall covered areas below 1 dm². However, there were several deposits with areas larger than 1 m². Most leakage signs in this surface covered areas between 1 cm² and 1 dm². Areas affected by biological colonization tended to be larger in the arch-gravity (areas from 1 cm² to 1 dm²) than in the main body (areas from 1 mm² to 1 cm²). The upstream wall was mostly affected by calcium carbonate deposits and biological colonization. Calcium carbonate deposits had areas between 1 cm² and 1 m². Due to the water proximity, the upstream wall was wet and presented large spots of biological colonization, which, in some cases, reached more than 1 m².
