# The failure of the Fonte Santa mine tailing dam (Northeast Portugal)

**ABSTRACT:** The Fonte Santa mine tailing dam situated in the Northeast of Portugal failed on the 27<sup>th</sup> November 2006 due to a combination of hazards, an extraordinary rainfall and an eventual clogging of the spillway. The dam was an earthfill embankment about 25 m high and with a crest length of roughly 35 m. After the overtopping of the crest, which originated the breaching process and consequent failure, the dam was completely washed away with a fraction of the mud retained in the reservoir. The present paper constitutes a preliminary report of the accident describing the dam breaching process and the morphodynamic changes on the downstream valley. The breach geometry is characterized and estimates of the water and mud releases are presented. The geomorphic changes in the valley are described, including deposition volumes of the dam material and eroded volumes from the riverbed.

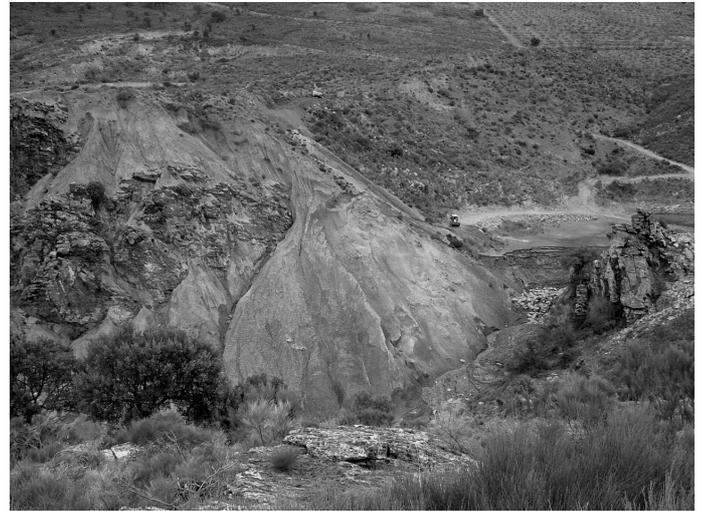
The dam is located in a section of the valley where a rock formation exists (Fig. 2). The flood discharge was made through an uncontrolled spillway excavated in the rock in an adjacent valley, with the upstream section at the level 504.4 m asl and a 3.5 m diameter roughly circular section. Eventually the upstream section of the spillway was clogged with rock

Figure 2. General view of the Fonte Santa tailing dam after the dam break. Almost the totality of the dam body was eroded. The dam is located in a rocky and very stable section of the valley. The mud deposited in the reservoir was released leaving a scar which is visible in this picture from downstream.

On the 24<sup>th</sup> November 2006, an extraordinary rainfall occurred in the region. The continuous feeding of the reservoir for three days, combined with the clogging of the spillway, lead to the overtopping of the Fonte Santa dam crest originating breaching and subsequent total failure. The dam was completely washed with a small portion of the mud retained in the reservoir (Fig. 2). The immediate consequences of the accident were mainly loss of low density crops and eventual soil contamination.

Local contractors exploited illegitimately the embankment material (fine gravel used as a construction material) excavating directly from the downstream dam toe. These actions may have contributed to a destabilization of the dam body and may be in the origin of the complete washout of the dam.

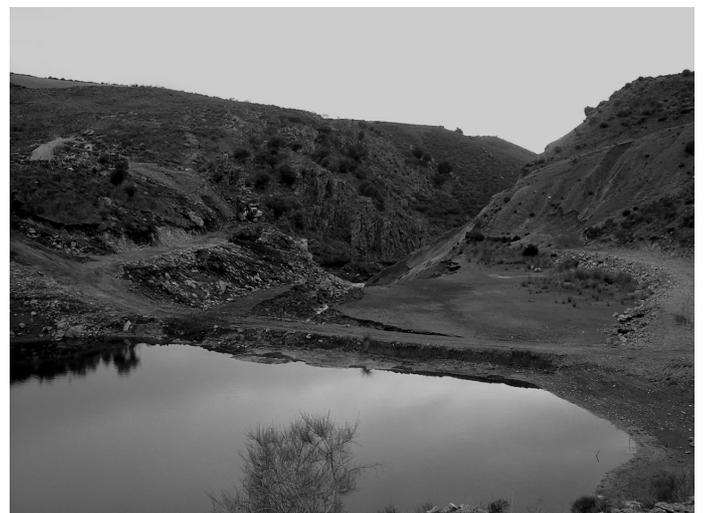
Figure 3. Reservoir where 1.5 hm<sup>3</sup> of the volume is filled with waste mud from the mining processes. After the accident, a temporary solution constituted by an embankment (visible in the photograph) was made to stop the downstream mud release.

The mud deposited in the reservoir was released leaving a scar which is visible in this picture from upstream.

During the dam break event the mud deposited immediately upstream the dam lost its stability and was eroded downstream, as it is evidenced by a scar in the reservoir bottom (Figs. 2 and 3). Locally we could infer that a volume of  $1600 \text{ m}^3$  was released and disseminated in the valley

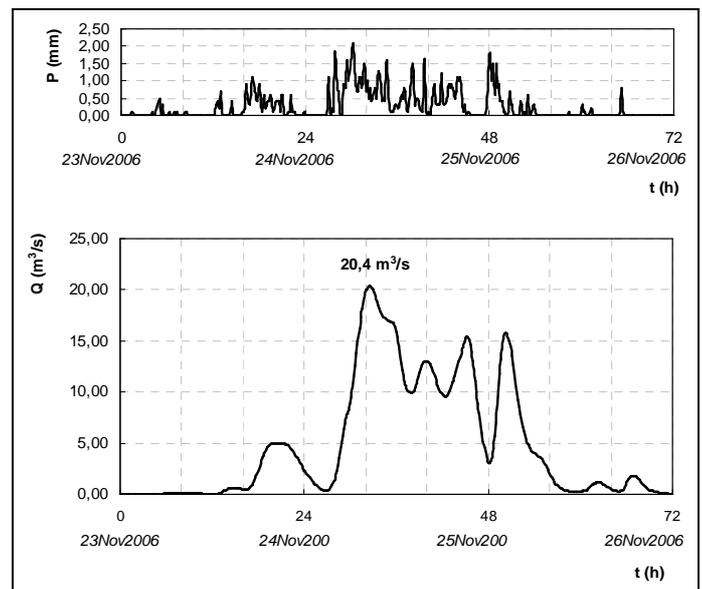
According to the meteorological information, between the 23<sup>rd</sup> and the 25<sup>th</sup> of November 2006, a total rainfall of about 115 mm occurred on the basin area. 63% of this precipitation took place on the 24<sup>th</sup>, having the remaining precipitation occurred equally distributed between the 23 and 25<sup>th</sup> November. The peak flow of the hydrograph (20.4 m<sup>3</sup>/s) at the Fonte Santa dam was obtained on the 24<sup>th</sup> of November at 8:30 am (Fig. 7). The total volume of water inflowing into the reservoir for the three days of rain was of 1 300 m<sup>3</sup>.

Figure 7 – Reconstructed hydrograph at the section of the Fonte Santa dam and Mogadouro precipitation hyetograph with a acquisition period of 10 min, for the 23, 24 and 25<sup>th</sup> of November.

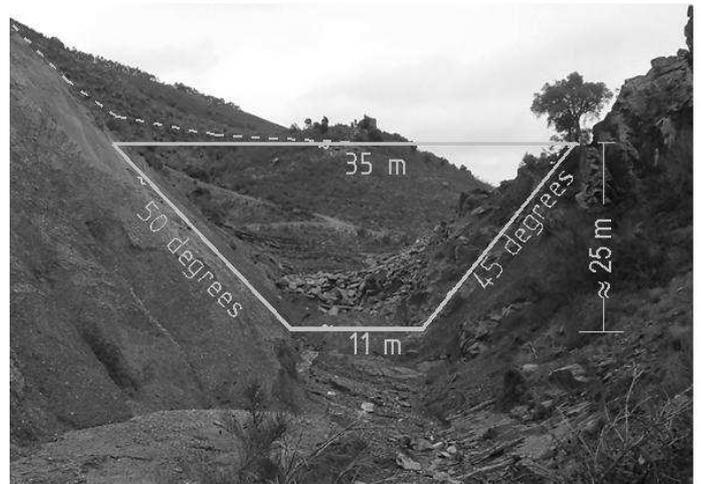
Knowledge on the breach final configuration provides information for the calibration and validation breaching models (Singh 1996). Wahl (1997) affirmed that the characteristic parameters of the dam breach in embankment dams are the width, the depth the lateral bank slope and the formation time – see the overview by Singh (1996). The breach geometry was inferred in the field by adequate topography instrumentation. Locally we observed that the total volume of what used to be the informal dam body was washed away (80 to 90% of the 4 500 m<sup>3</sup>, cf. Fig. 2) contributing to the large gravel accretion verified in the downstream valley. Fonte Santa breach has nearly a trapezoidal shape (Fig. 8). The dam breach reached the valley bottom, thus the ero-

sion depth was about 25 m. Fonte Santa dam breach geometric parameters are presented in Table 1.

Top width (m)	35 m
Bottom width	11 m
Height	25 m
Right riverbank slope (angle with the horizontal)	50°
Left riverbank slope (angle with the horizontal)	45°

The presence of fine mud elements within the gravel composing the dam provided enough cohesion to hold such high average lateral slopes of the breach banks; locally the breach walls are nearly vertical. The deposition of the breach material was made along approximately 2500 m of the valley.

Figure 8. Final configuration of the dam breach. In the figure, a reconstruction of what could be initially the geometry of the dam crest is represented in dashed; the crest was not horizontal. The mud deposited in the reservoir was released leaving a scar visible in the picture. The figure is not scaled and the dimensions are not proportional. In the picture one may see works undertaken by the dam owner to stop the mud and water release.

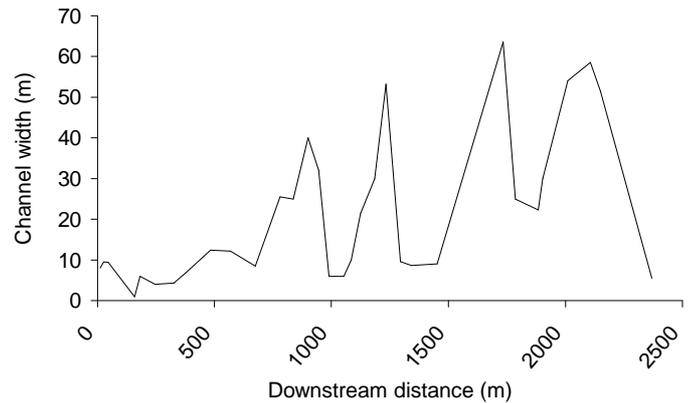
On Figure 9, we define the width across the channel where morphodynamic impacts from the passage

Figure 9 – Lateral extension of the morphological impacts of the flood passage.

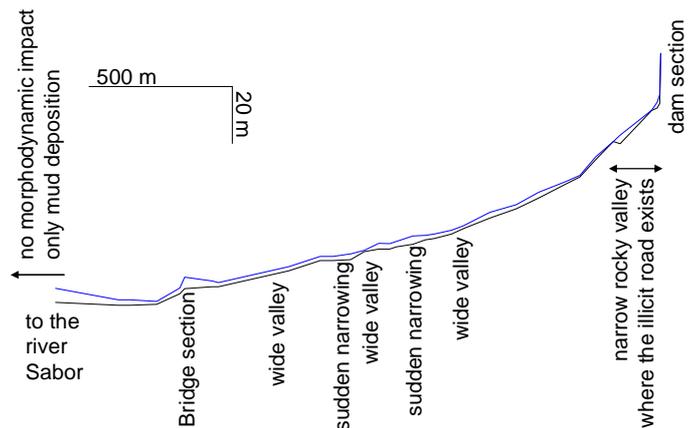
When the field visit was made, flood marks corresponding to the maximum water levels occurred during the dam break flood were visible. This allowed the mapping of the flooded areas along the downstream valley. Figure 10 shows the maximum flood levels observed throughout the valley, caused by the dam break flood event.

Figure 10 – Valley profile with the maximum flood levels observed in the field.

The maximum water depth verified with the passage of the flood is consequent with the channel geometry (cf. Fig. 9). Just after the dam, in the narrow reach of the valley, the water depths were as high as 5.5 m. Downstream, major elevation of the water depths occurred occasionally before river constrictions and in the bridge section which was overtopped over 0.5 m. Upstream the narrowing sections, the destruction was more evident on the vegetation, riverbed and occasional natural or manmade structures, due to the apparent formation of a hydraulic.

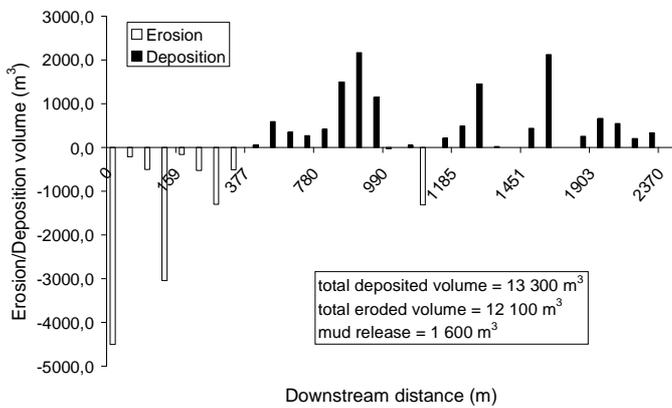
Figure 11 shows the estimates of deposition and erosion volumes on the riverbed, obtained from local assessment.

Figure 11 – Profile of the estimated erosion and deposition volumes of the river bed, throughout the downstream valley and based on the field survey.

The erosion peak observed at the upstream section corresponds to the erosion of the dam body (estimated in  $4\,500\text{ m}^3$ ). The main erosion occurs immediately downstream the dam until roughly 380 m after the dam, where the valley was filled with the illicit road referred previously. Actually, for the sake of the morphodynamic impacts analysis, the existence of this structure was positive allowing a good estimation of the erosion power of the passage of the flood.

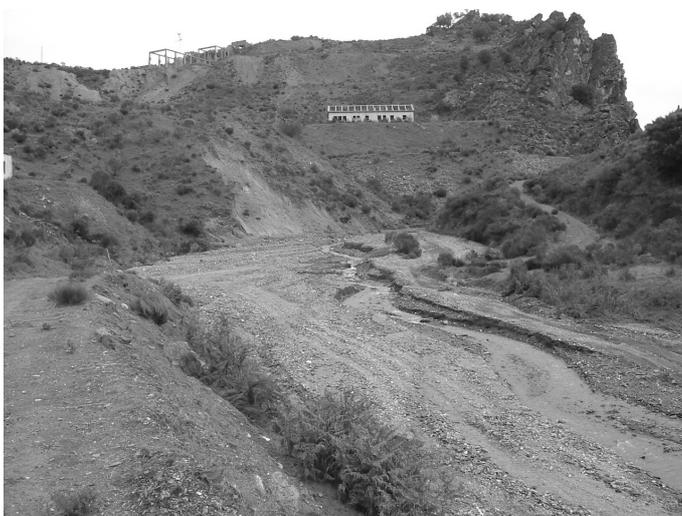
Downstream, mainly deposition of the dam material is verified due to the immense volume of fine gravel that composed the informal dam body (Fig. 12). Furthermore, part of the deposited material throughout the valley is originated from the gravel road embankment which is made from the same material of the dam body. The deposition occurred essentially in the river sections where the available flow area increased, allowing a reduction in the flow velocity and consequently the erosion capacity of the flow diminished (cf. Figs. 8 and 10).

Figure 12 – Deposition occurred on the riverbed, roughly 500 m downstream the dam section.

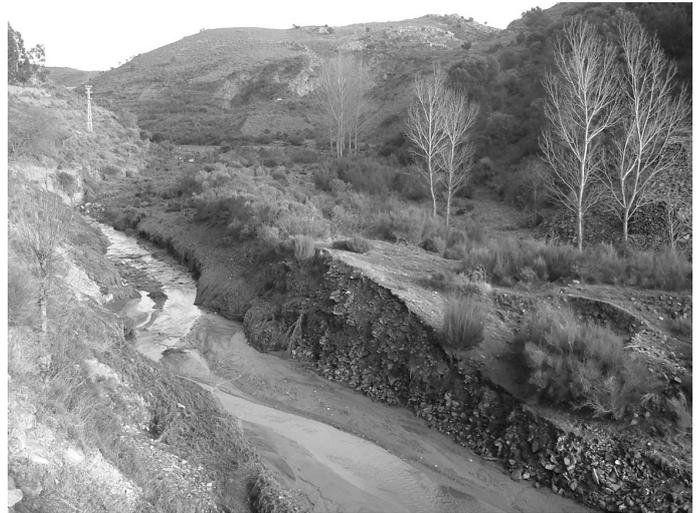
are observed after the section 380 m. Bank erosion (Fig. 13), though not assessed on Figure 11, was observed as well in sudden reductions of the available flow area and where the bank material allowed higher erosion rates.

Figure 13 – Erosion occurred on the riverbank, roughly 700 m downstream the dam section.
