Main Spatial Defects of Illegal Residential Buildings: The Case of Alto da Cova da Moura District

The purpose of the paper is to describe the main spatial defects in illegal residential buildings. Three research questions are addressed: What are the main spatial defects of the dwellings? What are the main spatial defects in the relation between buildings? What is the impact of spatial defects to the minimum habitability conditions of dwellings?

The defects were identified during a survey of the buildings of the Alto da Cova da Moura District (Amadora, Portugal), carried out in 2008. This district is made-up of illegal constructions, covers an area of 16.5 ha and has approximately 5,000 inhabitants. During the survey 833 buildings and 1,884 units were inspected. The main results are: a) 65% of buildings have problems with windows; b) about 20% of buildings have spatial defects in common stairways; and c) more than 50% of dwellings have spatial defects.

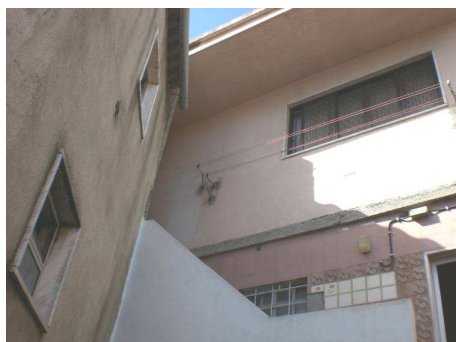
- 1) few buildings had parts overlapping other buildings;
- 2) almost half of the buildings had windows near windows of nearby buildings (*i.e.*, less than 6.0 meters) (Fig. 2);
- 3) few buildings had windows over roofs of nearby buildings (only roofs that do not comply with fire resistance requirements at a distance less than 3.0 meters);
- 4) almost one third of the buildings had windows over the edge of a bordering lot;
- 5) almost half of the buildings had windows near to obstacles that reduced natural light (Fig. 3).

Figure 2. Small distance between windows of neighbouring buildings.

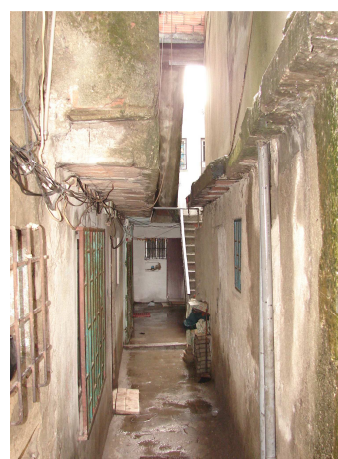
Figure 3. Windows opened to an alley with about 1 meter width.

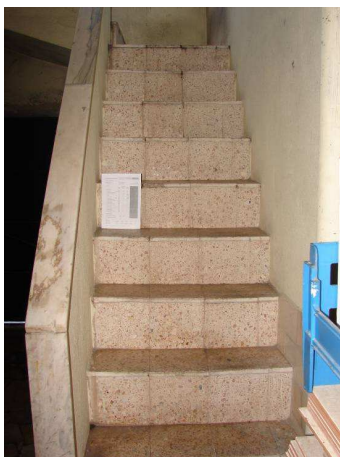
The most common defect in horizontal circulation spaces was an insufficient width of rest zones in front of the main doors of units or even the total absence of this zone. The most frequent defects in vertical circulation spaces were: low ceiling height, high rise and small tread of steps (Fig. 4) and narrow stairs (Fig. 5).

Figure 4. Stairs with high rise steps.

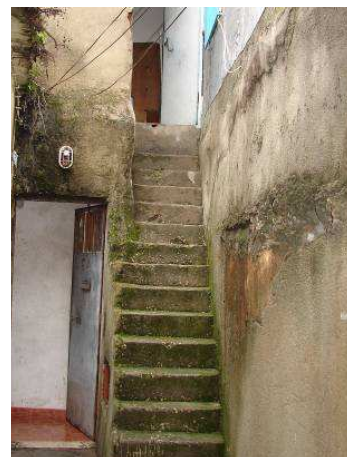
Figure 5. Narrow stairs with uneven development.

The main problem was the poor accessibility conditions in the buildings to access to units. This, in addition to affecting the safety and comfort in normal use, represents a special risk in emergency situations (e.g., in case of fire).

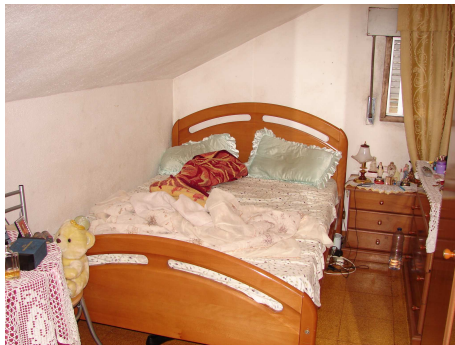
Low ceiling height of rooms was found in about 30% of the units with spatial defects (Fig. 7). This defect is more common in units located in attics. Solving this defect requires extensive and complex interventions on the structure, roof, walls and installations.

Figure 7. Bedroom with low ceiling height.

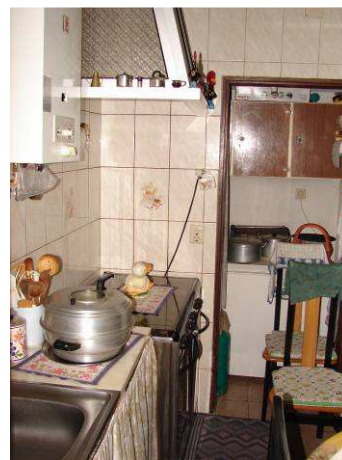
Rooms with floor area below the regulatory provisions were found in about 15% of the units with spatial defects. The rooms used as kitchens or bedrooms are particularly undersized (Fig. 8). In some cases, storage spaces were converted into bedrooms, and have an area less than 3 square meters. In most cases, bedrooms with very small floor area had no daylighting or ventilation. Undersized rooms had also more constructive defects.

Figure 8. Undersized kitchen.
