Monitoring the behaviour of Massingir dam in Mozambique

João Marcelino (1); João Portugal (2)

Abstract

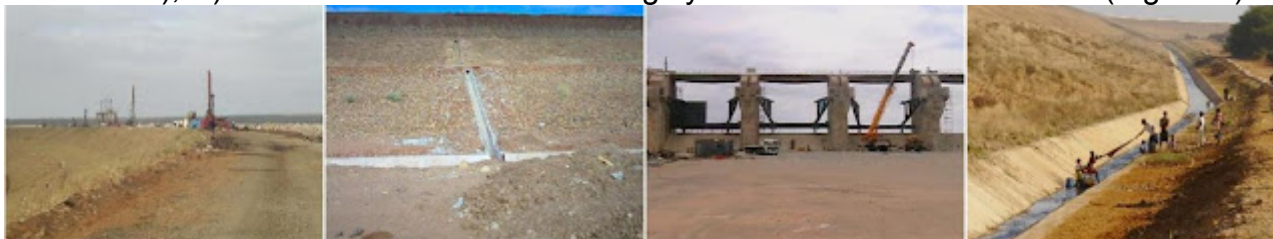
Figure 4 - Rehabilitation works: injections, stabilizing berm, gates and relief wells and ditch

From April 2004 to December 2006, Massingir dam was submitted to several rehabilitation works, based on a design from WAPCOS 1994, revised by Coyne et Bellier (as the consultant of ARA-SUL the owner). The rehabilitation included mainly the following tasks: i) sealing the foundation in certain areas, by grouting, ii) construction of a stabilizing berm downstream of the dam's right dike, iii) construction of 85 relief wells along the right bank the dike and the on main valley, with a drainage ditch to drain the water collected; iv) the lift of 1 m of the crest elevation; v) construction of a concrete parapet on the crest of the dam to increase security against extreme flood events; vi) rehabilitation of the rip-rap; vii) the installation of the spillway gates, viii) repair of hydro-mechanical equipments of the bottom discharges (cofferdams gates, sector gates, servomotors and downstream cofferdams), ix) rehabilitation of the monitoring system and other minor works (Figure 4).

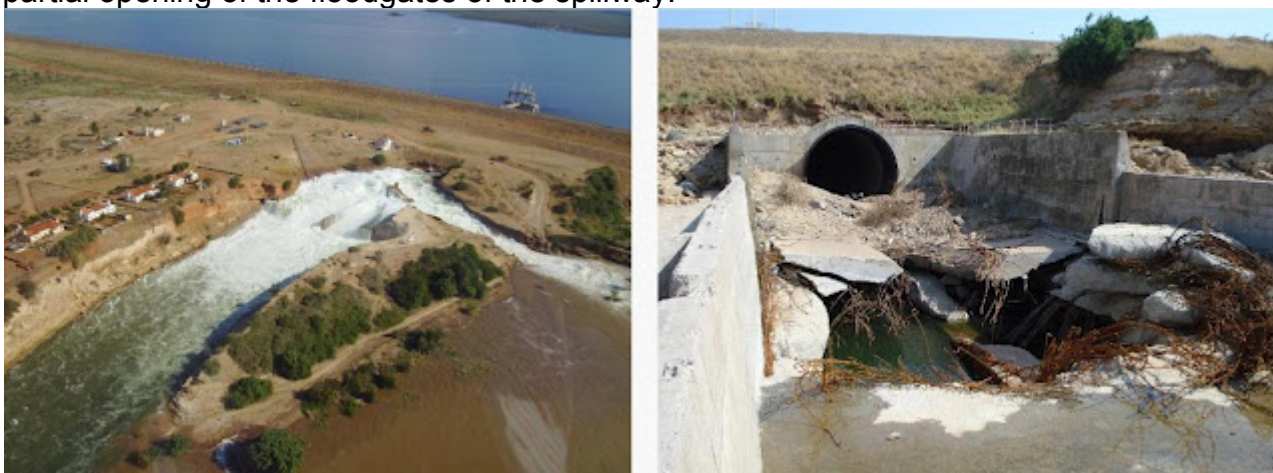
Figure 5 - Accident in the dam (May 2008) and final state of the central area and exits of bottom discharges

The refill of the reservoir, after the completion of the rehabilitation, followed a plan with three intermediate levels: 120, 122.5 and 125 m (MWL) (Coyne et Bellier, 2007). Filling was, however, interrupted by the accident that occurred in bottom discharges on 22 May 2008 when the water in the reservoir was at level 122.6 m (Figure 5). The analysis of possible causes of the accident is outside the scope of this paper and the subject will not be addressed. There is interest, however, to mention the consequences of the situation. Indeed, since then, the dam operation is very limited, because the bottom discharges are virtually inoperative. The level of the reservoir is controlled above the level 115 m, by the partial opening of the floodgates of the spillway.

Below this elevation the dam can not be operated unless they proceed to the opening of the floodgates of the bottom discharges, with all the inconveniences that might ensue, namely very strong vibrations.

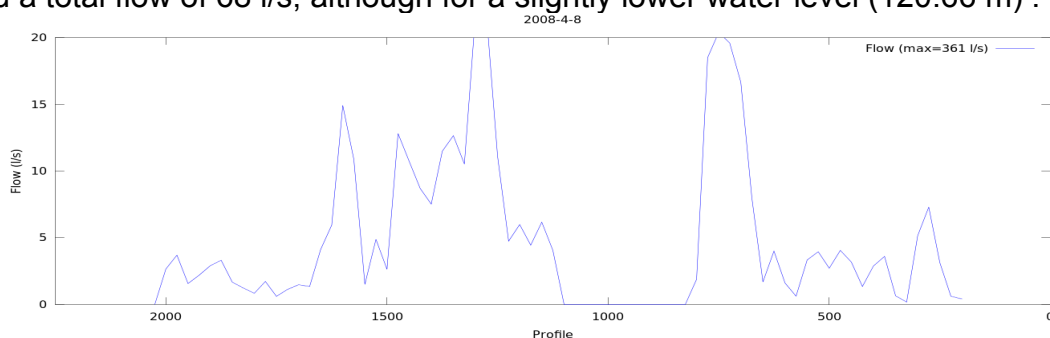
Figure 8 - Flow measured in the relief wells on 08/04/2008

As expected, because of the errors due to the measuring system, some of the values in the data used have significant errors. In particular, very often, between consecutive readings of the flow, the change is of the same magnitude of the actual reading, without apparent reason for this to happen. Apart this aspect, there are interruptions in the readings, in particular when the reservoir level is higher, which relates to the fact that some wells become drowned, preventing the measurement. The available results, nevertheless, allow the realization of forecasts.

Figure 8 shows measurements of flow corresponding to reservoir level 122.53 m on 8 April 2008. Some of the wells were not measured because they were drowned. The sum of the measured flow (in the wells) in this date is 361 l/s. The predicted value, according to the model established in section 4.2 is 424 l/s. Thus, it is assumed that the wells that have not been measured, between the profile 825 and 1100, could have a flow corresponding to the difference, ie about 63 l/s. This value is compatible with other dates on which measurements were made in these wells. This was the case, for example in May 2010, where in the same set of wells (except those situated to profile 850, 950 and 1075) it was obtained a total flow of 68 l/s, although for a slightly lower water level (120.66 m) .

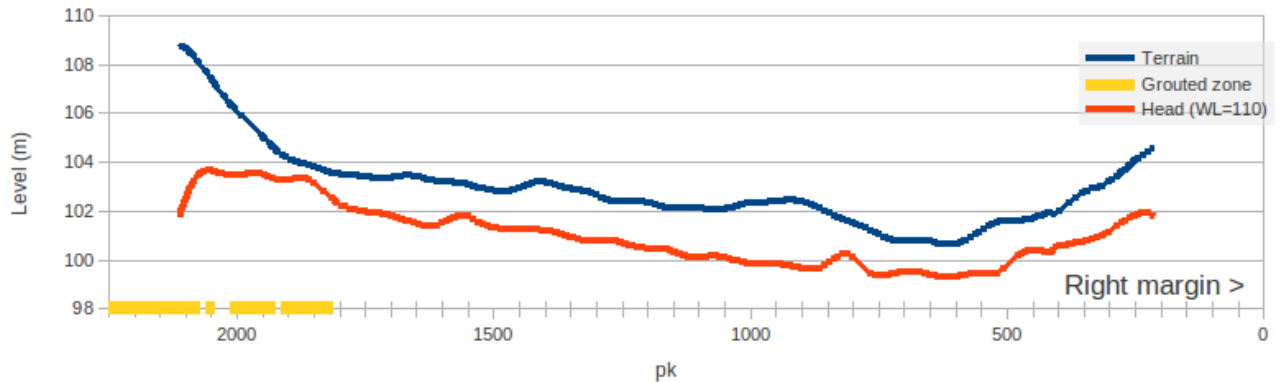
Figure 9 - Prediction of pressure in the foundation of the right bank dike for water level = 110 m

Figure 9 illustrates the situation observed for the lower levels of the reservoir - WL at elevation 110 m (in yellow, the limit of the areas treated with foundation grouting). The pressure head is always below the terrain elevation. Figure 10 illustrates the prediction for the maximum water level. In a considerable extension of the foundation, the water head is above the terrain. The worst situation, with a head of about 3.7 m above the foundation, is close to the profile 0+862.50, near the limit of an area treated with grouting. Although the hydraulic gradient is not very high - about 0.17 - this gradient is computed over 23 m (the length of the piezometer). Given the amount of wetlands that occur to the highest levels of the reservoir, probably the gradients are substantially higher.

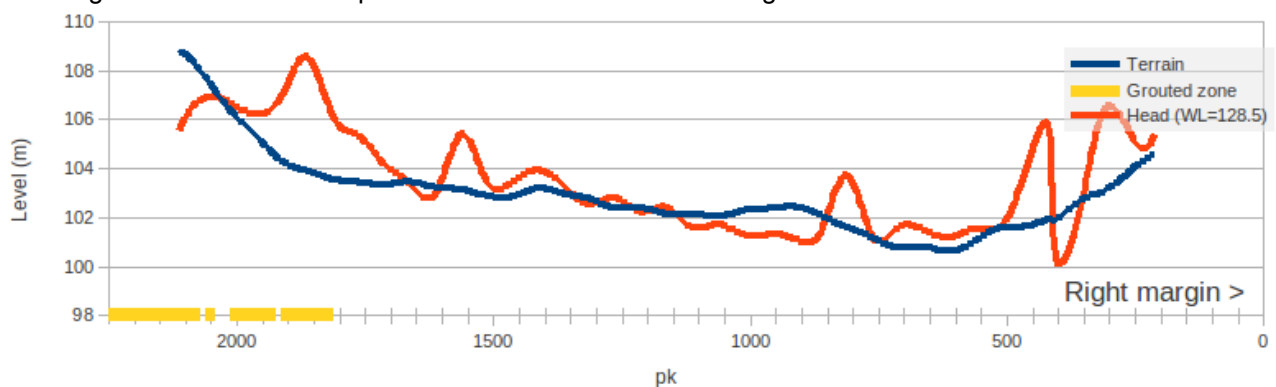
Figure 11 - Prediction of pressure in the foundation of the right bank dike for water level = 128.5 m

Figure 11 shows the estimate corresponding to the maximum flood level. In these circumstances the maximum head height is 4.6 m above the ground and artesianism occurs in about 67% of the length of the dike. At the full storage level, about 50% of the foundation has artesianism.

The results obtained by observation of the Massingir dam, particularly those related to the behavior of the foundation of the dike on the right bank, indicate that, even after the rehabilitation works, the dam is not fully safe. In fact, there are strong indications that the high flows and excessive pressures through the foundation are not yet controlled. The treatment with relief wells has shown to be ineffective to reduce the uplift and piping possibility and, the high flow indicate the occurrence of high seepage velocities. For higher levels of the reservoir, there is widespread flooding of the foundation.
