Valtorno-Mourão Dam. Reinforcement of the foundation grout due to problems detected during the first filling

Abstract

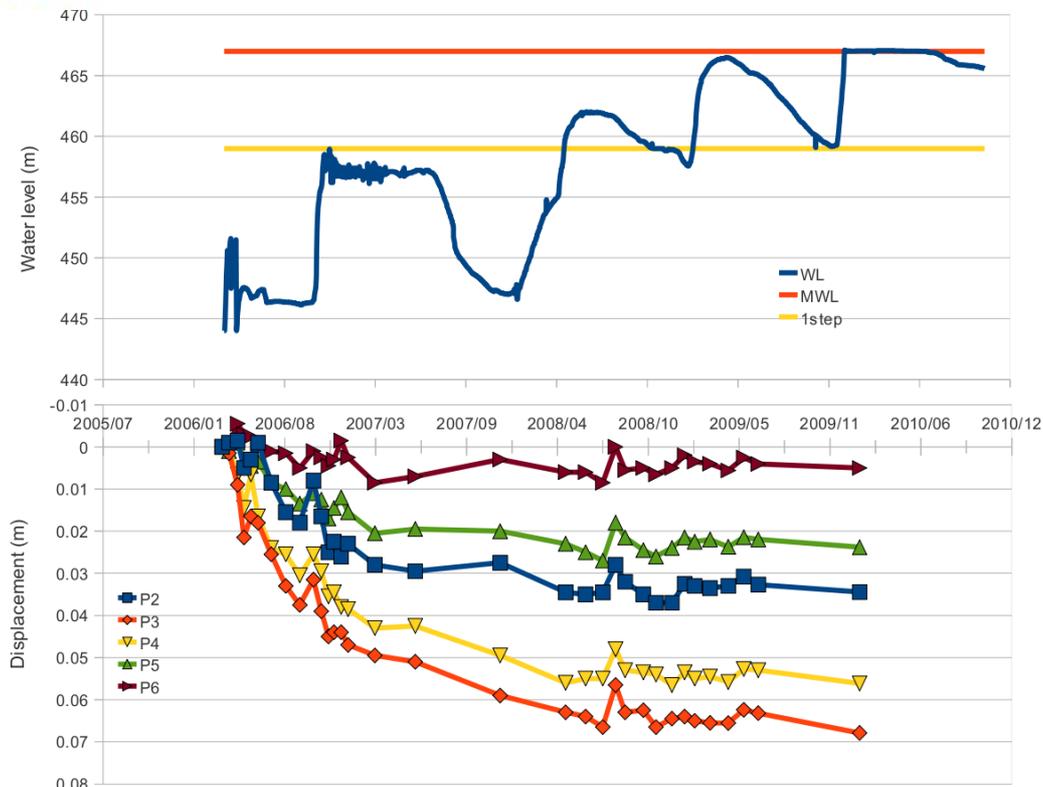
Figure 4: Water level and crest displacement records

After an initial survey, the Portuguese authority for dam safety (INAG) gave permission to initiate first filling. The level of the first filling step was attained after 40 days, in October 2006, giving an average rise of the water level of 22 cm per day (Figure 4).

The displacement records at that time were quite normal. The maximum settlement was recorded at the cross-section P3, which at the time was about 5 cm. This value was inside the expected range.

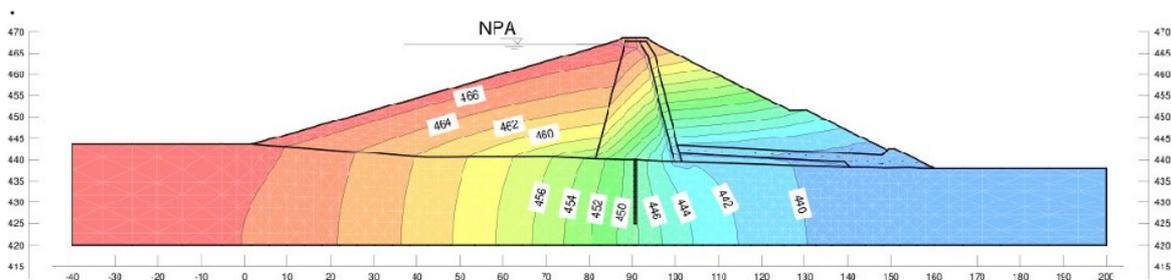
Figure 5: FEM model results (equipotential lines)

On the other hand, seepage flow recorded at the dam's toe was much higher than expected. According to the FEM model established in the monitoring plan (Figure 5), the total flow to the maximum water level, should be about 2.6 l/s. Instead, values recorded were up to 10 times this value.

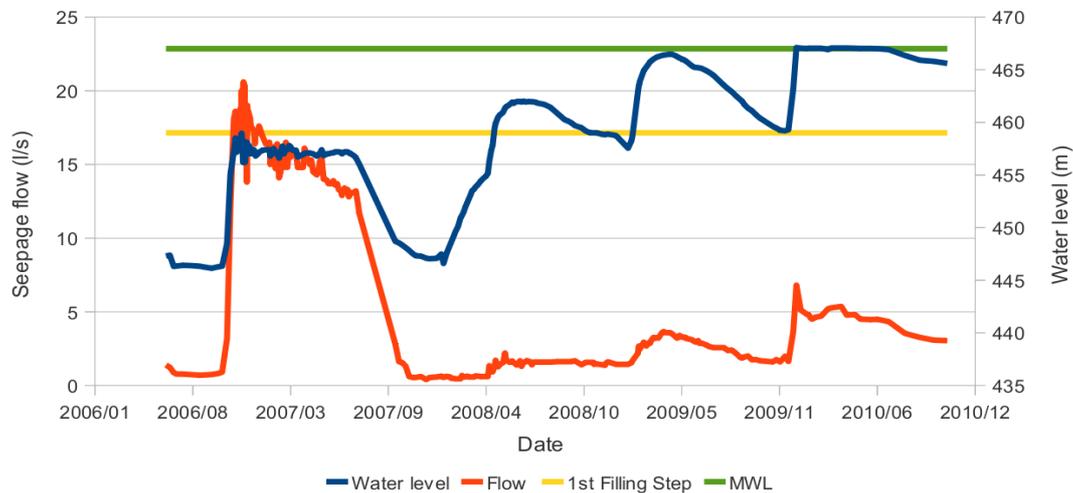
Figure 6: Water level and seepage flow against date

Figure 6 plots the reservoir's water level and the measured flows against the date. As can be seen from the figure, the flow rates recorded in December 2006 and January 2007 were higher than 20 l/s, but for the first filling step instead than at the MWL as forecasted by the model.

According to this model, the forecast for the MWL is (perhaps optimistically) roughly 30 l/s. This situation posed two serious issues. The first was safety-related, because with that amount of flow the dam foundations could experience erosion problems. The other issue was related to the storage itself. According to the figures, with no indraught, the reservoir would lose almost all of the stored water in one year time.

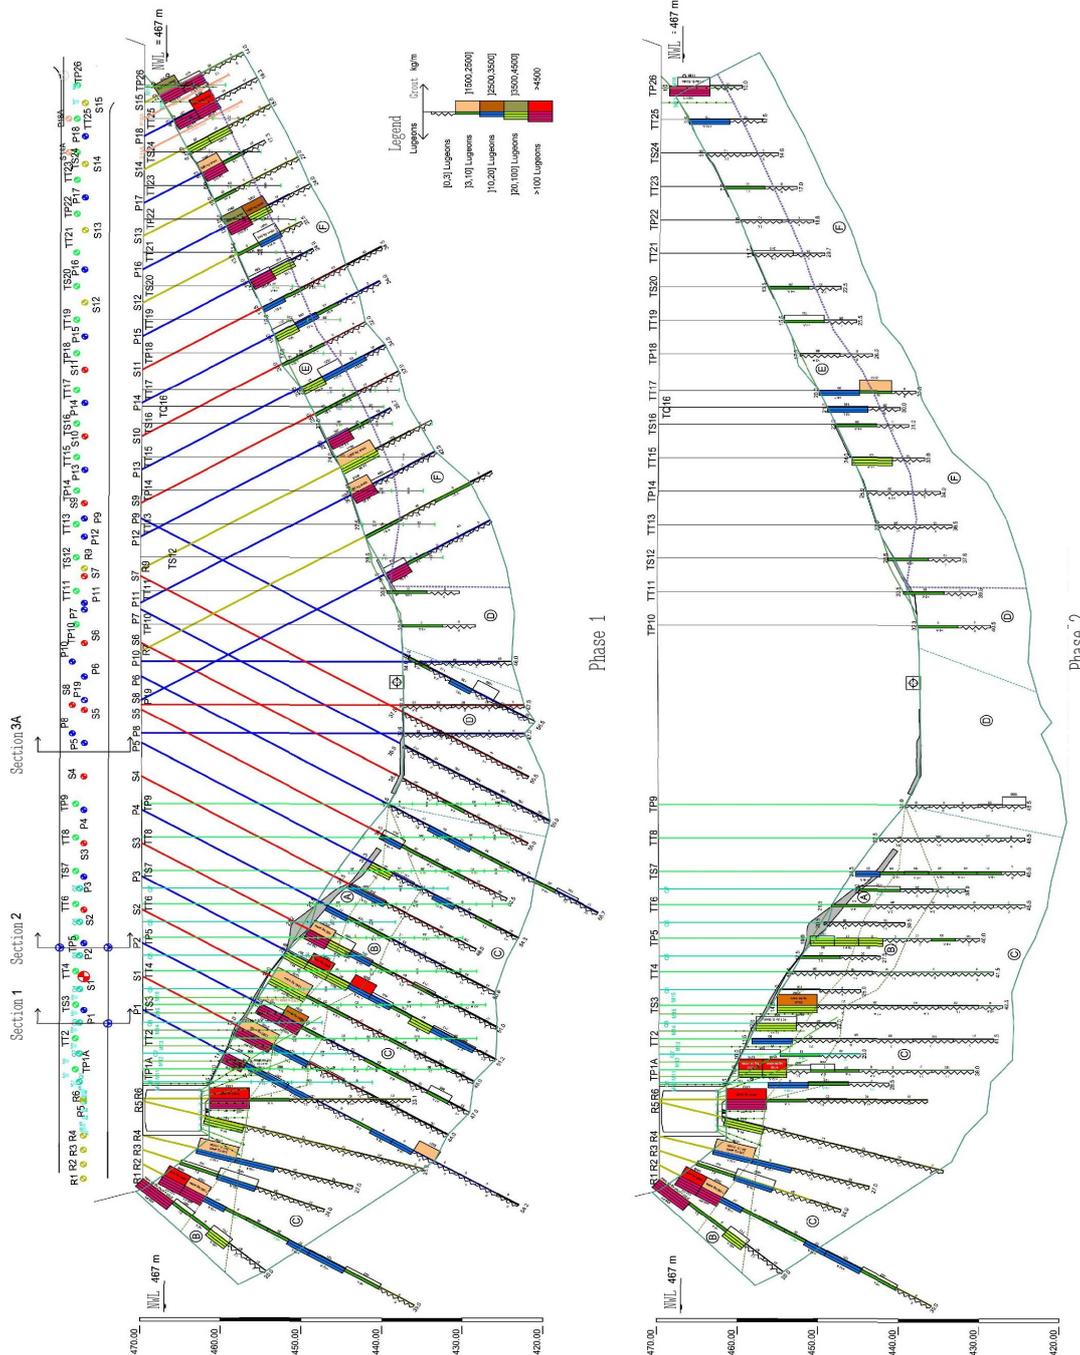
Figure 7: Results of the waterproofing reinforcement injections, 1st and 2nd phases

The analysis of the waterproofing treatment res3.5 Grout Cement Compositionults in real time, was done by a geotechnical zoning of the rock foundation, which allowed the most critical areas of the curtain that required particular injection procedures to be individualised. This zoning divided the area of the curtain into six geotechnical zones. Zones A, B and C are in the right abutment (RA), the zone D in the valley (V) and zones E and F on the left abutment (LA). The partial areas of each zone are shown in Table 2.

The most permeable zones, where higher intakes of cement were observed and/or it was difficult to achieve the prescribed pressure or refusal, were zones A and E and, to a lesser extent, zone B, totalling 30% of the curtain. The remaining 70% was related to zones C, D and F, with low to moderate permeability, but with high grout consumption, which includes the lower horizon of the curtain, and corresponded to about 30% of the overall treated area.

In the 1st phase, the average specific consumption of solids per square metre of curtain was 119.3 kg/m². These generic data show that the consumption was very high, both in the 1st and 2nd phases. There are many sections with several tons of injected cement. In relative terms, the consumption was higher in zones A, B and E, with values of between 418 kg/m and 2050 kg/m in the 1st phase. In the 2nd phase there was a sharp reduction in consumption, however it remained high in some sections for the quaternary holes. Although there are sections of the quaternary holes with high consumption, it was decided to finish the treatment, leaving in the most critical areas, some holes reserved for possible future grout reinforcement.

This high consumption resulted from easy penetration of the grout into the rock mass, filling the voids, which were sometimes quite open, and from the migration of grout at the remote areas of the curtain. On the other hand, there were no signs of any damage to the filters and drains due to the grouting operations.

The treatment by injection of the curtain in the dam's foundations was carried out over 170 m of length, between the right and left abutments, with a height ranging between 15 m at the bottom of the valley and left abutment and 30 m on the right abutment. The total area of the curtain created by this treatment was 3200 m², including the area under the spillway (Figure 7).

The injections were made by the successive approximations method. Initially the treatment consisted of injections via the primary and secondary holes provided for in the project and still some holes to the reinforcement of the abutments, where a lot of uncompressed solid rock with open joints was detected.

Given the difficulties in obtaining refusal and the high consumption of cement, resulting from the poor quality of the rock foundation, it was decided to continue treatment with a second phase of injections with tertiary and quaternary holes in the most critical zones, near contact with embankments and those identified by the geotechnical zoning.

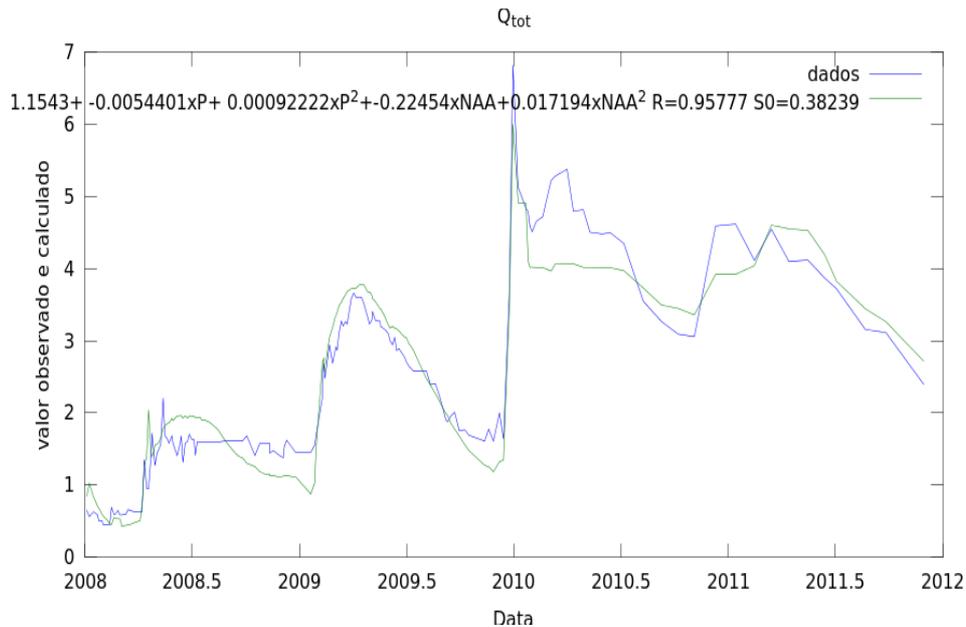
Figure 8: Valtorno dam seepage flow measurements and model

After conclusion of the treatment, the filling of the reservoir re-started according the same plan that was initially established. As regards to seepage flow, the behaviour of the foundations was substantially different than that previously registered. It was verified that, although the total flow was slightly higher than predicted by the model, an acceptable behaviour of the foundations had been achieved.

Indeed, the maximum flow rate measured for the MWL is 4-5 l / sec (except for a peak value of about 7 l / sec), while in the initial flow rate was about 20 l / s at the first filling step. The hydraulic behavior of the foundation it is now compatible with the safety of the dam.

On average, at the highest levels for the reservoir, the flow was reduced to about one fifth of the initial value.

Figure 8 presents all the flow readings taken following treatment. The best fit curve obtained can be expressed by the equation:

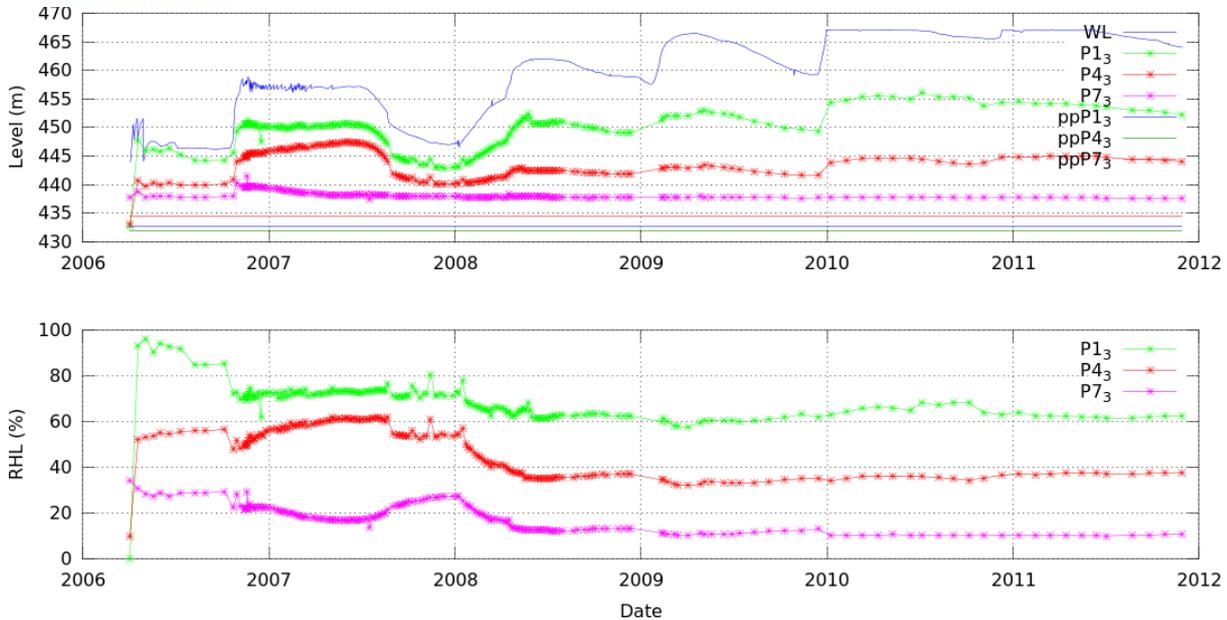
Figure 9: Profile 3-3. Pressures measured in the foundation

Some significant changes were also noticed at the pore water pressure in the foundation and in the dam. For example in profile 3-3, (Figure 1), the pore pressure in the foundation is shown in Figure 9. The first plot presents the head in piezometers 1, 4 and 7, all in the foundation. The second plot presents the relative hydraulic load defined as:

and expressed in percentage. In the expression PWL represents the piezometer water level, WL the reservoir water level and FTL the filter tip level. It is noticeable that, before the treatment of the foundation, the piezometers 1 and 4 had relative hydraulic load (RHL) of about 70% and 60% of the reservoir's load. After the treatment, the RHL is about 60% and a little less than 40%, respectively. A similar scenario is observed for piezometer 7, where the relative hydraulic load dropped from 20 to 10%.

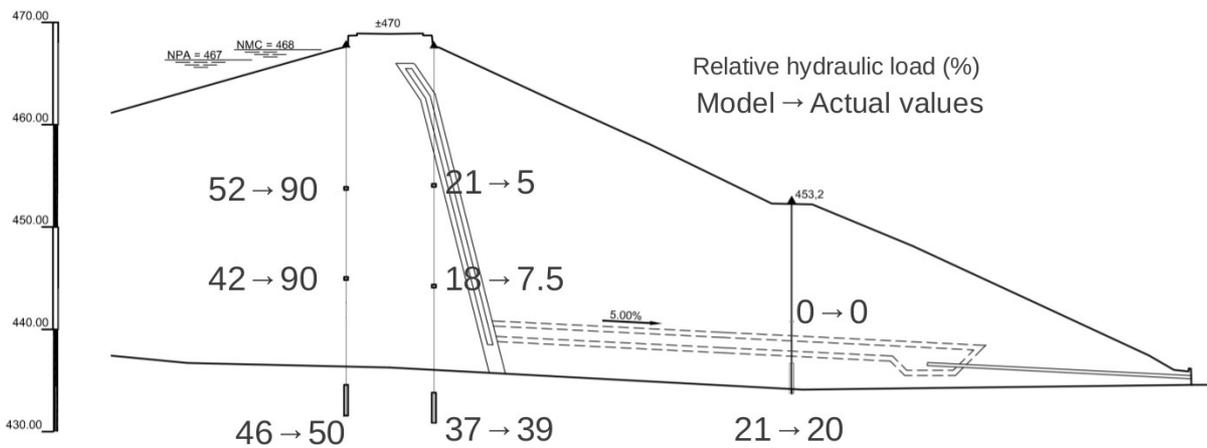
Figure 10: Comparison between model and actual values of RHL

Considering the readings from cross-sections 3-3 and 4-4 the actual RHL can be compared with the predictions shown in Figure 10.

As it can be deduced from the figure, the f.e.m. model predicts very well the pressure in the foundation but in the dam body the predictions are far from the actual values. As the actual values are much higher than in the model, it is probably a sign that the material is more impermeable (and / or less anisotropic) than what considered in the model.
