THE USE OF POLYMER CEMENT MORTAR IN THE REHABILITATION OF SERVICE STAIRS IN LISBON, PORTUGAL

M. S. Ribeiro

LNEC, Lisbon, Portugal

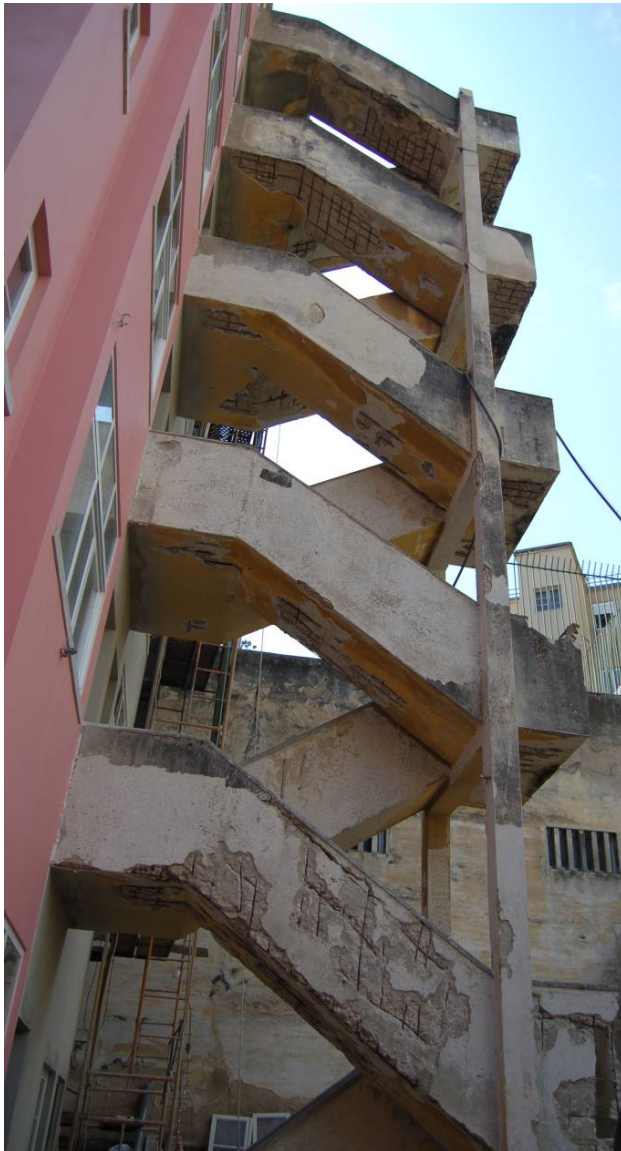
Figure 1: Left side view of the stairs

- the absence of cover on the underside of the flight and landing was widespread and the remaining plaster was delaminated or micro cracked (Figs. 1 and 2);

- reinforcement corrosion and delaminated concrete was much less in the piers and beams than in flights, landings and guards (Figure 3);
- the worst deterioration of concrete was in the last two landings (Figs. 1 and 2), as they are the most vulnerable ones to the action of rain, sun, wind. The concrete was, in general, micro cracked around the coarse aggregate and the loss of steel-area on reinforcement due to corrosion was high, jeopardizing the ability of the structural element to perform its function (Figure 4);

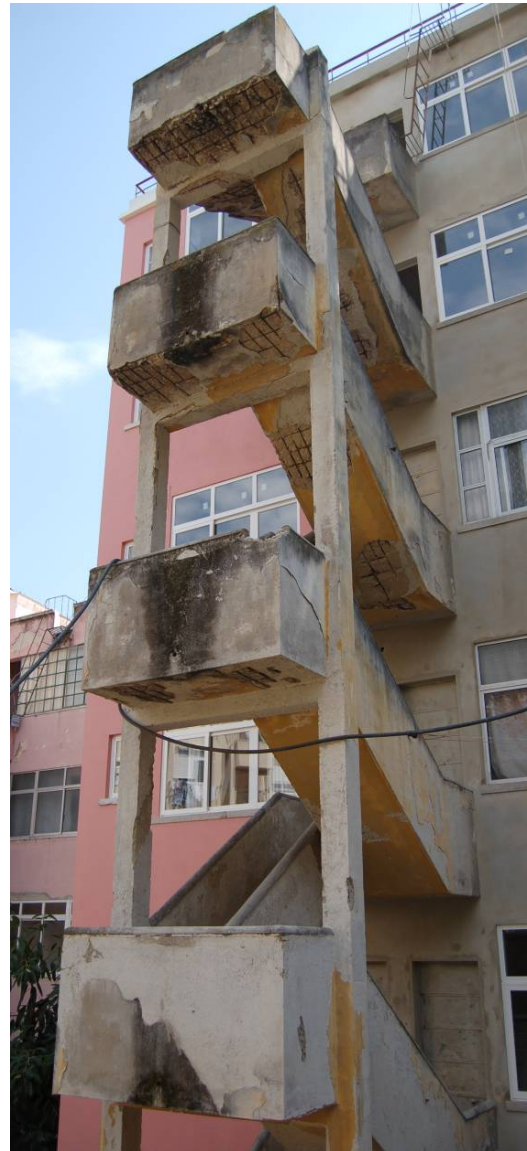
Figure 2: Front/right side view of the stairs

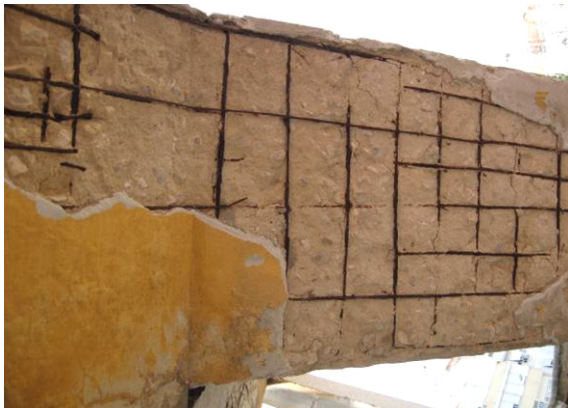
Figure3: Deterioration of landing (underside)

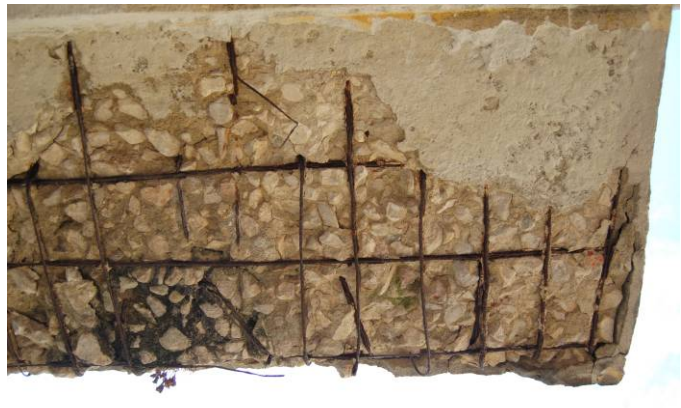
- the absence of a constructive detail, intended to avoid the runoff of water on the underside of the landings, has caused and accelerated the reinforcement corrosion due to the consequent increase in the relative humidity of the concrete (Figure 4).

Figure 4: Deteriorated concrete in the final landing

In order to prevent the draining of water on the underside of the landing a hollow out was performed along all the edges (Fig. 9), which serves as a pickaxe.

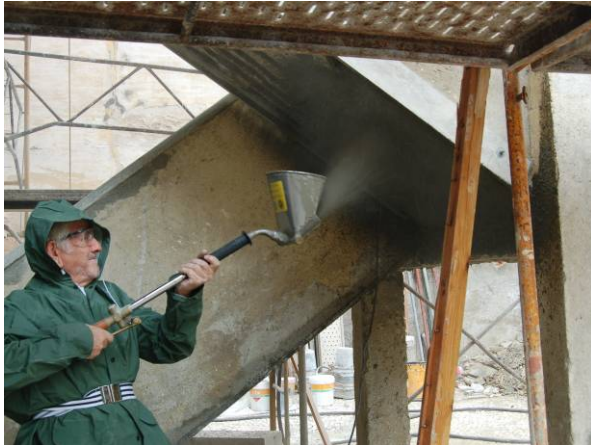
Figure 5: Spraying PCM of SB

Both PCM were manufactured in situ and applied using the spraying equipment for plaster (Fig.5). The consistency of PCM was adjusted to obtain a projection without formation of voids and with a minimum loss of material by rebound (Fig.6).

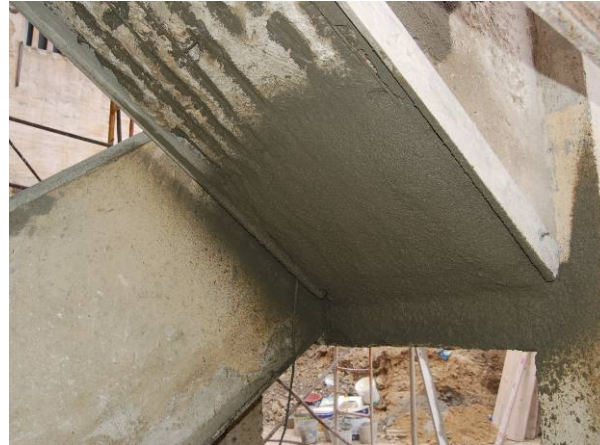
Figure 6: Aspect of layer before finishing

The PCM composition enabled its application in a simple layer finishing with strikeoff (Fig. 6). The thickness of PCM ranged from 30 mm to 50 mm.

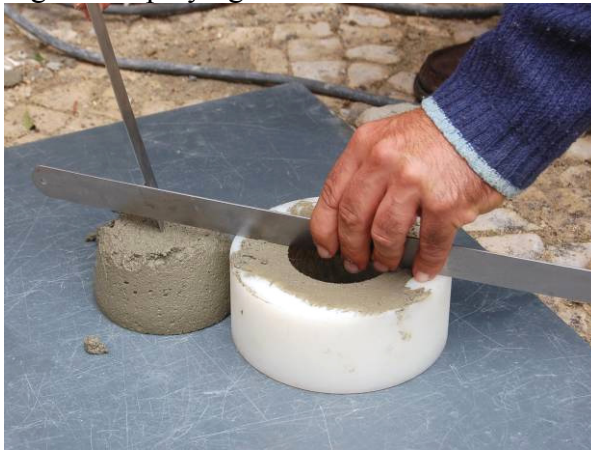
Figure 7: *In situ*, slump of PCM of AS

At the site, a slump of 12.5 ± 2.5 mm was adopted (Fig. 7), which corresponded to a consistency by flow of $107 \pm 5\%$, according to ASTM C 109 (Fig. 8). It should be noted that the correlation line between the two methodologies ($\text{Consistency}_{\text{ASTM C 109}} [\%] = 2 \cdot \text{Slump}_{\text{In place}} [\text{mm}] + 82$) was previously determined in laboratory.

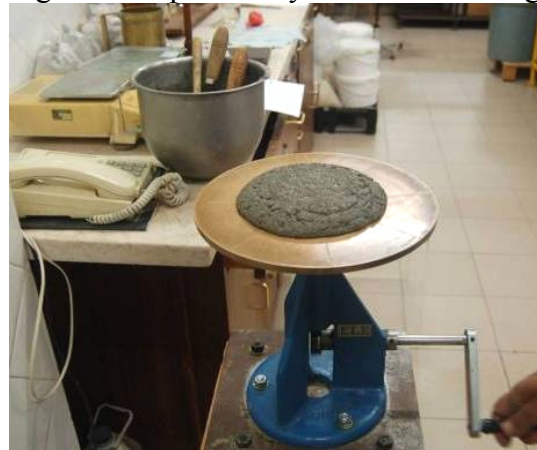
Figure 8: Lab: consistency by flow of PCM

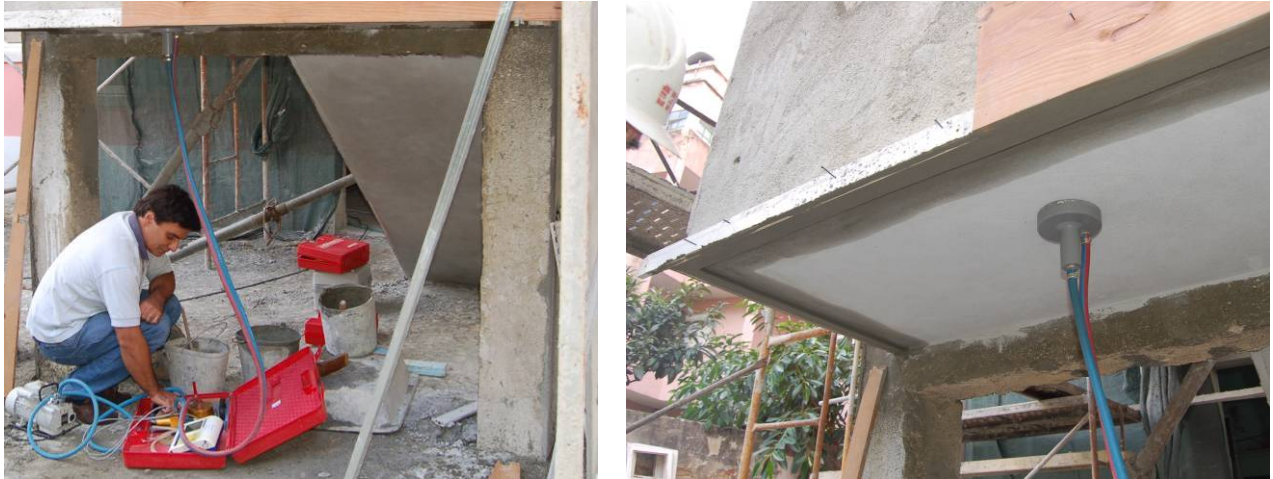
To assess the porosity of PCM, in particular by gas permeability, tests were carried out *in situ* with Torrent equipment, according to Swiss standard SN 505 262/1 (Fig.9). However, it was not possible to test the PCM, as the roughness of PCM surface was high.

Figure 9: Torrent test in PCM of As
