## **Selected solutions for rehabilitation of wooden structures: some Portuguese case studies**

Artur O. Feio<sup>1,a</sup>, Daniel Félix<sup>2,b</sup>, Vítor M. Cunha<sup>3,c</sup> and José S. Machado<sup>4,d</sup>

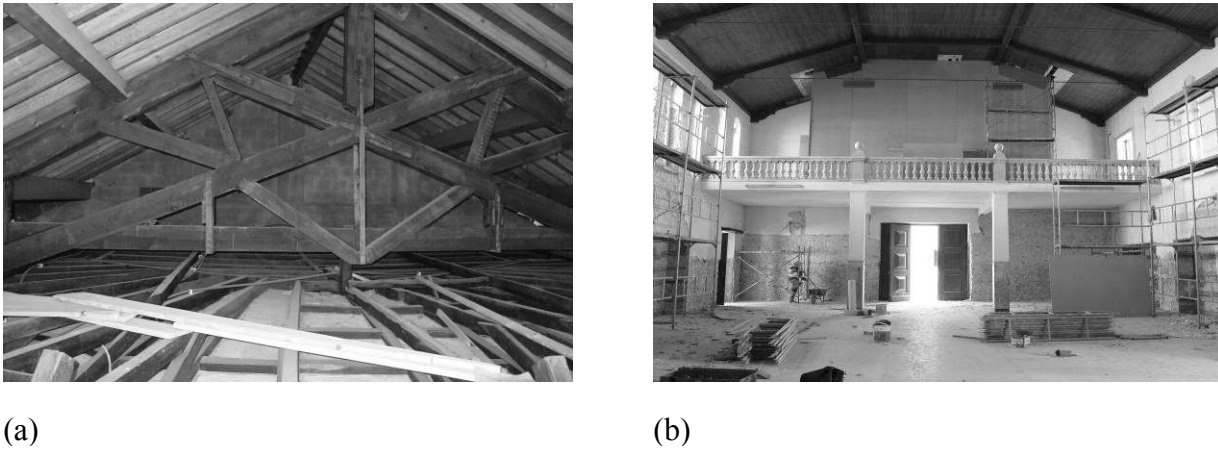
Figure 2. Salesiano's Church: (a) view of the roof structure (example of the existing main trusses), and (b) localization of the choir-organ and its proximity to the ceiling.

The structure was initially visually inspected and it was possible to verify that the timber is globally in good condition and exhibits no structural damage; however treatment against xylophagous insects was needed. In this case, no NDT or SDT *in situ* tests were performed.

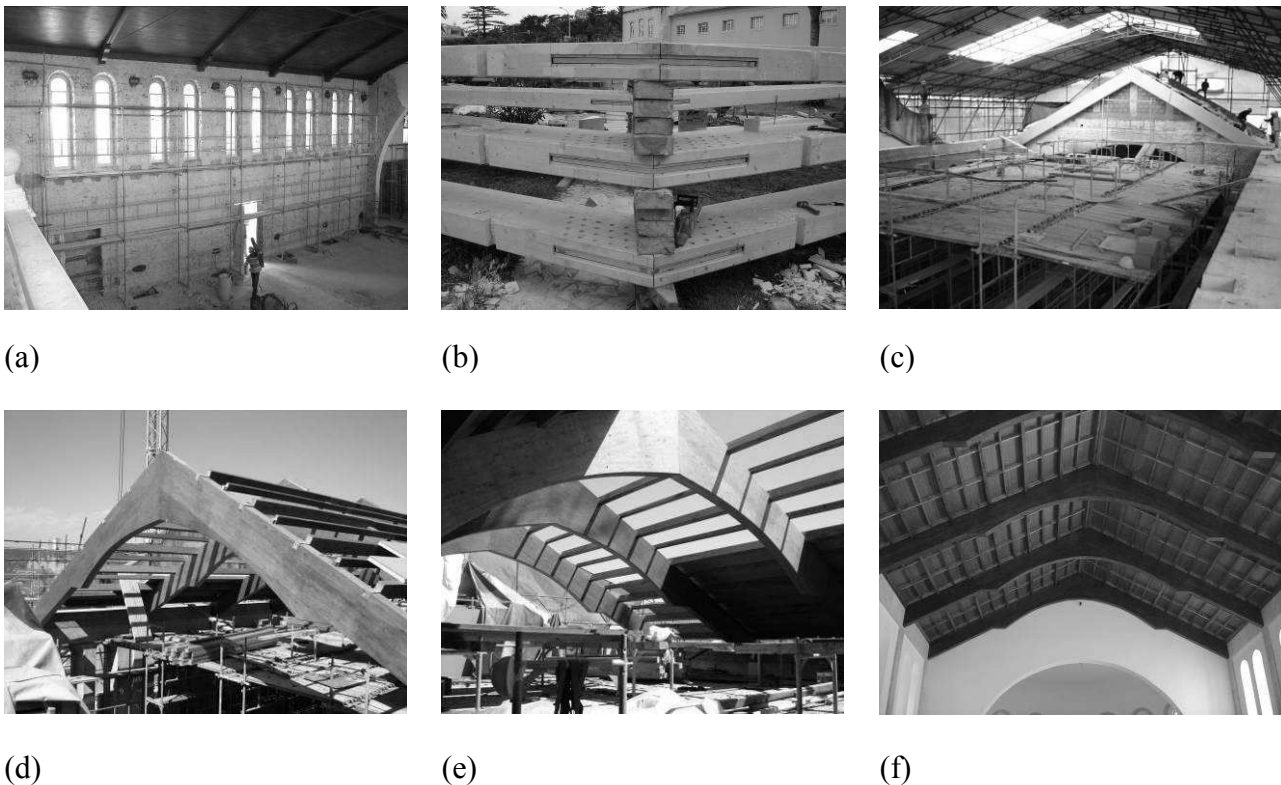
Figure 3. Salesiano's Church: (a) to (f) different perspectives, details and phases of the construction process of the new roof structure.

A solution has been proposed: to adopt a new timber solution using new curved elements/trusses, see Fig. 3a to Fig. 3f, supported in a ring concrete beam that will be constructed on the side masonry walls. The timber structure was of glulam conifer wood (GL 28h, according EN 1194) elements ranging about 7.0 m long and 190/670 mm cross-section.

The top ridge tiles are to be placed dry, in order to allow ventilation. The airflow is to be ensured by small plastic tubes located in the bottom part of the roof. All the joint connections (nails, bolts and plates) are made with steel cross connectors (AISI 316). The upper and bottom steel crosses are

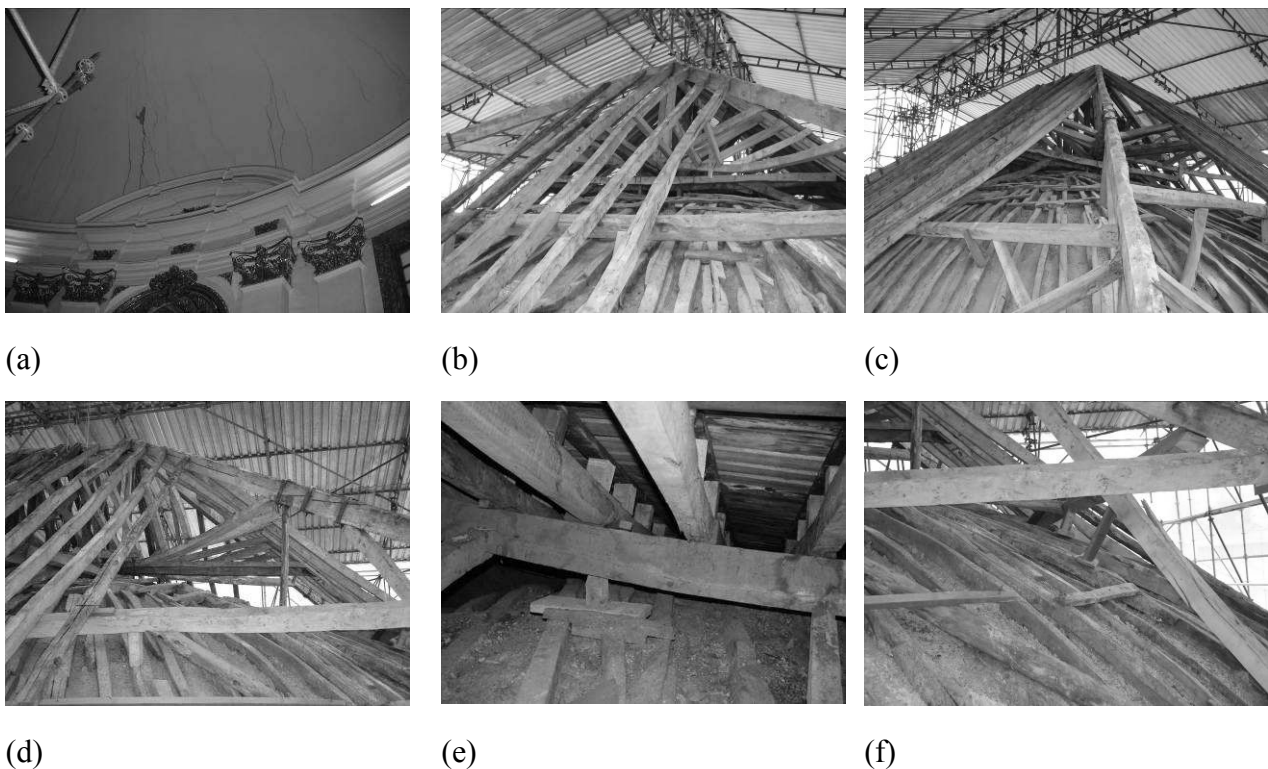
The reliquary room exhibits considerable deformation and cracking of a timber vault, due to deformation of the roof above it, see Fig. 4a. The ground plan dimensions of the room are 12.5 × 15 m<sup>2</sup>, with a four-sloping roof with clay tiles and a timber lathwork vault rendered with stucco. It was carried out a visual inspection of each element within the structure, including a detailed description of the type, location and extent of defects and alterations, species identification, geometrical dimensions and joints evaluation. Also a more detailed timber analysis, by means of appropriate in situ application of semi and non-destructive techniques, in order to provide qualitative data about some properties and biological damages, especially those located in the inner and hidden parts of the structure. It included moisture content, drill resistance (Resistograph) and Pilodyn measurements. Finally, the safety assessment of the structure and design of the rehabilitation/reinforcement plan was performed on the basis of the collected data.

The main timber structure is extremely complex and was exposed during its life to several degradation factors leading, in the absence of appropriate maintenance interventions, to the loss of its structural integrity, see Fig. 4b to Fig. 4d. Additional supports were successively introduced to the roof (mainly timber struts) during its life, to face the excessive deformations, which loaded, and therefore cracked and damaged the lathwork vault, resulting also in several structural modifications of the original roof system, see Fig. 4e and Fig. 4f.

Figure 4. Santa Cruz Monastery – existing wood structure: (a) cracking of the stucco due to the deformation of the timber lathwork vault, (b) to (d) details of the complex existing structure, (e) and (f) additional supports introduced.

Due to a poor design, some timber elements became loose/sloppy and some joints suffered premature failure due to large displacements. Damage includes humidity stains and rotten roof sheathing (it was estimated that 30% of the sheathing needed replacing). Also, most timber elements presented medium to severe decay, usually limited to the sapwood, while some elements presented also mechanical failure. The semi and non-destructive tests' results confirm that only the sapwood of the structural elements is attacked and the sheathing boards are usually strongly deteriorated.

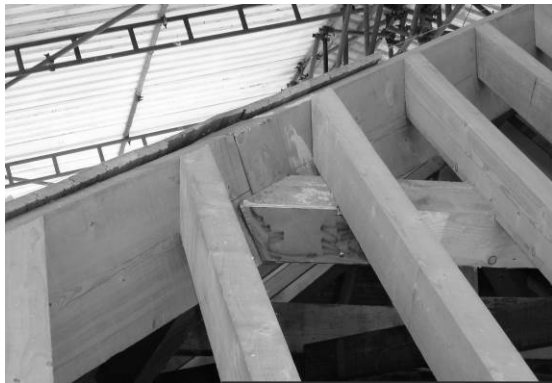
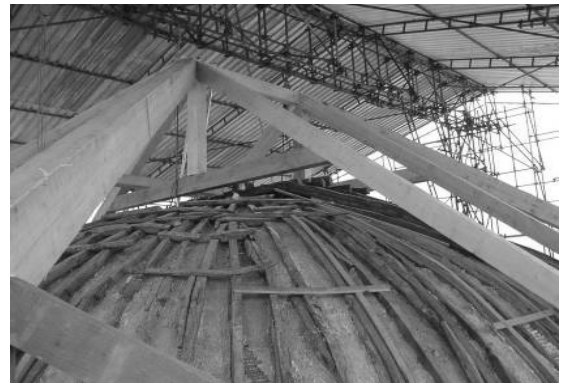
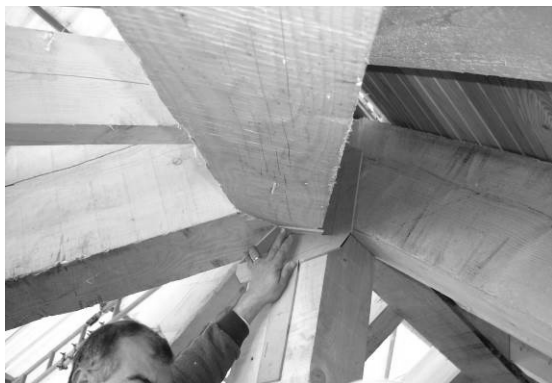
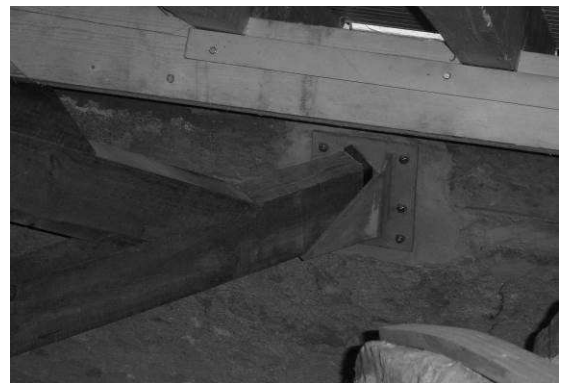
Figure 5. Santa Cruz Monastery: (a) to (d) view and details of the new roof structure and existing vault.

Due to the generally poor state of the main roof structure, and taking into account that the structural safety and timber conservation requirements were not satisfied, two alternative solutions have been proposed to the owner: (i) keep the existing timber structure using new curved elements supported on the side walls; (ii) adopt a new timber structure. The owner decided to proceed to the integral replacement of the roof structure restoring and preserving some of the original members and their functionality, see Fig. 5. The timber used was pine (*Pinus Pinaster* Ait.).

The presence of the inner vault does not allow a traditional roof structure using a tie beam. Therefore, the solution includes four diagonal rafters and a ridge board, together with a set of purlins at mid-height of the rafters, two central trusses and four corner trusses (reducing the span of the main trusses), see Fig. 5a. The supports of the diagonal rafters and the side trusses will be made in existing recesses in the ring concrete beam introduced at the top of the masonry walls to hold them together, see Fig. 5d.

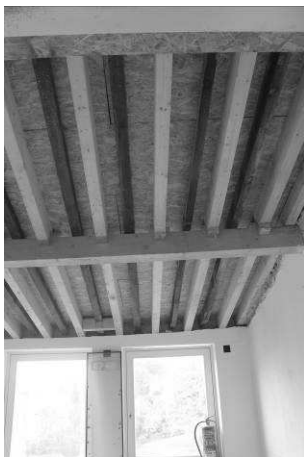
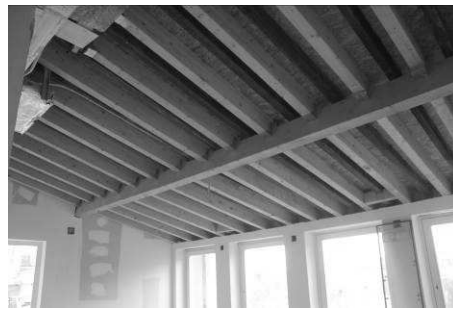
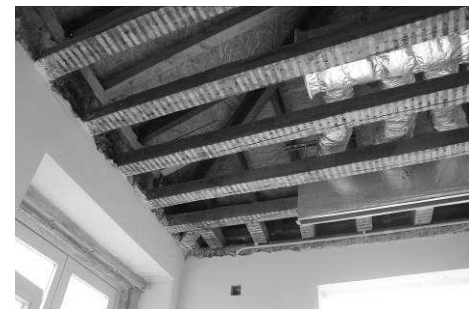
Figure 6. Lisbon historical neighbourhoods housing: (a) to (c) Lapas' house ceiling rehabilitation, and (d) to (f) Graças' house floor reinforcement.

Fig. 6a to 6c present a Lapas' house ceiling rehabilitation with the partial substitution (80%) of the timber elements with CCA vacuum treated pine timber (*Pinus pinaster* Ait.). The visual inspections allowed to maintain some of the original elements, see Fig. 6c., and no other NDT or SDT *in situ* tests were performed.

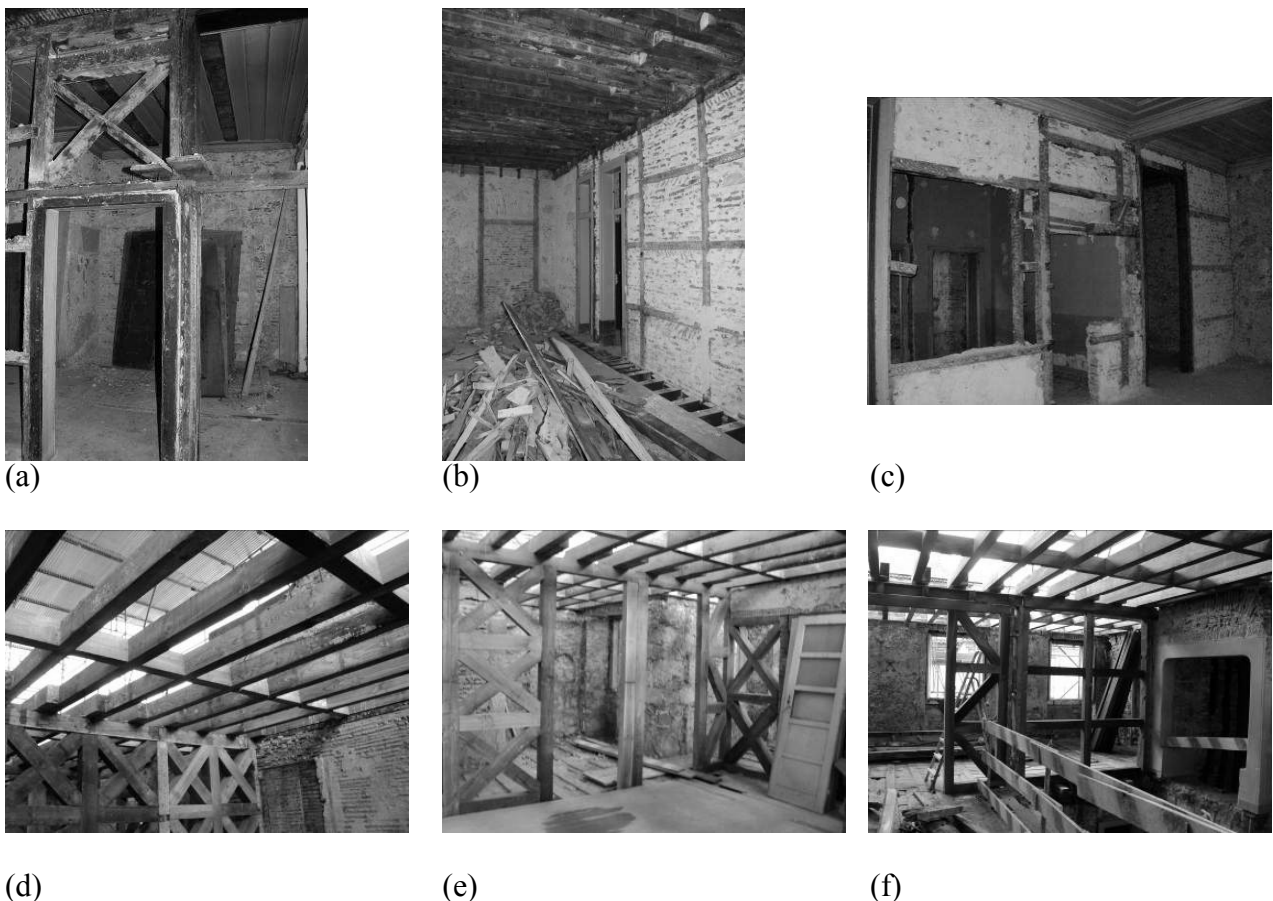
Figure 7. Downtown Lisbon (Baixa Pombalina): (a) to (f) different perspectives and details of an intervention in a “Pombaline” system building.

Here, it is possible to observe, see Fig. 7d to 7f, a reconstruction of some of these “Pombaline” frames using CCA vacuum treated pine timber (*Pinus pinaster* Ait.) following the pre-existent structural solutions.
