## DAMAGE ASSESSMENT AND DIAGNOSIS FORM

<b>Name of the building – Location</b> Basement of the SW building of Jesus (or Eleven Thousands Virgins) College
<b>Type of damage – decay pattern</b> <ol style="list-style-type: none"><li>1. Efflorescences, sanding and crumbling, detachment of the superficial coat of plaster, dark (moisture) spots, red spots (probably of biological origin)</li><li>2. Efflorescences, dark (moisture) spots</li><li>3. Efflorescences between the plaster and the paint, blistering and further detachment of the paint</li><li>4. Efflorescences on the tiles, efflorescences on the mortar joints</li><li>5. Dark (moisture) spots</li></ol> <b>Materials concerned</b> <ol style="list-style-type: none"><li>1. Painted lime plaster</li><li>2. Stone</li><li>3. Painted cement plaster</li><li>4. Ceramic wall tiles</li><li>5. Cement-based pavement</li></ol>
<b>Tests performed</b> <ul style="list-style-type: none"><li>▪ Moisture and hygroscopic moisture content (HMC) profiles of the plaster and of its substrate.</li><li>▪ HMC of adjacent samples of mortar and of stone, directly collected (by hammer and graver) at different depths.</li><li>▪ Ion chromatography on three superficia

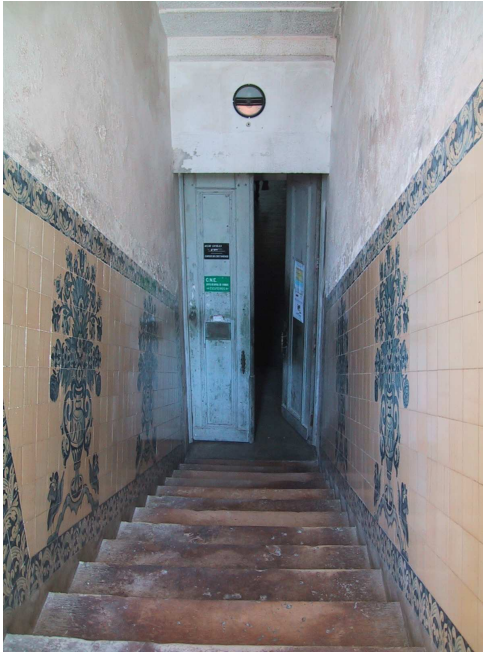
Fig. 8 – Entrance stairs (2003-09-11)

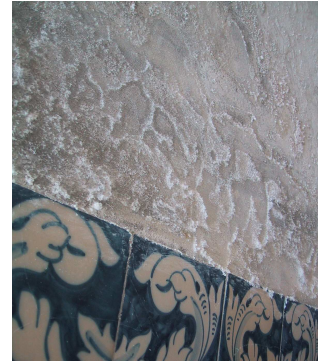
Fig. 9 – Efflorescences on plaster at the entrance stairs (2003-09-11)

Repair of this basement damaged plasters could be done with a lime-mortar, as similar as possible to the existing one, namely in its high capillary absorption (shown by the water absorption tests). A paint that does not constitute a barrier to the incoming salt solutions (i.e. providing a good hydric continuity with the plaster, as well as with high capillary absorption and high water vapour permeability) should be used.

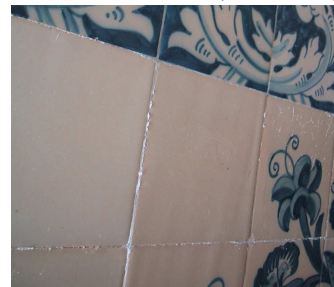
Fig. 10 – Efflorescences on ceramic tiles joints at the entrance stairs (2003-09-11)

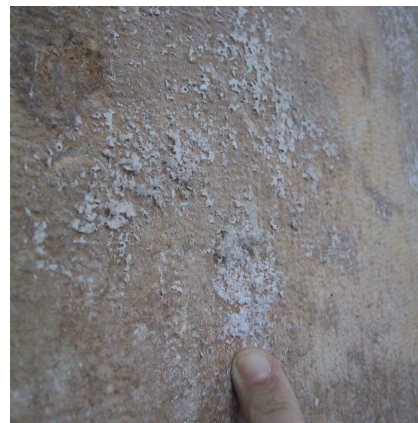
Fig. 12 – Efflorescences on stone (2004-01-06)

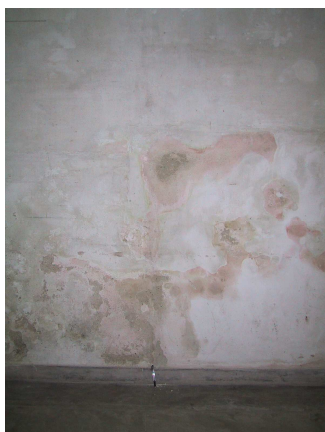
Fig. 13 – Damaged lime plaster/paint system at a corridor (2003-12-04)

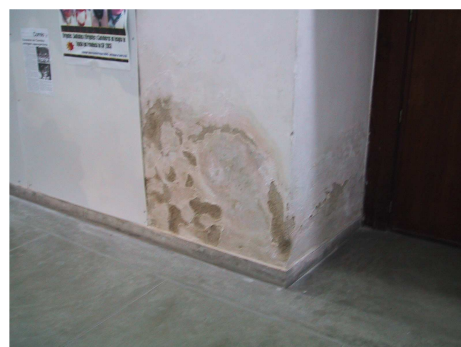
Fig. 14 – Damaged lime plaster/paint system at a corridor (2003-09-11)

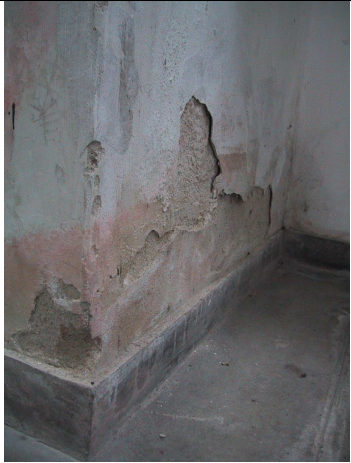
Fig. 15 – Damaged lime plaster/paint system at a corridor (2003-12-04)

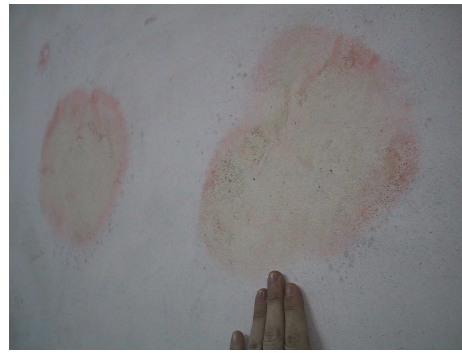
Fig. 16 – Red spots (probably of biological origin) on painted lime-plaster (2004-01-06)

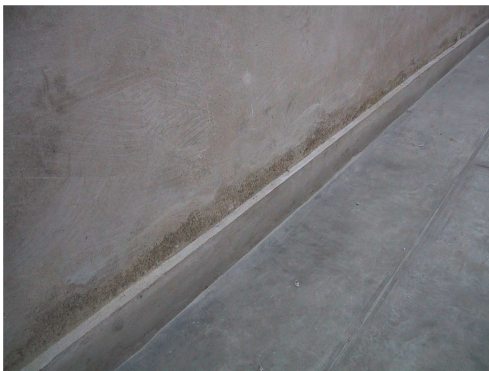
Fig. 17 – Damaged lime plaster/paint system at the base of a corridor wall (2003-12-04)

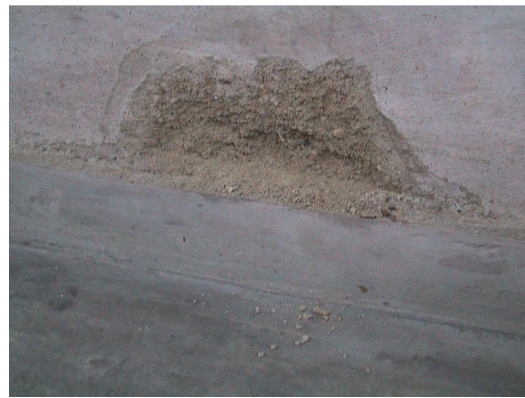
Fig. 18 – Sanding and crumbling of lime-plaster/paint system at a corridor (2004-01-06)

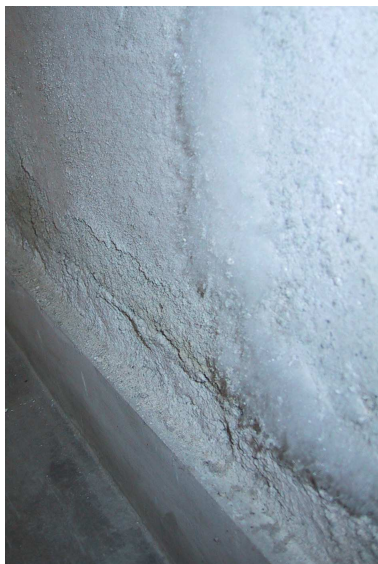
Fig. 19 – Efflorescences and salt damage on a lime-plaster/ paint system, at a corridor (2003-12-04)

Nitrates are the main type of salts responsible for the plasters deterioration, as indicated by the ion chromatography analyses of plaster samples and by the XRD of efflorescences. The nitrates may come from the soil.

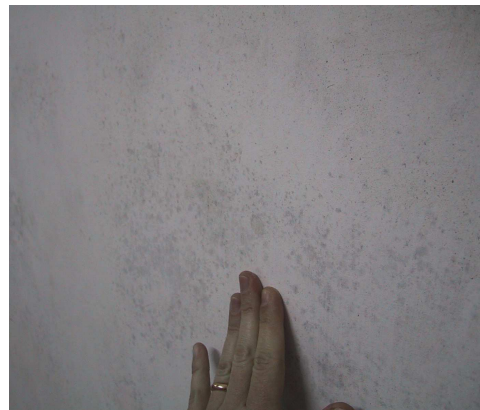
Fig. 20 – Efflorescences on lime-plaster/ paint system, at a corridor (2004-01-06)

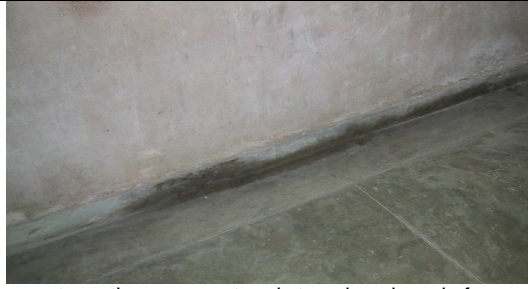
Fig. 21 – Moisture spots on the pavement and stone baseboard of a corridor (2004-01-06)

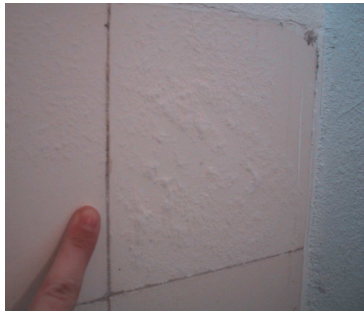
Fig. 22 – Efflorescences on the WC ceramic tiles (2004-01-06)

On the WC tiles, the efflorescences are carbonates and sulphates. They are probably coming from the bedding cement mortar.

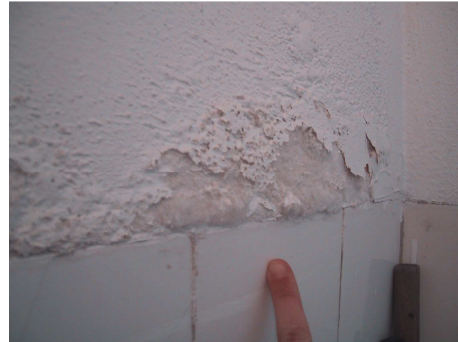
Fig. 23 – Efflorescences, blistering and detachment of the WC "plastic" paint (2004-01-06)

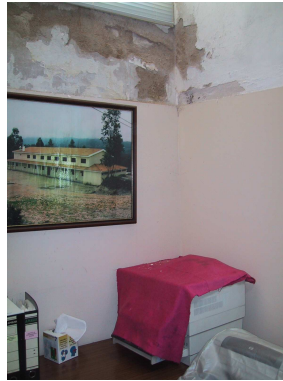
The interior environment at the basement is extremely humid. At the scouts secretary, an electric air dryer is working in permanence to improve the conditions of habitability and of paper conservation. At this room, the damage on the lime plaster seems stronger, probably due to the higher evaporation rate of the walls moisture. The bottom of the walls was covered with gypsum boards and (probably also in consequence of this) there is strong damage until more than 2 m above the pavement.

Fig. 24 – Scouts secretary: salt damage on plaster (2003-09-11)

Attention must be paid to the fact that a sudden increase of the building internal ventilation may result in a relevant increase of the plasters degradation rate. For this reason, it is advisable to first proceed to the elimination of the moisture source. Then, monitoring of the walls moisture content (by periodic sampling) should be done. The internal ventilation should only be increased after the walls have dried.

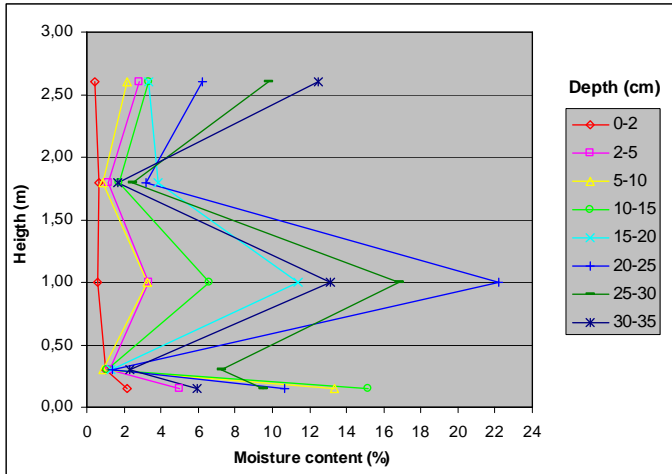
Fig. 25 – Moisture content profile of wall 1

The moisture (fig. 25 and 28) and the HMC (fig. 27 and 30) profiles show discontinuities, which should therefore be due, at least partially, to the variable nature of the samples collected by powder drilling (tables 5 and 6). Evaluation of the materials of these samples was done by combining the visual observation of the powder with an “in situ” qualitative evaluation of the materials resistance to the drilling. However, this procedure does not often permit to have an effective determination of the sampled materials nature and contents, due to the following main factors:

- From 0-2 cm and, in the case of wall 2, also from 2-5 cm always the same material (lime mortar) was collected. These lines (red and pink) point for capillary rise as the origin of moisture.
- A general increase of moisture content seems to exist towards the interior of both walls.
- At wall 1 (peripheric wall, probably semi-embedded), significant moisture contents are also present deep inside at the top of the wall, while at wall 2 (interior wall) this does not occur.

Capillary rise at wall 2 and capillary rise plus an income of moisture from the ground at the back of wall 1 are consistent hypothesis.

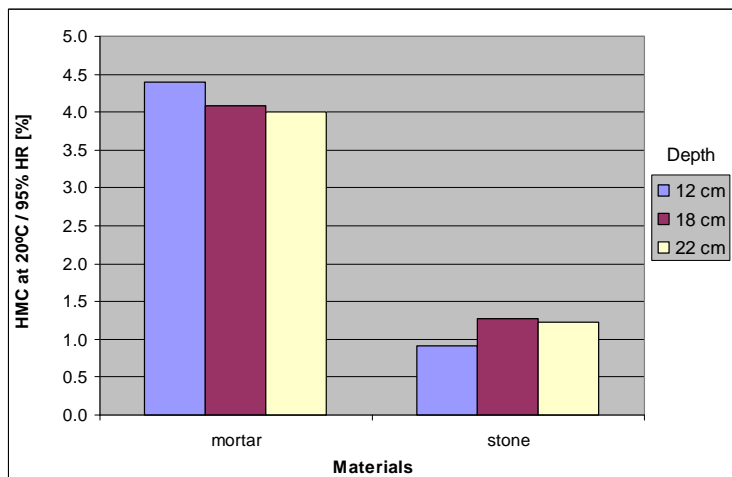
Fig.31 – Ongoing HMC 95% test (preliminary results after 5 days of test)

The HMC test done on adjacent samples of mortar and of stone (fig. 31) indicates a much higher HMC for the mortar samples.
