## DAMAGE ASSESSMENT AND DIAGNOSIS FORM

<b>Name of the building – Location</b> Salvas Chapel – Sines, Portugal
<b>Type of damage – decay pattern</b> <ol style="list-style-type: none"><li>1. Cracking, sanding and crumbling. Detachment of the paint layer and of the superficial coats.</li><li>2. Efflorescences and detachment of the paint layer.</li><li>3. Powdering</li><li>4. Moisture spots, water flow marks and biological development</li></ol>
<b>Materials concerned</b> <ol style="list-style-type: none"><li>1. Render</li><li>2. Plaster</li><li>3. Red ceramic tiles of the pavement</li><li>4. External façades of the church</li></ol>
<b>Tests performed</b> <ul style="list-style-type: none"><li>▪ Moisture and hygroscopic moisture content (HMC) profiles, at two exterior locations</li><li>▪ Ion chromatography on four superficial samples of render</li><li>▪ XRD characterization of efflorescences collected at the interior of the church</li></ul>

LNEC

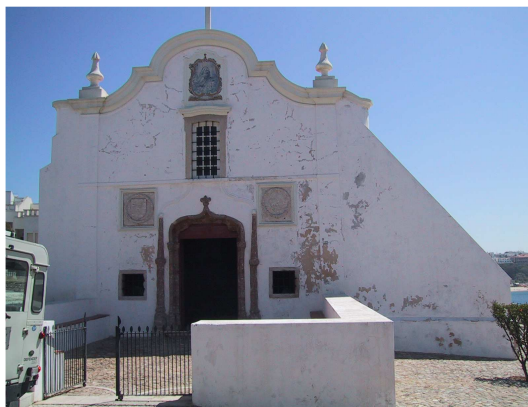
Fig. 8 - SW (front) façade, July 2002

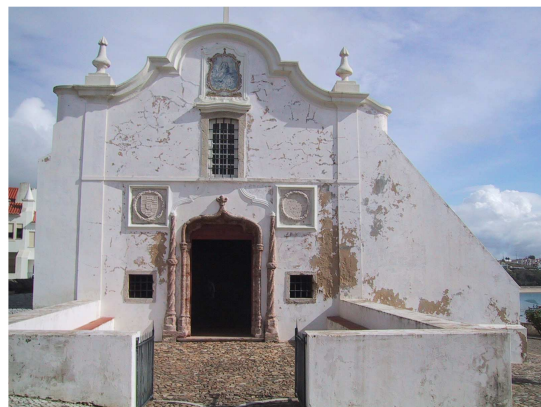
The following pictures show the evolution of the damage at the exterior of the chapel, between July 2002 and October/November 2003. Damage seems to be growing very quickly.

Fig. 9 - SW (front) façade, October 2003

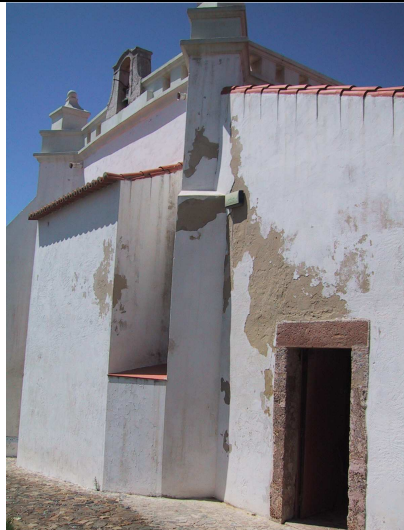
Fig. 10 - NE (back) façade, July 2002

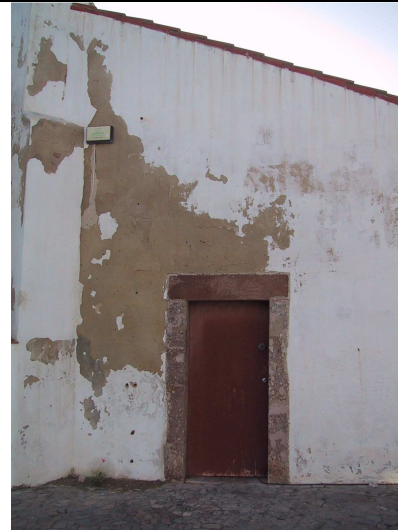
Fig. 11 - NE (back) façade, November 2003

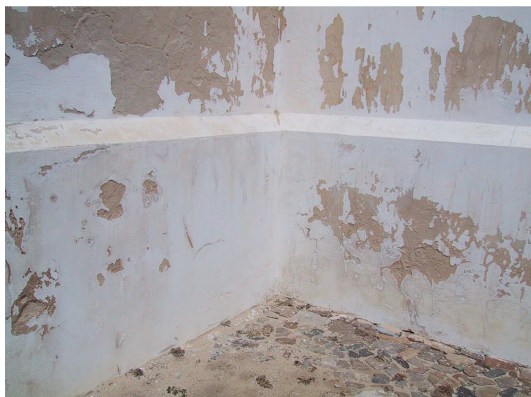
Fig. 12 - Sanding of render and crumbling of render/paint system (2002-07-03)

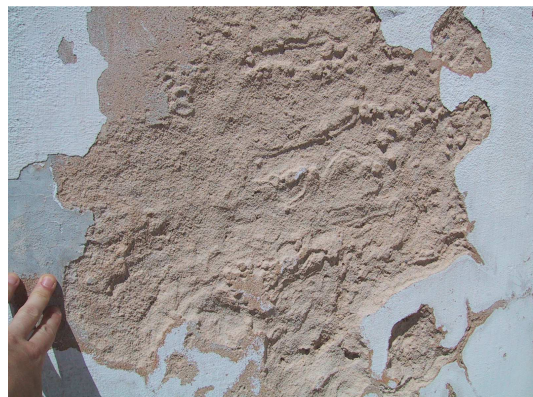
Fig. 13 - Erosion of render/paint system (2002-07-03)

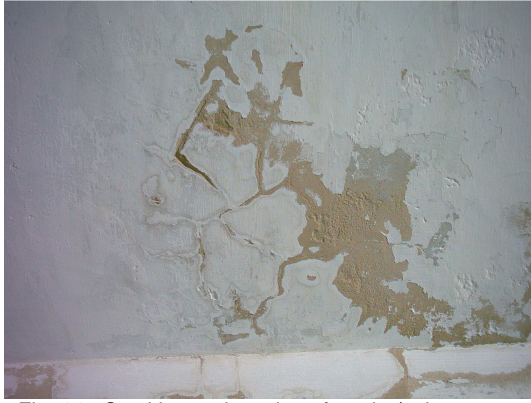
Fig. 14 - Cracking and erosion of render/paint system (2003-11-19)

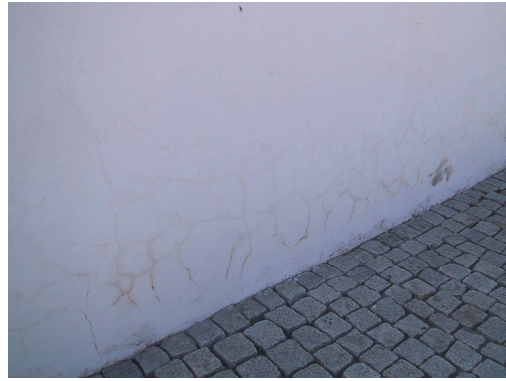
Fig. 15 - Cracking of render/paint system (2002-07-03)

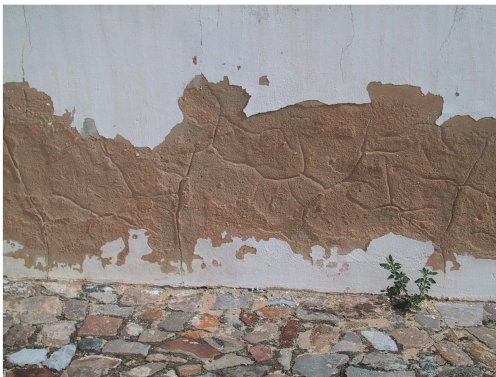
Fig. 16 - Detachment of paint and cracking of render (2003-10-30)

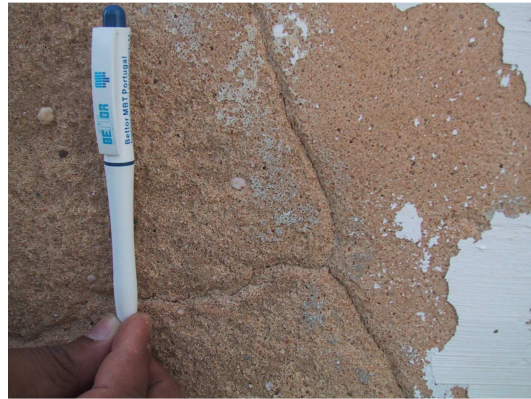
Fig. 17 - Cracking of render (2003-10-30)

The new renders should be resistant to cracking, namely to cracking due to the drying shrinkage.

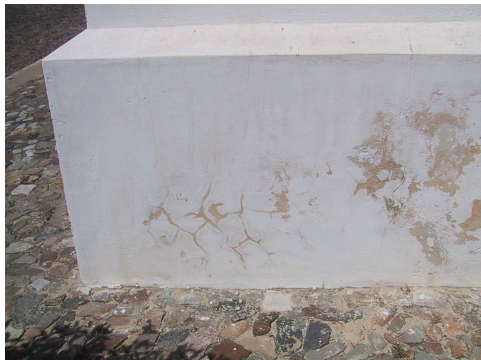
Fig. 18 - Damage seems to start from the cracks (2002-07-03) ... and from other singularities (2003-10-30)

Visual observation of the chapel façades in the several inspections (see Evolution of Damage and Pictures of Damaged Areas), indicate that salt damage starts at the mortar cracks and other singularities.

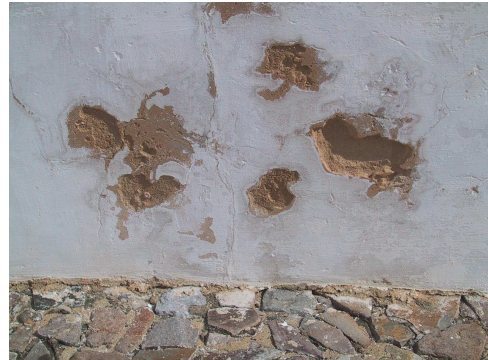
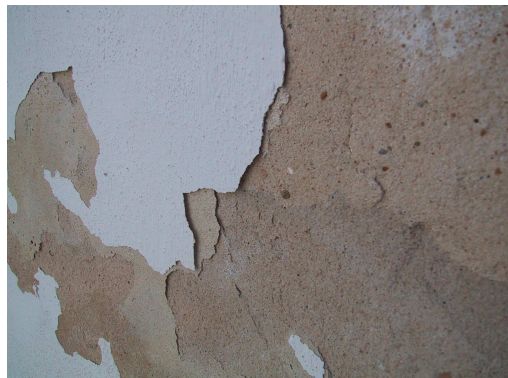
Fig. 19 - Detachment of paint and of render superficial coat (2002-07-03)

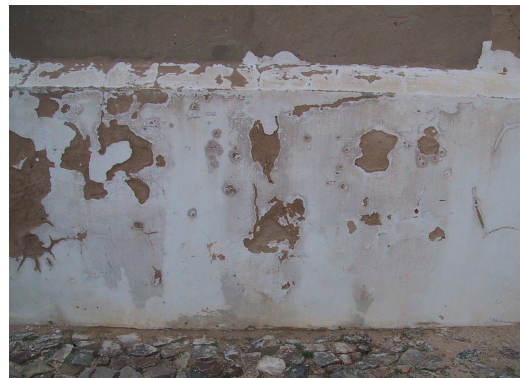
Fig. 20 - Moisture spots and other degradation of render/paint system (2003-10-30)

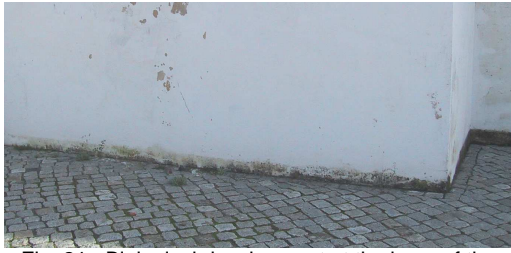
Fig. 21 - Biological development at the base of the northern façade (2003-11-19)

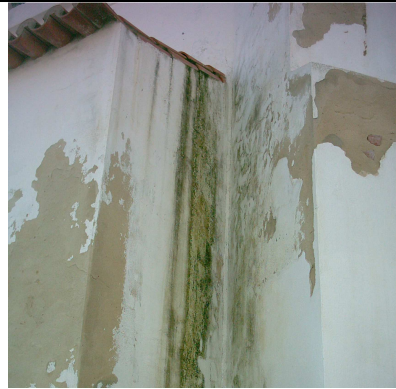
Fig.22 - Water flow marks from the tiled roof and biological growth (2003-11-19)

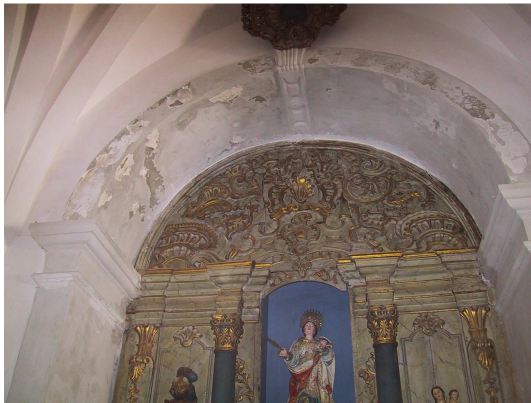
Fig.23 - Detachment of paint at the interior of the church (2002-07-03)

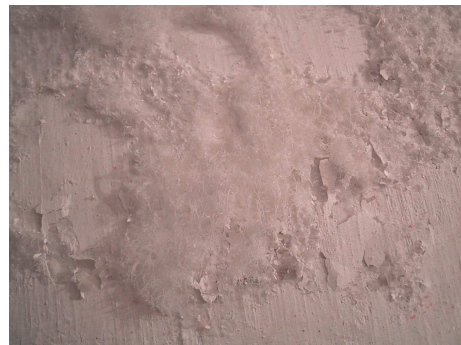
Fig. 24 - Efflorescences and detachment of paint on an internal wall (2002-07-03)

At the interior, the efflorescences are mainly constituted of carbonates.

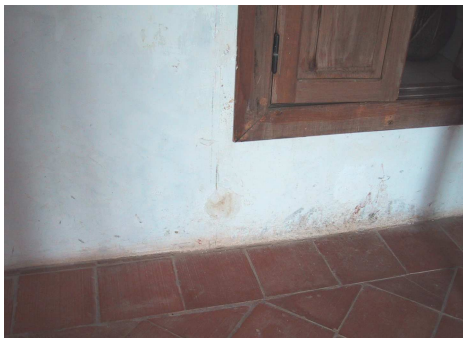
Fig. 25 - Efflorescences, detachment of paint and sanding of render at the base of an internal wall (2003-10-30)

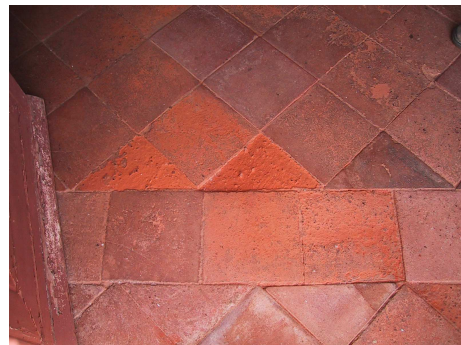
Fig. 26 - Powdering of internal pavement ceramic red tiles at the chapel main entrance (2003-10-30)

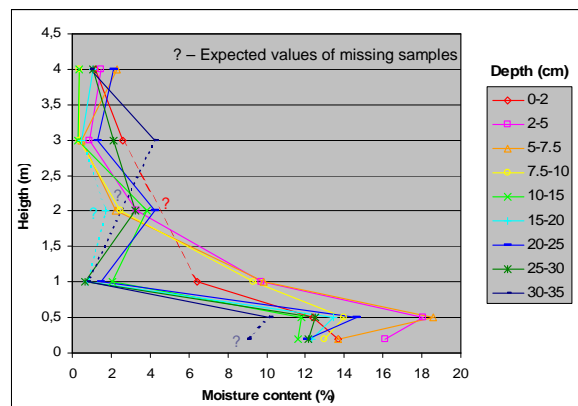
Fig. 28 – Moisture distribution in the back façade

Analysis of the moisture content profiles (general decrease of the moisture contents with height) points for capillary rise being the main source of moisture (although it is not clear the reason why, at the back façade, the moisture content at the height of 0.2 m is lower than at 0.5 m).

The increase (very clear at the back façade, less clear at the lateral façade), towards the surface of the wall, of the moisture content at the base of the wall suggests that superficial water is the main responsible for the capillary rise. However, more profiles, namely at interior walls, would be necessary to be sure of this fact.

Moisture content is very high (between 12% and 18%) at the base of the back façade and it is expected that the same happens at the other areas with similar degradation (namely, at the front and at the lateral façade facing the harbour). At the buttress of the lateral façade (opposite to the harbour), moisture content (and also degradation) is not so high (a maximum of 8% at the base), but a general decrease with height also exists.

Further research seems necessary to detect the origin of the rising damp (superficial draining water or phreatic water). Apart from other moisture profiles, done at both the interior and at the exterior of the chapel, it is necessary to evaluate;

Measures to reduce the capillary rise should be taken, according to the results of this research.

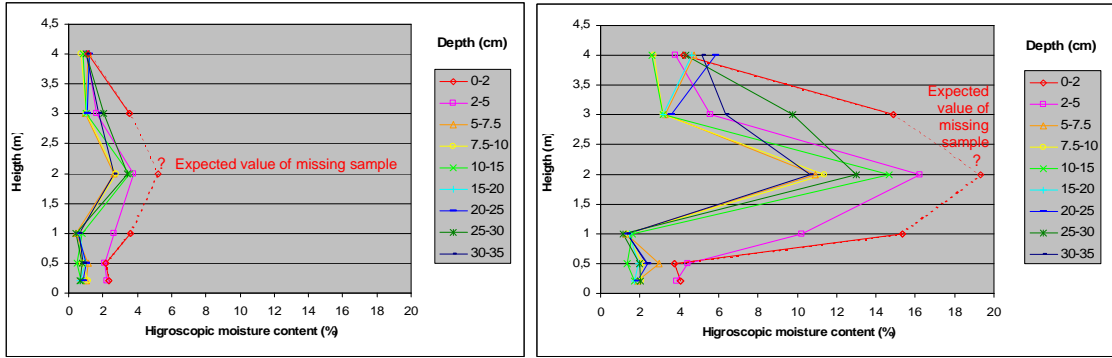
Fig.29 – Back façade: HMC at 80% RH (left) and at 95% RH (right)

At the back façade, the salts contents are very high, especially in the superficial coats, above the 0.5 m and below the 4.0 m (where damage is also higher). Salts seem to be mainly chlorides (probably from the nearby sea, whether directly wind blown or mediated by deposition in the soil), but also nitrates (probably from the soil). The relevance of the presence of carbonates is not yet established for the exterior façades.

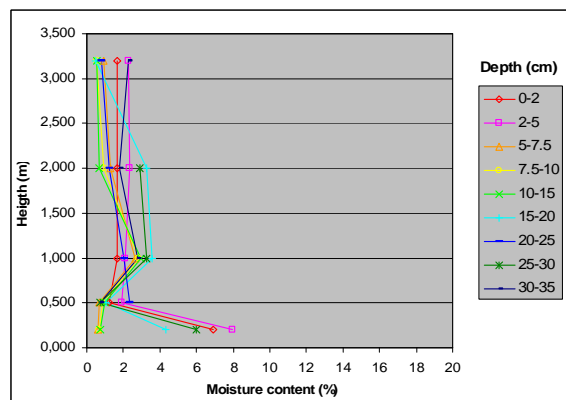
Fig. 31 – Moisture distribution in the lateral façade

At the buttress of the lateral façade, which has an adjacent drain, the salts contents, the moisture contents and the damage are low.

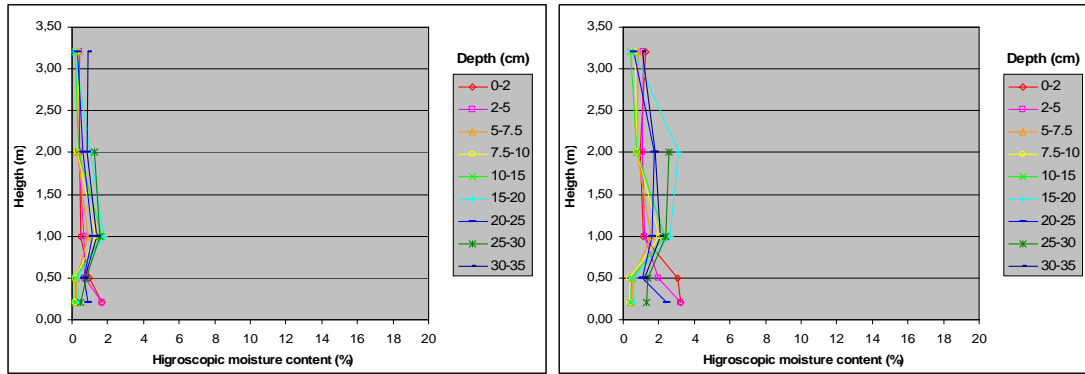
Fig. 32 – Lateral façade: HMC at 80% RH (left) and at 95% RH (right)
