## Restoration of semi-industrial glazed ceramic tiles by re-firing

*SUMMARY: Semi-industrial glazed ceramic tiles lining urban façades represent a rich heritage asset of Portuguese cities and in particular of Lisbon. However, still a sizeable part of them is being continuously lost. Whenever the façade tiles are decayed, they are usually merely removed and replaced by newly manufactured ones.*

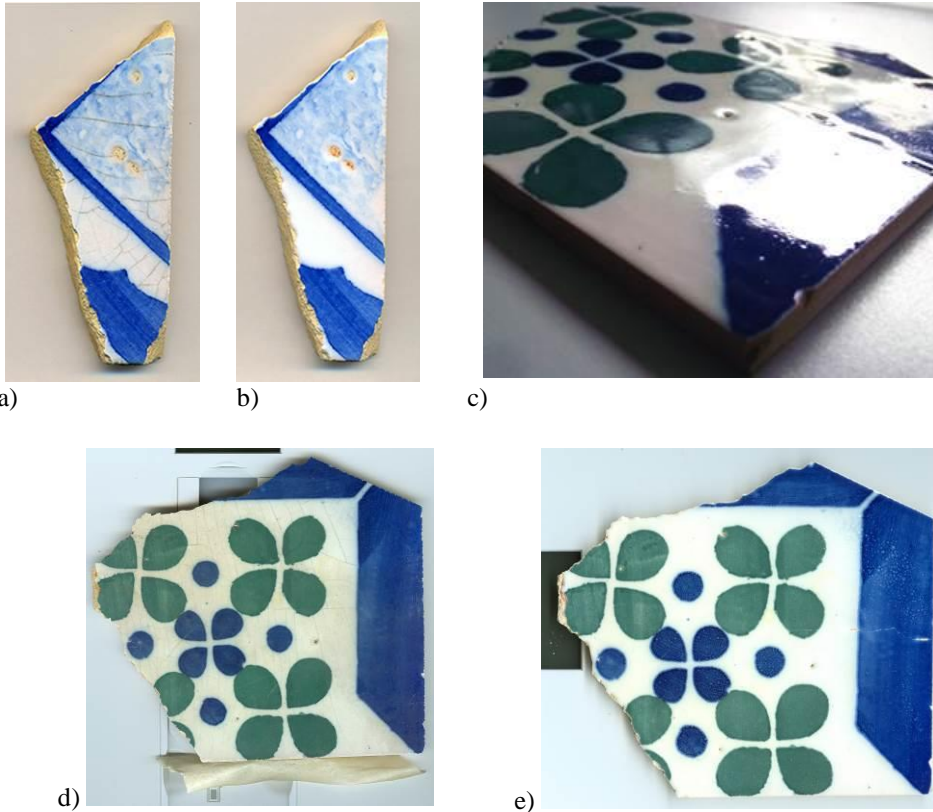
The *single stage re-firing* obliterated the crazing, restored the glaze whiteness and shine (Figure 1) and showed good promise in terms of lacunae restoration for most samples. But in three of 35 tiles it failed. In these cases a restoration was not achieved due to bubbles protruding from the glaze surface or extensive “orange skin” on the surface.

Figure 1. Visual observation of single-stage re-firing results: *a) and d) before re-firing; b) after re-firing at 890°C during 3 hours; c) glossy glaze surface after re-firing e) after re-firing at 930°C during 20 minutes.*

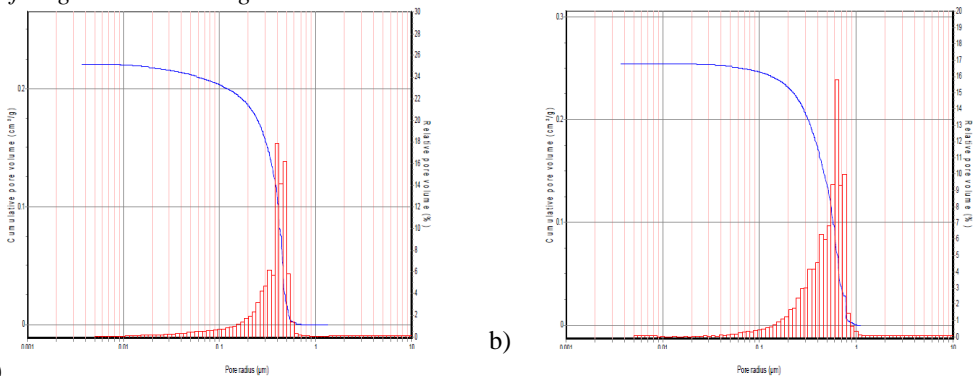
At the same time, all the samples showed an increase in porosity when re-fired at the lower range of temperatures but a decrease in open porosity in all cases when re-fired at 1100°C. The results of mercury intrusion porosimetry have showed a slight increase in pore size in the samples re-fired at 890 and 950°C (Figure 2).

a) Figure 2. Pore size distribution diagrams: *a) before re-firing, peak  $\phi$  0.3-0.4  $\mu\text{m}$ ; b) after re-firing at 950°C during 40 minutes, peak  $\phi$  0.6-0.7  $\mu\text{m}$ .*

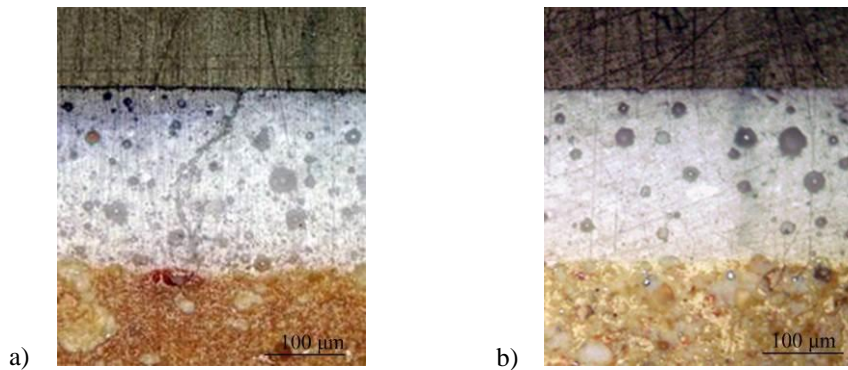
The microscopic observation of the glaze (Figure 3) in the studied samples has shown that crazing cracks had been effectively sealed through re-firing eventually leaving scar-like marks. The number of bubbles seen in the glaze also tended to decrease, through confluence or elimination at the surface (Figure 3).

Figure 3. OM observations of single-stage re-firings: *a) before re-firing; b) after re-firing at 950°C during 20 minutes.*

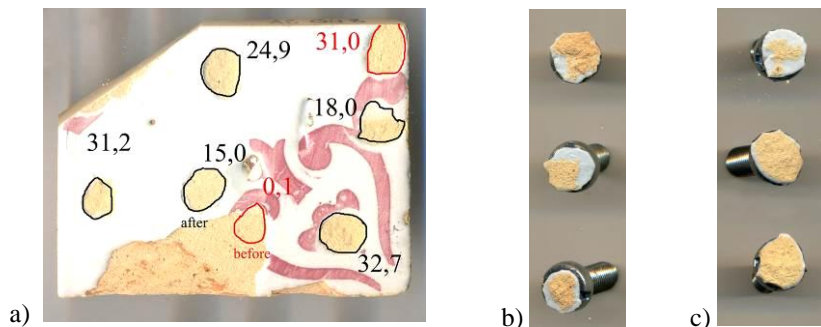
The glaze to biscuit adhesion did not show to worsen after re-firings and in two cases small pieces of detached glaze were verified to have adhered after re-firing in a way that they could not be separated with the nail. In no case did a pull-off test detect any evident impairment of the glaze to biscuit adherence (Figure 4) but it made evident that the cohesion of the biscuit decreased on the firings at lower temperatures but increased in all cases at 1100°C.

Figure 4. Pull off tests: *a) ultimate force results before (red) and after re-firing (kN); b) fracture in not re-fired condition; c) fracture after re-firing at 950°C during 40 minutes.*

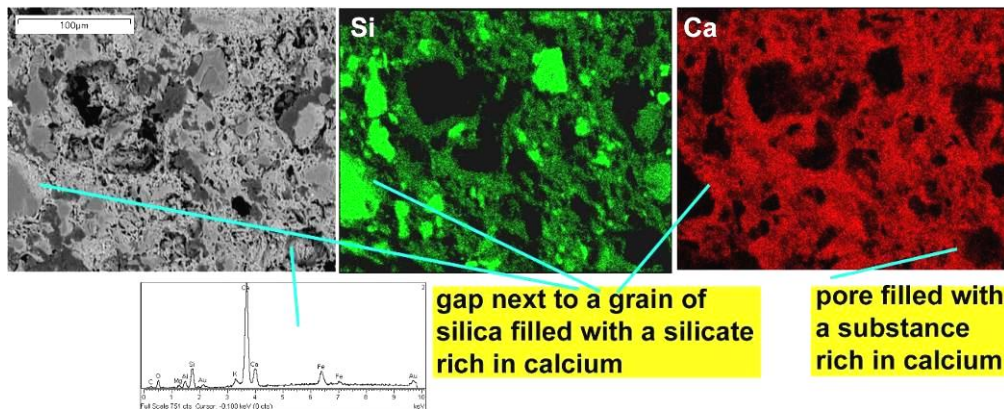
An analysis by SEM-EDS of a re-fired sample identified lime or calcite deposited in the hollows accessible to solutes circulating in the walls and biscuits. Upon firing the calcite is transformed into lime or combined e.g. with silica to form wollastonite or with aluminosilicates to form e.g. gehlenite, releasing carbon dioxide in the process (Figure 5).

Figure 5. SEM observations of a re-fired sample.

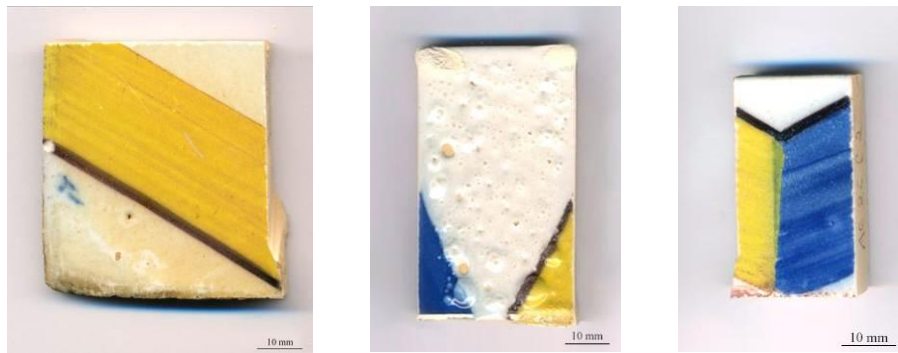
The method worked well and the bubbling problem was successfully solved (Figure 6). The further tests were aimed at finding the minimal duration and optimal temperature to let the carbonates decompose and the carbon dioxide escape from the ceramic body. Heating ramps of 200°C/h and 240°C/h were tested, as well as the effect of pre-firings on 21 samples at 550, 600, 650 and 700°C during 1-4 hours. The maximum temperatures evaluated in double-stage re-firings were 890, 950 and 990°C. However, it was still not possible to avoid completely the appearance of “orange skin” on the surface of one tile. We can assume that this anomalous result is caused by the glaze softening at a lower temperature than in the other tiles so that during the de-carbonation phase the gas already starts bubbling through the glaze.

Figure 6. Visual observation of double-stage re-firing results: *a) not re-fired; b) single-stage refiring (990°C 5 minutes); c) double-stage re-firing*

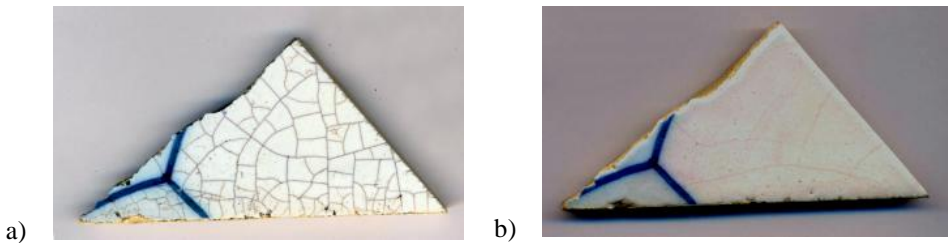
The re-firing treatment did not influence in any noticeable systematic manner the degree of pull-off resistance after ageing in boiling water. More revealing: the boiling in water caused in some cases new crazing but this did not usually coincide with the original crazing, meaning that the re-firing did reverse the fissures in a way that the scars do not constitute preferential propagation paths to new crazing phenomena (Figure 7).

Figure 7. Comparison of crazing pattern: *a) not re-fired; b) re-fired and aged in boiling water- crazing highlighted with red ink*

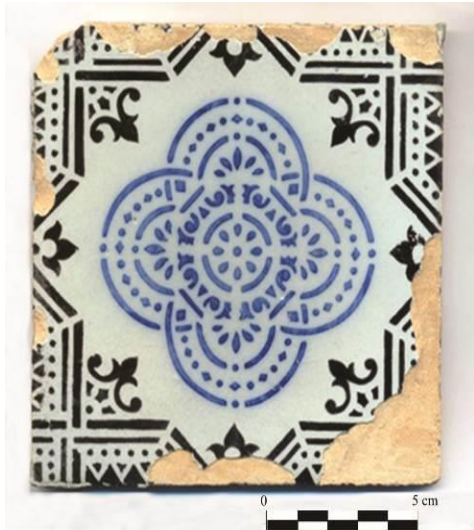
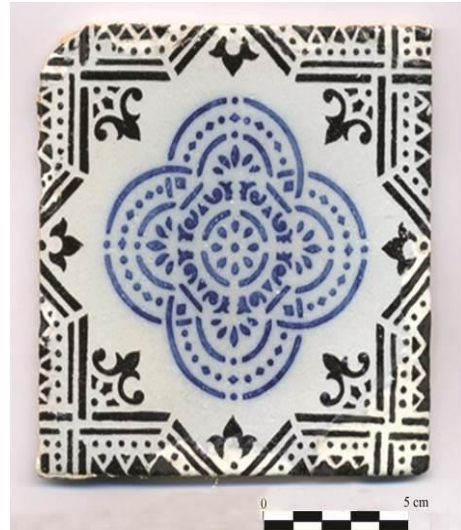
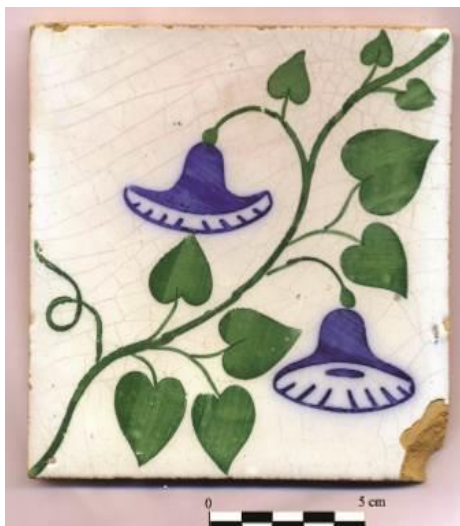
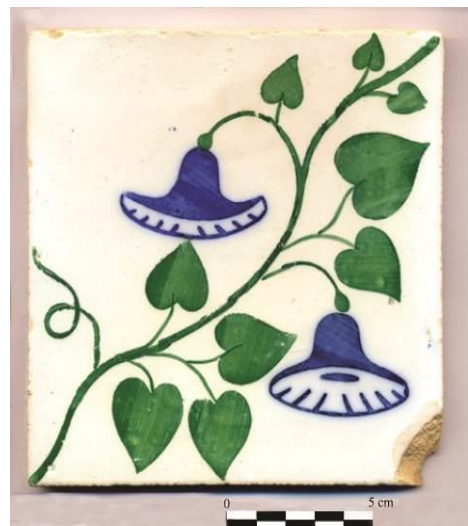
Figure 8. Application of double-stage re-glazing and re-firing technique to the restoration of spalled tiles

The technique has been applied and evaluated as a technological option for full restoration of spalled tiles (Figure 8). The lacunae in 8 spalled tiles have been reintegrated with new glaze CE VTR- 81 (manufactured by Ferro S.A. and widely used nowadays in tiles production), painted and subsequently re-fired. The double-stage firing at 650°C for 3 hours and then 890°C for 45 minutes proved efficacious and 890°C is likely inferior to the temperature at which the biscuit has been originally fired [11] and should not lead to the formation of new chemical species in the ceramic body.

*a) before restoration;*

*b) after restoration by re-firing;*

*c) before restoration;*

*d) after restoration by re-firing;*

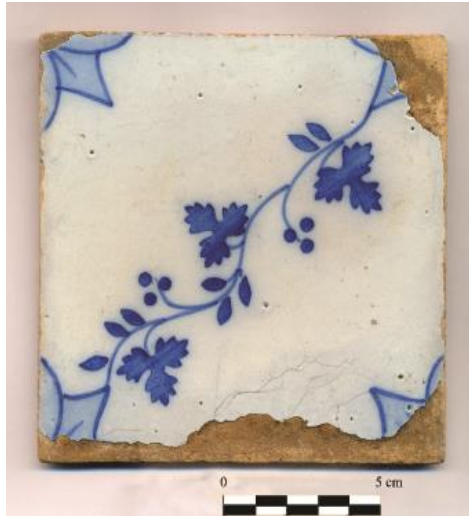
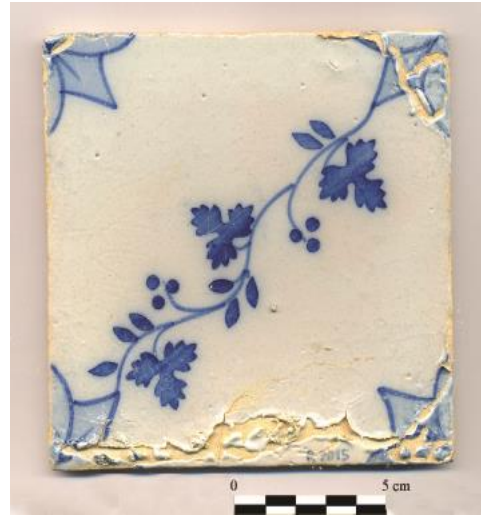
Figure 8. Application of double-stage re-glazing and re-firing technique to the restoration of spalled tiles

Small patches of minimal orange skin were occasionally reported but they did not led to unacceptable results. However, one sample returned completely unexpected results since the new glaze did not adhere to the biscuit and the original glaze now curled at the edges (Figure 8f). The problem in this case is not related to calcite decomposition during the firing and has not been explained so-far.

e) before restoration;

f) after restoration by re-firing

Each case is a case in itself and although a receipt was developed that may be applied successfully to most cases, there was a definite failure. It is recommended that, if possible, preliminary tests and trials should be done to determine the content in carbonates of the samples and, in all cases, preliminary firings be run to check the response of the azulejos to different firing cycles so as to determine the most appropriate and efficient one.
