COMPREHENSIVE ASSESSMENT OF THE CAHORA BASSA DAM'S CONCRETE SWELLING PROCESS

António Lopes Batista^{1*}, Ezequiel Fernandes Carvalho², Ilídio Marcos Tembe²

¹Laboratório Nacional de Engenharia Civil (LNEC), Lisbon, PORTUGAL

²Hidroeléctrica de Cahora Bassa (HCB), Songo, MOZAMBIQUE

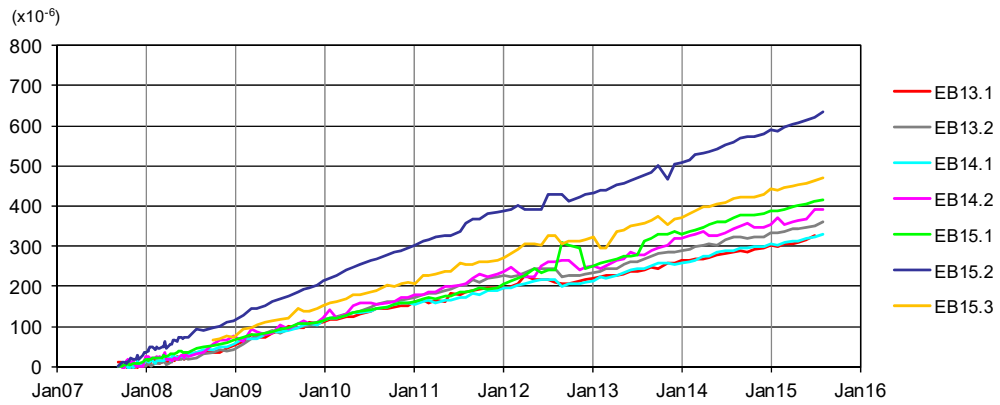
Figure 3 represents the time evolution of the strains computed from the horizontal displacements measured on the rod extensometers of the South attack gallery buttresses, from 2007 to 2015, which can be considered as free strains. The evolution is almost linear in all the cases. The average strain value is about 400×10^{-6} after 8 years of monitoring that corresponds to an annual average value of 50×10^{-6} . This value can be considered as an envelope of the swelling development.

FIGURE 3: Time evolution of strains computed from the horizontal displacements measured by the rod extensometers of the South attack gallery buttresses, from 2007 to 2015

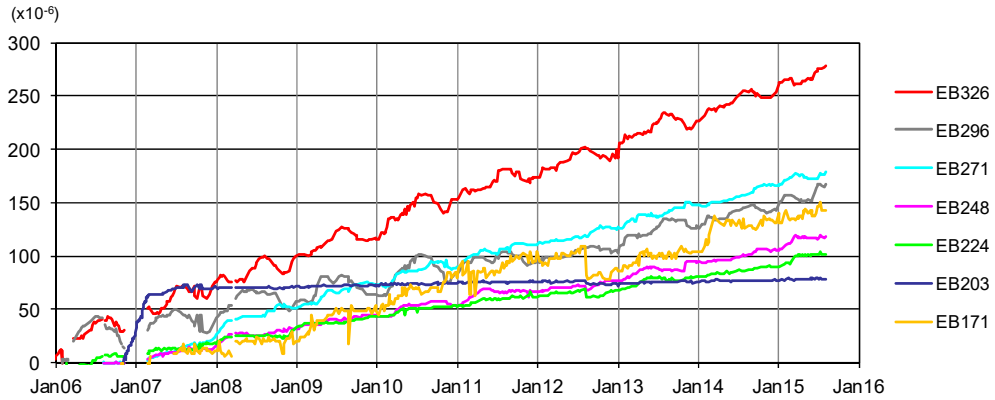
Figure 4 presents the vertical strains computed from the displacements monitored by rod extensometers installed in 2006 and 2007 at the central cantilever of the dam. The strain pattern evolution is similar for all the devices, except on the lower extensometer EB203 that recorded unusual displacements. At the intermediate zone (extensometers EB224, EB248 and EB271), the strains follow an almost linear evolution, with peak accumulated values ranging from 100×10^{-6} to 180×10^{-6} . At the upper section, where extensometers EB296 and EB326 are installed, the strains also have a linear evolution, if the thermal portion is disregarded, but the accumulated values in about 9 years rise up to about 170×10^{-6} and 280×10^{-6} , respectively. These vertical strains average values are about $15 \times 10^{-6}/\text{year}$ and $30 \times 10^{-6}/\text{year}$ at the large intermediate zone and for the upper device, respectively.

FIGURE 4: Time evolution of strains computed from the vertical displacements measured by the rod extensometers of the dam's central cantilever, from 2006 to 2015

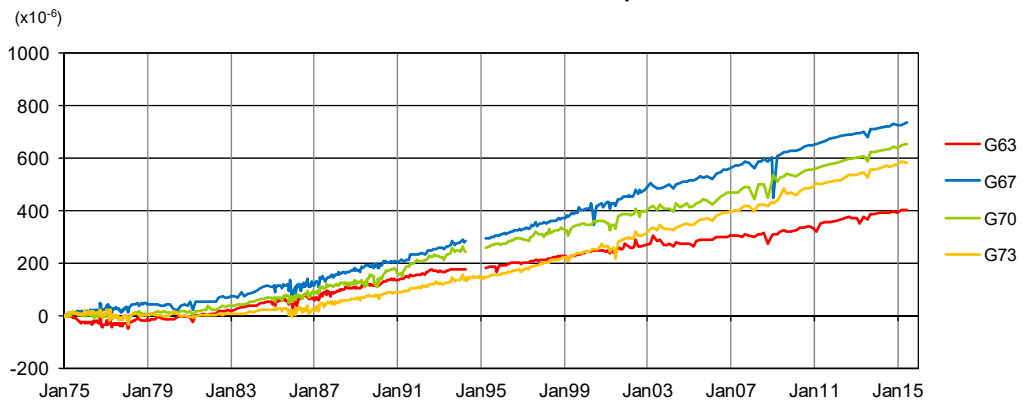
Figure 5 represents the time evolution of the free strains measured by the stress-free Carlson strain-meters of the embedded strain-meter groups located at the middle surface of the bottom arches of the dam, from 1975 to 2015. The typical sigmoid shape of the curves must be pointed out. The currently free strain values are between 400×10^{-6} and 750×10^{-6} . The strain average value in the last 10 years is about 200×10^{-6} , which corresponds to a value of $20 \times 10^{-6}/\text{year}$. These monitored swelling strains are of the wet-screened concrete that involves the strain-meter groups, and may have a magnitude different from swelling corresponding to the full-mixed concrete of the dam.

FIGURE 5: Time evolution of free strains measured on the stress-free Carlson strainmeters located at the middle surface of the bottom arches of the dam, from 1975 to 2015

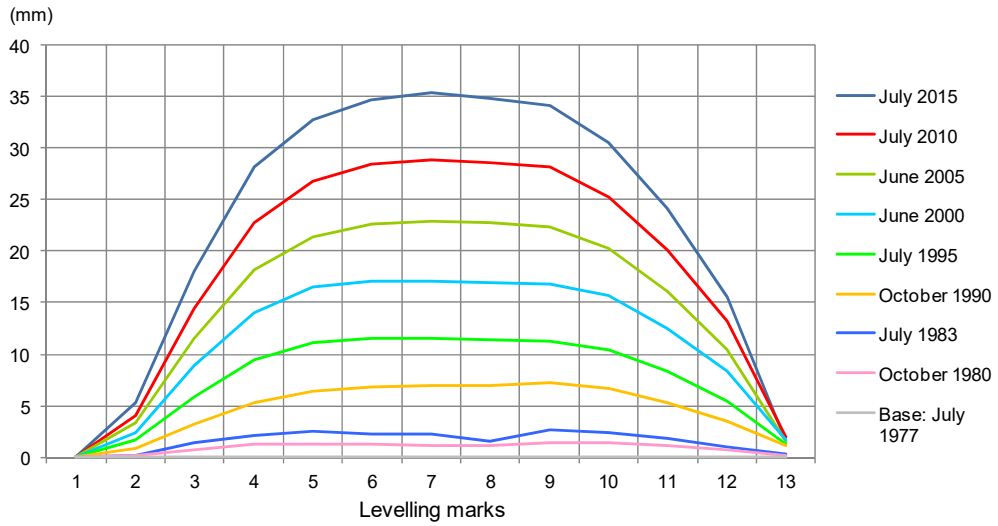
Figure 6 presents the evolution of vertical deformations of the gallery at elevation 296.0 m, observed between July 1977 and July 2015. It is noticed that, for identical time intervals between observation periods, there are progressive and approximately constant swellings since 1983 (the vertical displacements rate is almost constant over time), which is in agreement with the previous considerations regarding the swelling rate.

FIGURE 6: Vertical displacements at the 296.0 m elevation gallery, measured by geometric levelling between July 1977 and July 2015

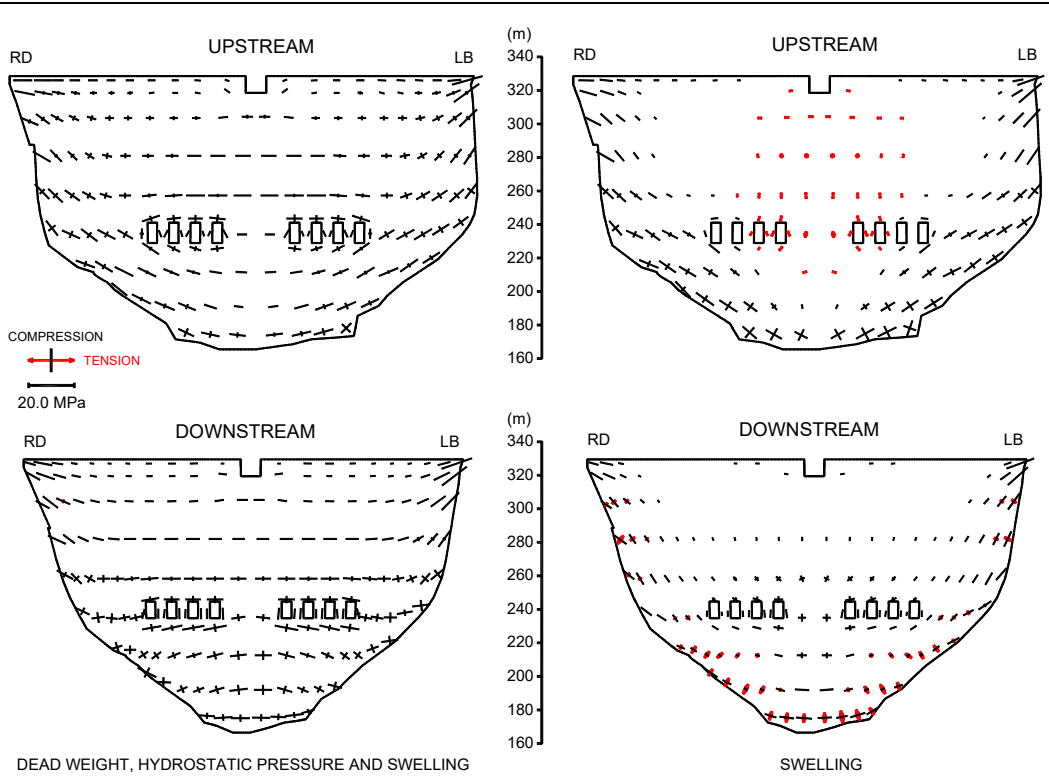
The behaviour analysis of the dam over time carried out until the end of 2008 showed that the swelling has led to an increase in compressive stresses on a large part of the structure, and to a decrease in these stresses along the insertion downstream, and on the upper central zone upstream. Due only to swelling, the compressive stresses reach values of about 12 MPa at the bearings of the upper arches, both upstream and downstream, whereas the highest tensions, near the insertion surface downstream, reach values of about 3 MPa. At the end of 2008 all the tensile stresses were largely compensated by compressive stresses due to dead weight and hydrostatic pressure. By considering the set of all loads, a generalized compression field was computed for the dam's body, with peak values of about 12 MPa at the bearings of the upper arches, upstream and downstream, and of about 8 MPa at the closure of the arches above the spillway orifices (Figure 7).

FIGURE 7: Principal stresses on the dam surfaces computed at the end of 2008 [10,11]

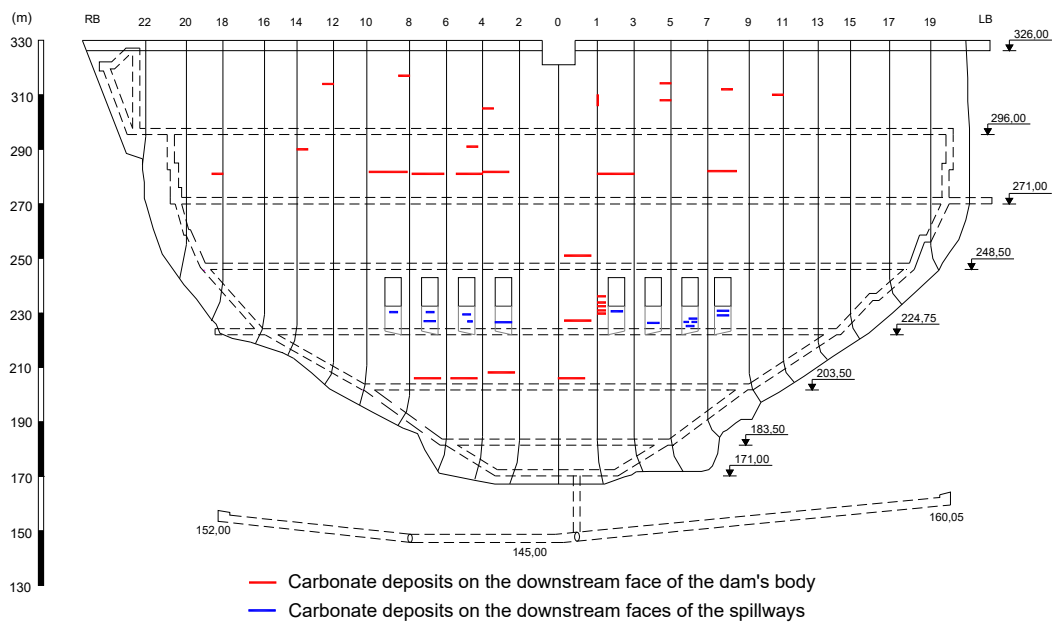
Although there are some diagonal cracks on the left bank concrete structure, on the access to the open gallery under the crest, at elevation 326.00 m, which were formed due to localized restriction of this weak structure to the dam body expansions in the vertical direction, mention must be made to the fact that the dam concrete does not present any significant cracking. There are only a few older cracks, at the top and at the sidewalls of some galleries, and diffusive cracking, which is more relevant close to the abutments at the sidewall of the mentioned open gallery near the crest. That cracking has had no significant evolution over time [1,9,10]. In Figure 8 are represented the reduced calcium carbonate deposits on the downstream face, at concreting and contraction joints, identified in LNEC's 2008 inspection [10].

FIGURE 8: Downstream dam surface with the location of carbonate deposits in June 2008 [10,11]
