## OBSERVATION OF THE BEHAVIOUR OF FOZ TUA DAM DURING THE FIRST FILLING OF THE RESERVOIR

**Abstract:** *The Foz Tua Project is the latest accomplished hydroelectric investment of EDP - Energias de Portugal, located in a tributary of Douro River, close to its mouth, in the northeast of Portugal, which includes a concrete double curvature arch dam 108 m high with a total crest length of 275 m, closing a narrow granitic valley.*

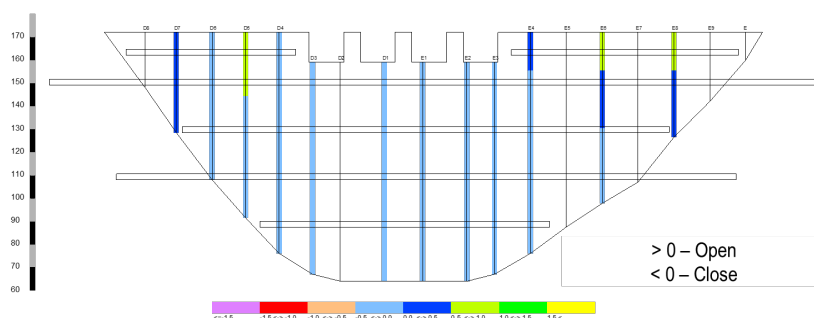
Figure 7: Joint movements, in millimetres, measured between the beginning of the first filling and stage P2 in electrical resistance jointmeters placed at half thickness

The dam presented a continuous behaviour, characterized by small movements in all structural joints, with the exception of small sections located at levels almost all the time above water level (Figure 7).

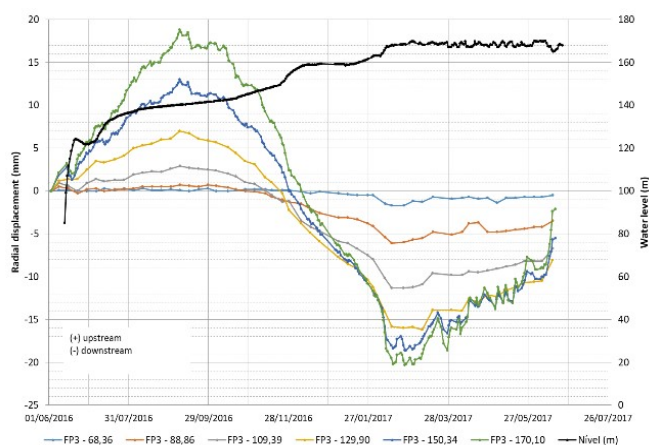
Figure 8: Radial displacements measured during the first filling in all measuring points along FP3 plumb line.

The horizontal displacements monitored in the five plumb lines show a good structural behaviour, explained by the evolution of the main actions, according to the model results. The temperature variations had the more important influence until the end of 2016 (Figure 8).

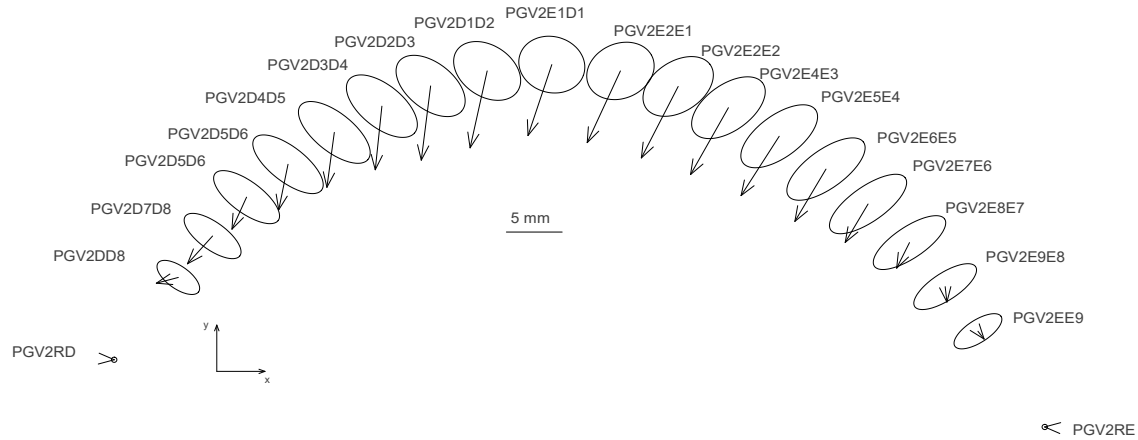
Figure 9: Horizontal displacements measured in the traverse line installed in GV2 gallery between May 2016, with the reservoir empty, and June 2017, at the end of the filling

The horizontal components of the displacements determined in the precision traverse lines GV2 and GV4 galleries were also coherent with the expected structural behaviour and with the results obtained in the plumb lines (Figure 9).

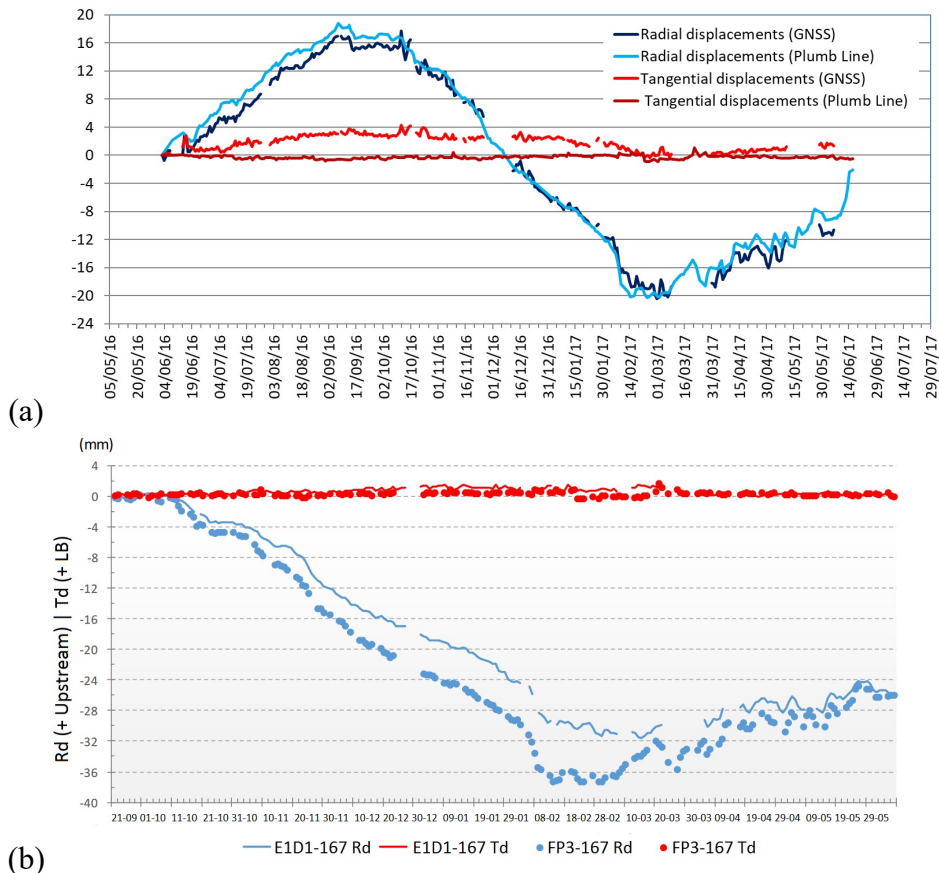
Figure 10: Comparison of the horizontal displacements measured during the first filling in the higher measuring point of plumb line FP3 with (a) GNSS results and (b) continuous geodetical monitoring system

Figure 10 shows the comparison between the horizontal displacements measured in the higher measuring point of the plumb line FP3 with the results obtained with the GNSS antenna and with the 3D continuous geodetic monitoring system. The results of the comparisons are good, particularly in the radial component.

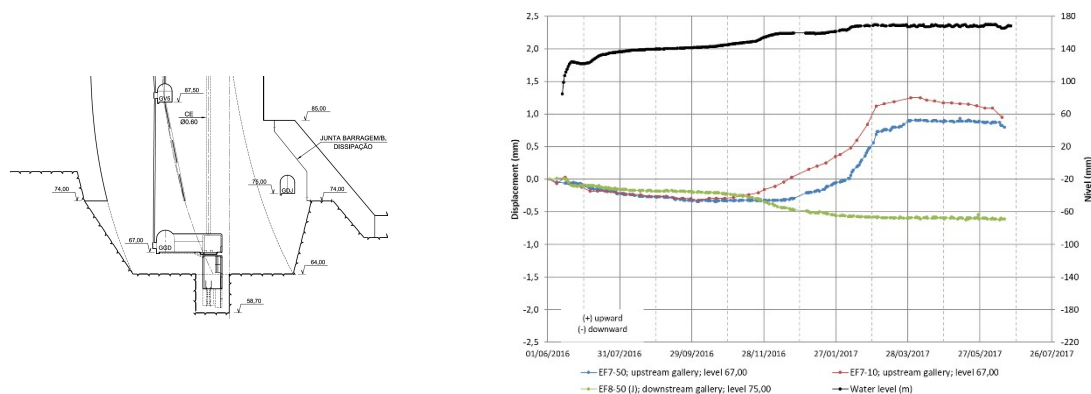
Figure 11: Vertical displacements measured in rockmeters placed in the central block.

The vertical displacements measured by rod extensometers along the dam/foundation interface were also coherent with the loads variation. In Figure 11 the effect of the level rise in the end of 2016 is notorious, when were observed upward displacement in the upstream gallery and downward displacements in the downstream gallery.

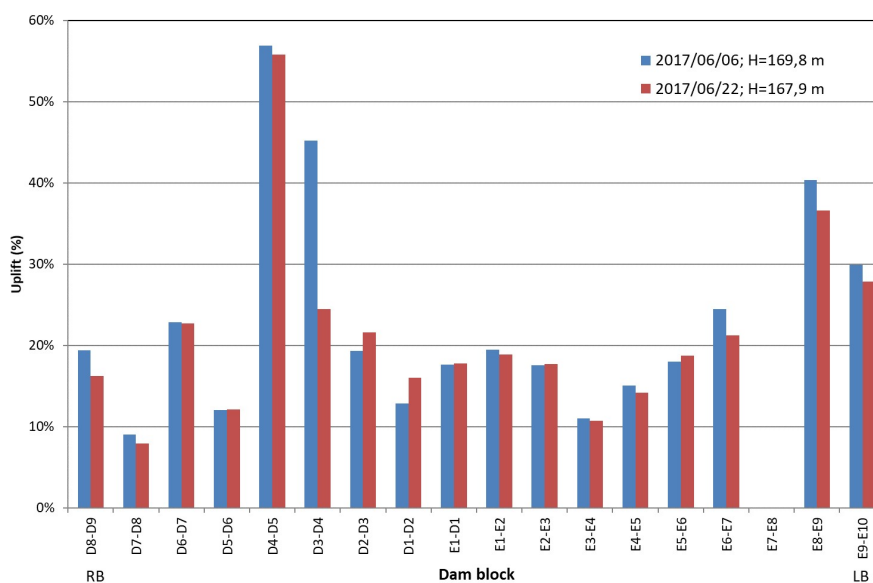
Figure 12: Uplift percentage measured in piezometers.

During the first filling of the reservoir, some piezometers indicated higher values of uplift than expected (Figure 12). A maximum value of about 70% of the reservoir hydrostatic pressure was attained approximately at the central section of the right bank, in block D4/D5. The piezometer located in block D3/D4 also indicated a relatively high value of uplift of about 50% of the reservoir hydrostatic pressure. Another zone with relatively high values of uplift of about 35% to 50% of the reservoir hydrostatic pressure was detected in the upper portion of the left bank, in blocks E/E9 and E9/E8, but a tendency of reduction was observed.

The drains located in the zones of higher uplift did not yield significant flows. Nevertheless, relatively significant values of flow were measured in several drains, mostly located in the five central blocks (E3/E2 to D2/D3). A maximum value of 38 l/min was measured in a single drain, and a total of six drains exceeded a flow of 10 l/min during the first filling of the reservoir. The values of uplift in the central blocks were well below the reference of one third of the reservoir hydrostatic pressure.

A more detailed analysis of these situations and an evaluation of additional actions to be taken was considered necessary, leading to the definition and execution of a set of tests to gather further information and to investigate if the flow or pressure were higher at certain depths or if they were relatively homogeneous along the tested drain and piezometer holes. Subsequently, a set of eight supplementary drains and one piezometer was implemented in the central section of the right bank, in blocks D3/D4 and D4/D5, resulting in a satisfactory reduction of uplift values, generally assuming values below the reference of one third of the reservoir hydrostatic pressure.

The observation campaigns allowed the detection of some small zones of the foundation with high uplift values. The drilling of more eight drains and the installation of one more piezometer corrected the situation, confirming the foundation's good hydraulic behaviour.
