PRELIMINARY IDENTIFICATION OF THE STRUCTURAL EFFECTS OF CONCRETE SWELLING IN CHICAMBA DAM (MOZAMBIQUE)

ABSTRACT

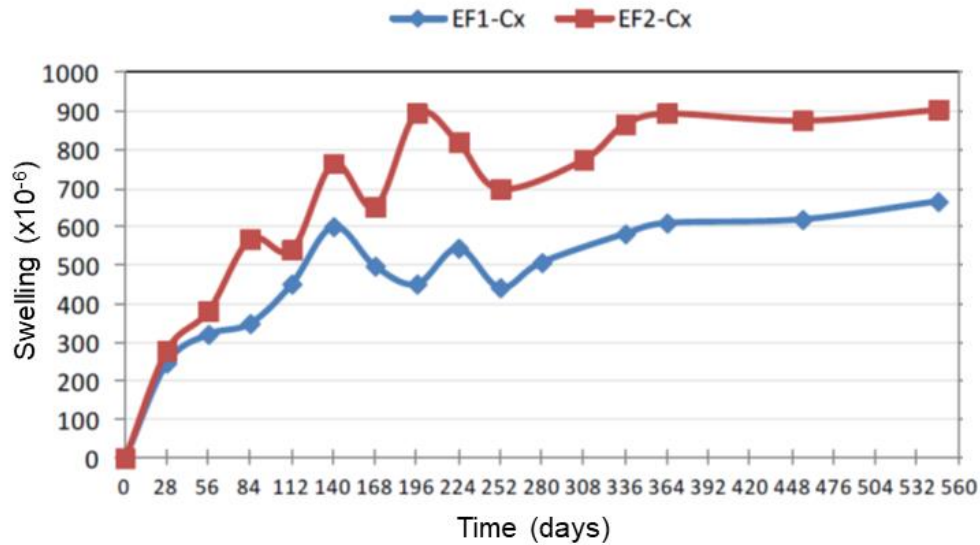
The results obtained in tests carried out at LNEC between June 2011 and December 2012, on concrete samples extracted from the body of the main arch when drilling for the installation of rod extensometers in the foundation, indicate the development of swelling reactions in the dam’s concrete [8,9]. The obtained values for the residual expansions, 667×10^{-6} and 906×10^{-6} ,

in the two samples that had sufficient dimensions to carry out this type of tests (Fig. 4), can be considered high in terms of the remaining expansive potential [9].

Fig. 4 – Results of the accelerated expansion tests, carried out at LNEC in 2011-2012, on concrete samples extracted when drilling the rod extensometers EF1 and EF2

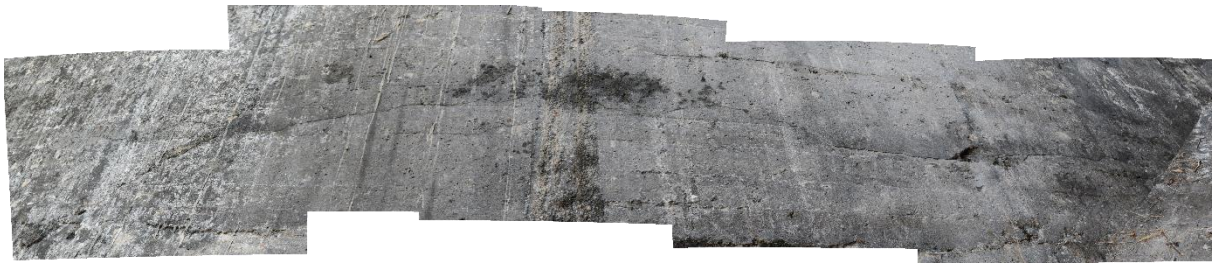
In the last visual inspections cracks were detected on the downstream surface of the two arches, close to the dam-foundation interface and parallel to this surface, being more expressive in the secondary arch, in the lower section on the right bank side [10,11]. The main cracks are described in Table 6.

Main arch (downstream surface)	Secondary arch (downstream surface)
Cracks parallel to the dam-foundation interface, on the right bank side, on block G-H, near the G joint	Horizontal cracks with a maximum opening of about 5 mm, between joints IV and VII
Cracks parallel to the dam-foundation interface, on the left bank side, near the P joint	Cracks parallel to the dam-foundation interface, on the right bank side, between joint II and the middle of block IV-V, with an opening between about 1.5 mm and 2.0 mm (Fig. 6)
Horizontal crack near the dam-foundation interface, on the left bank side, on block Q-R (Fig. 5)

Fig. 5 – View of the horizontal crack near the dam-foundation interface, on the downstream surface of the main arch, on the left bank side, on block Q-R

These cracks might be related to the existence of concrete expansions. In order to monitor its opening-closing movements, two deformeters were installed on cracks of the secondary arch in 2015. The observation period for these devices, which is still very short, coincided with the high rise of the water level in the reservoir, that occurred in the last years. The observed movements were of closure, so it is not possible, yet, to associate the opening-closing movements of the cracks with the development of expansions in the dam's concrete.

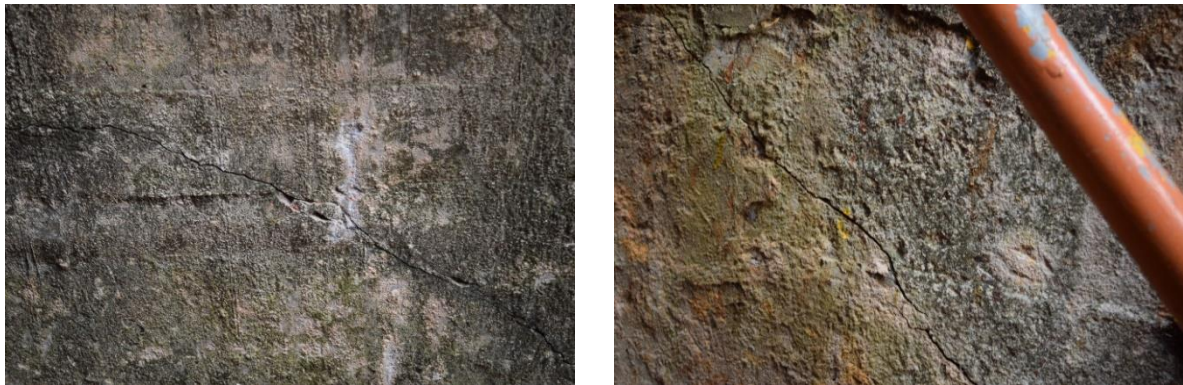
Fig. 6 – Views of cracks parallel to the dam-foundation interface, on the downstream surface of the secondary arch, on the right bank side, between joint II and the middle of block IV-V

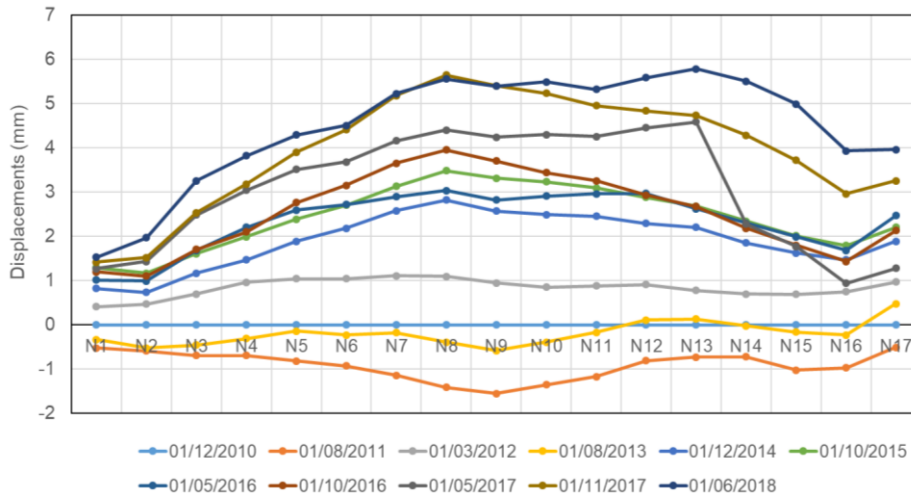
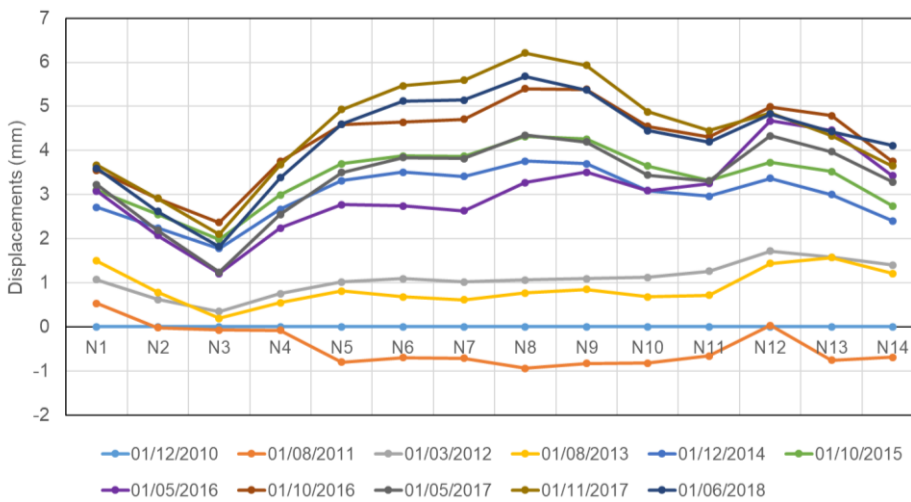
Fig. 8 and Fig. 9 present the vertical displacement along the levelling lines obtained on 11 surveys performed between 2010 and 2018. The obtained movements are consistent with seasonal thermal variations and with the existence of moderate expansions in the concrete.

Fig. 8 – Vertical displacements measured by precision levelling on the open gallery under the crest of the main arch, at the elevation of 222.50 m, between 2010 and 2018

Fig. 9 – Vertical displacements measured by precision levelling on the crest of the secondary arch, at the elevation of 225.00 m, between 2010 and 2018

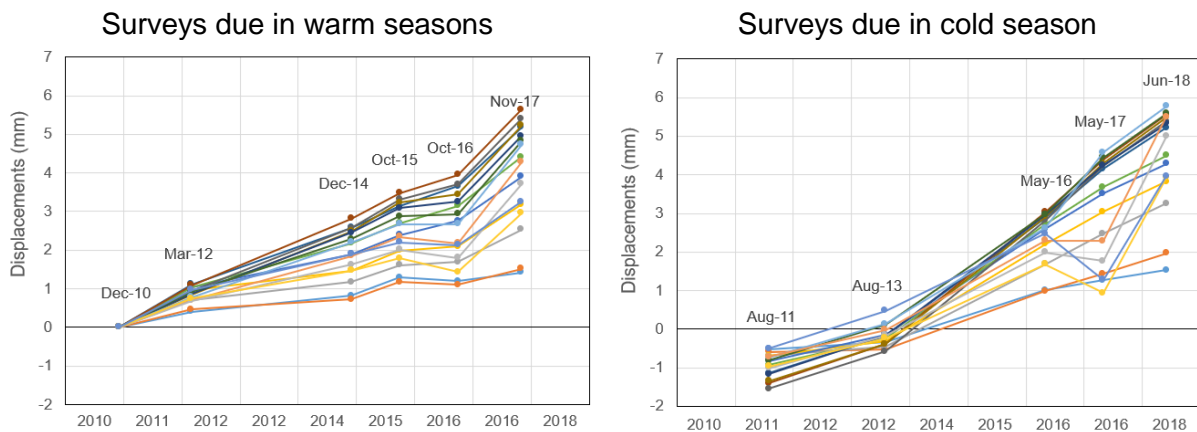
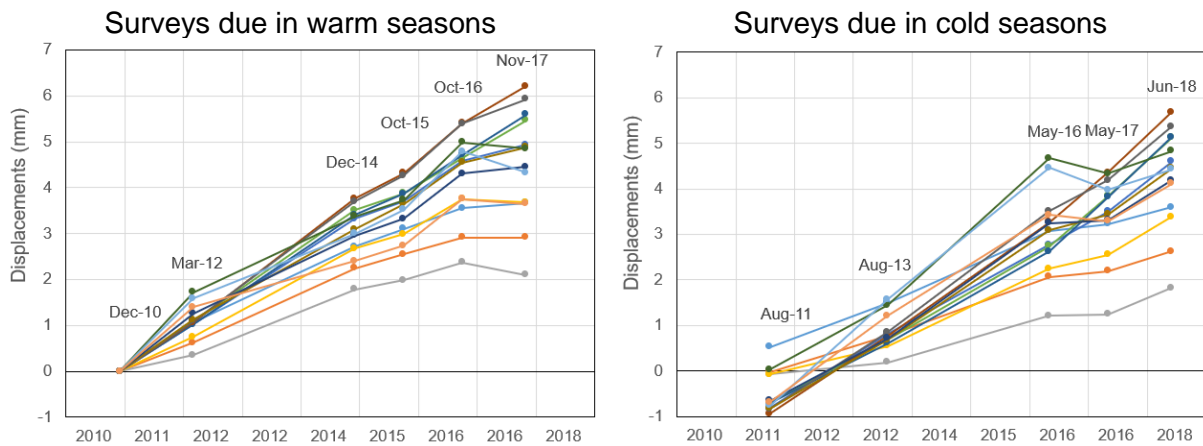
The evolution of the vertical displacements is shown in Fig. 10 and Fig. 11. For better appreciate the progression of the vertical displacements, the results obtained in the warm and in the cold seasons were plotted in separated charts. Permanent upward vertical displacements of about 5,5 mm and 6 mm were observed on the central measuring points of the main and secondary arches, respectively, between December 2010 and November 2017, which correspond to average annual expansion rates of about 11×10^{-6} and 19×10^{-6} , respectively (Table 7). It seems that the expansions effects are more significant in the secondary arch, which is consistent with the more expressive cracking existing near the interface of this structure with the foundation, downstream.

Fig. 10 – Evolution of vertical displacements measured by precision levelling on the open gallery under the crest of the main arch, at the elevation of 222.50 m, between 2010 and 2018

Fig. 11 – Evolution of vertical displacements measured by precision levelling on the crest of the secondary arch, at the elevation of 225.00 m, between 2010 and 2018

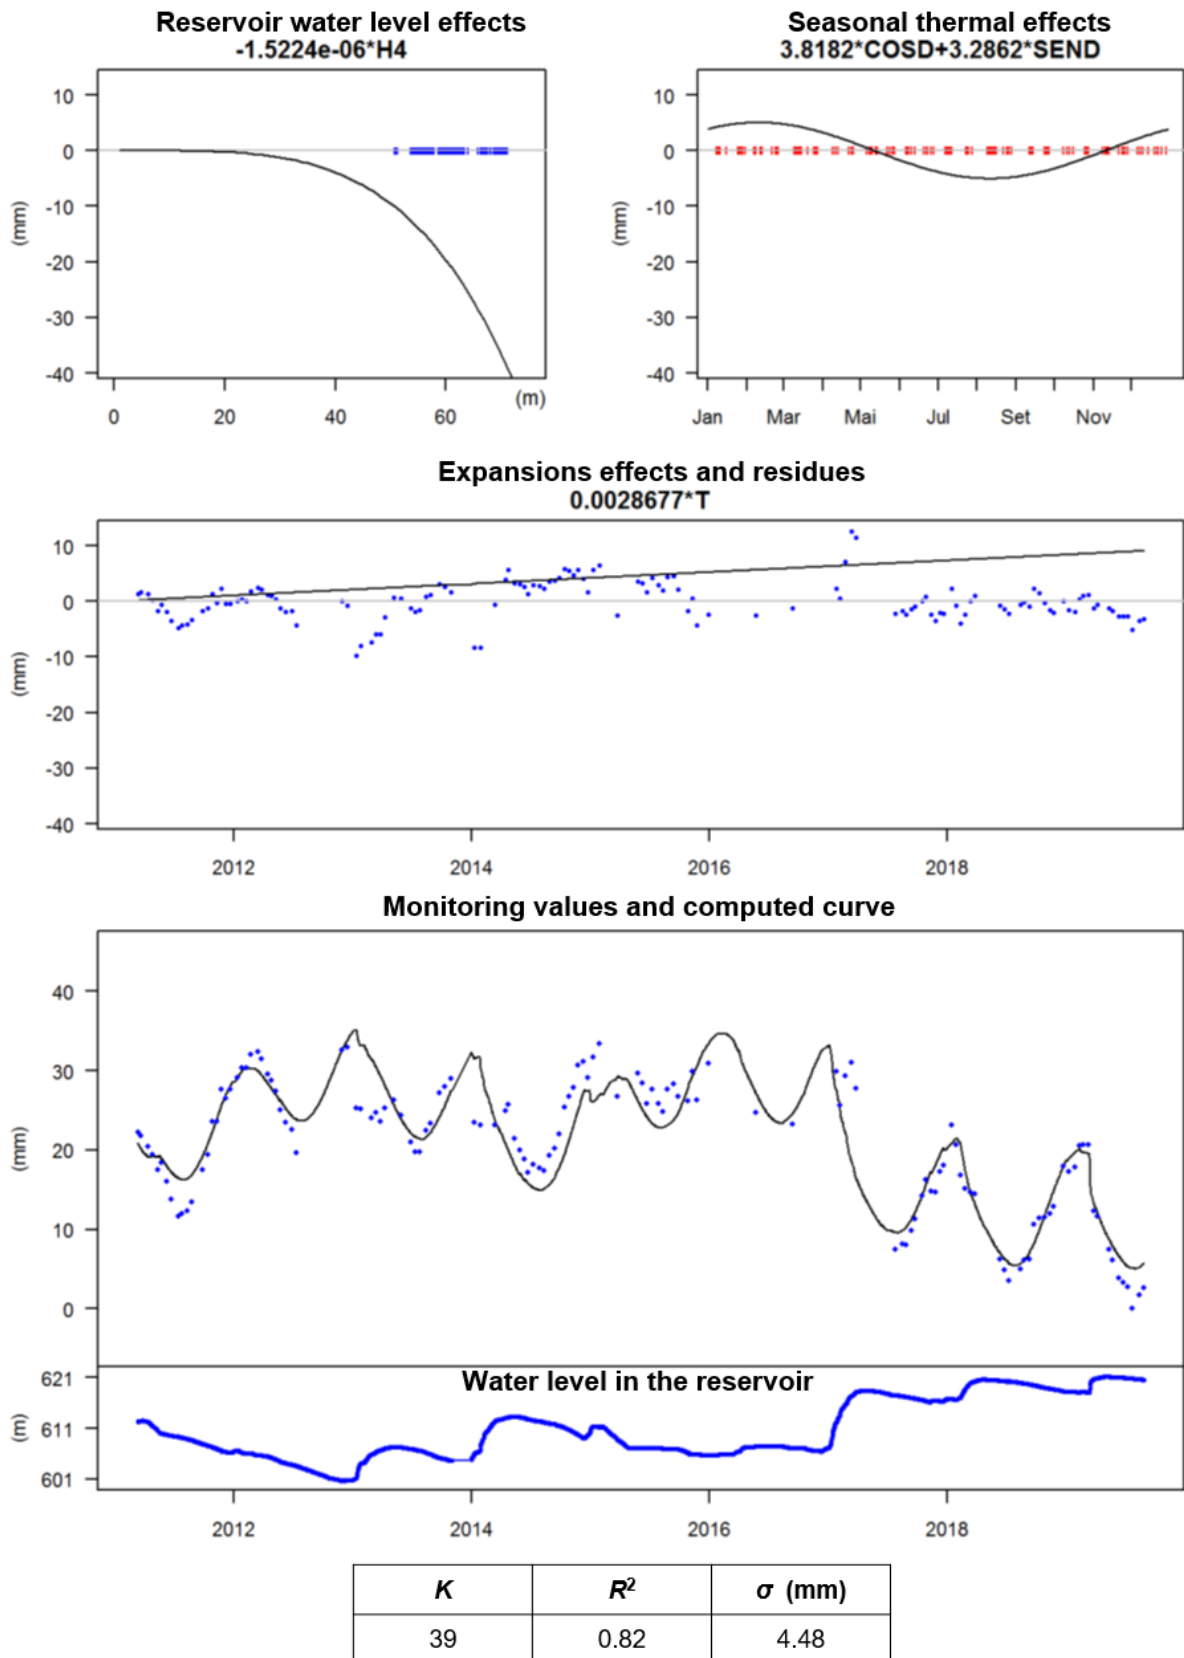
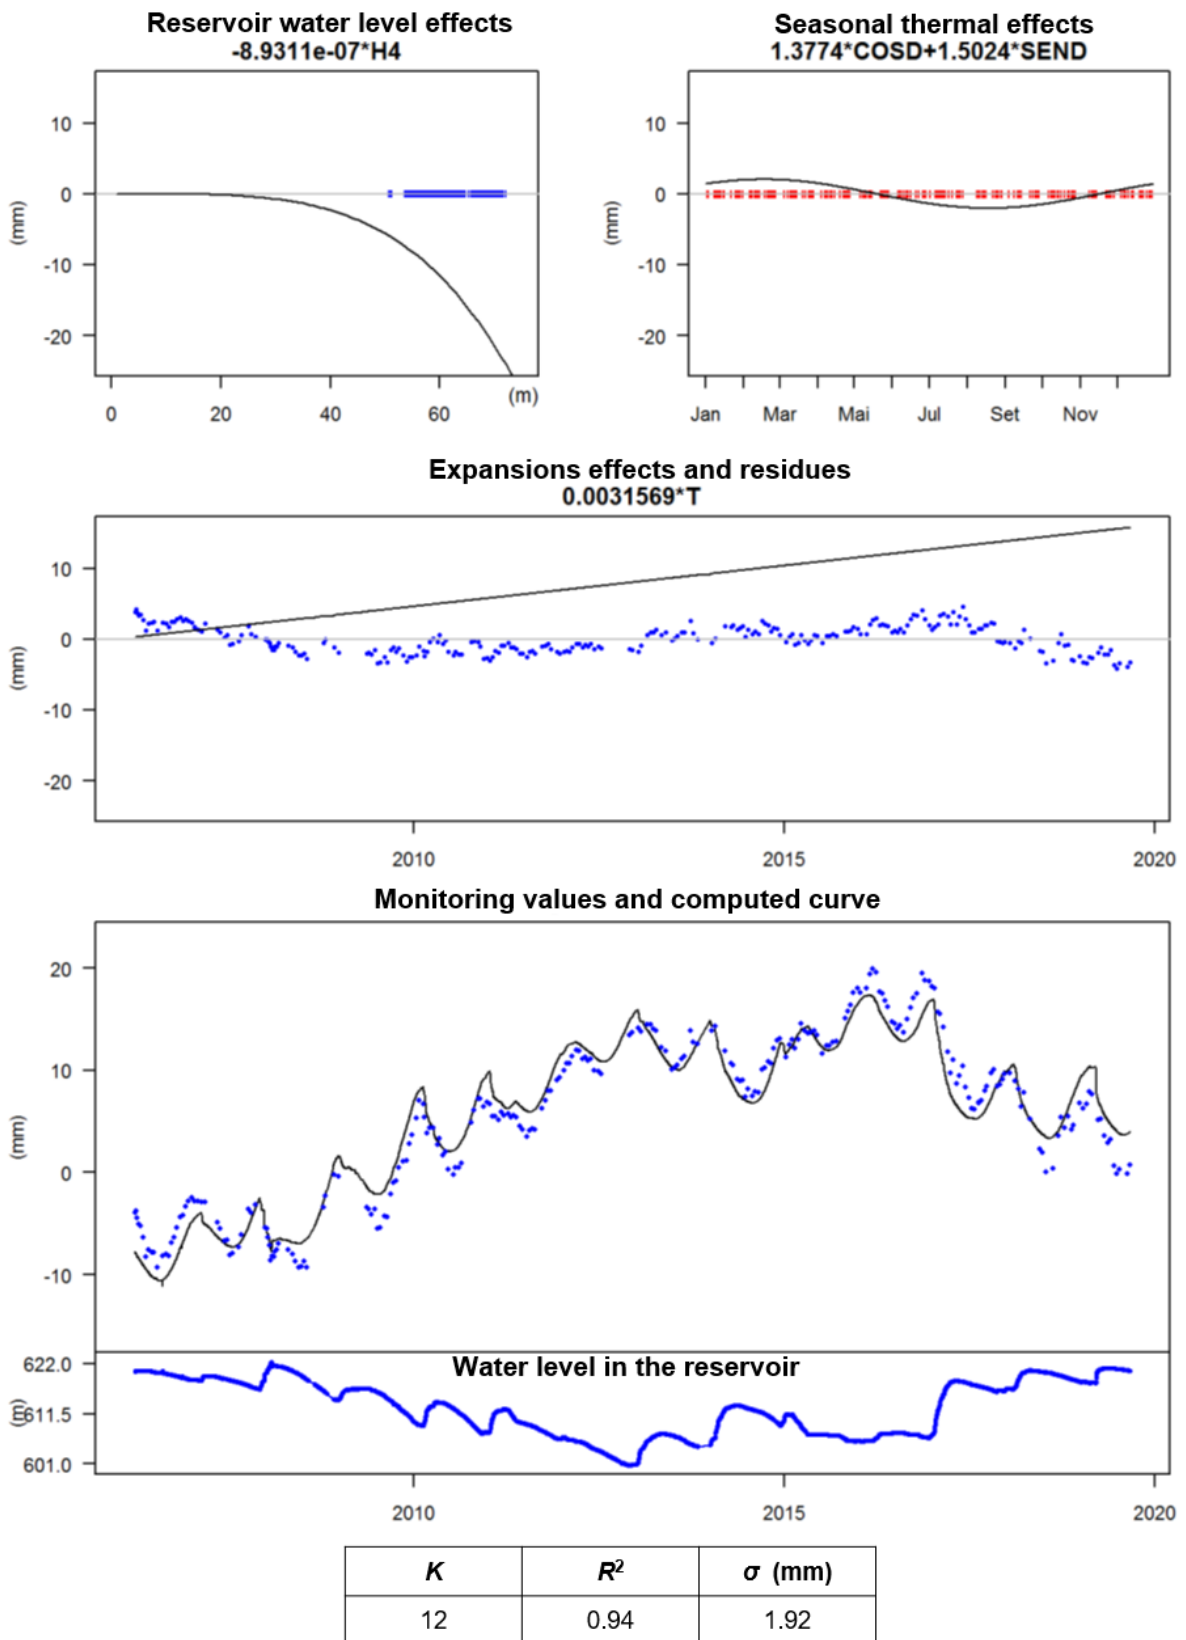
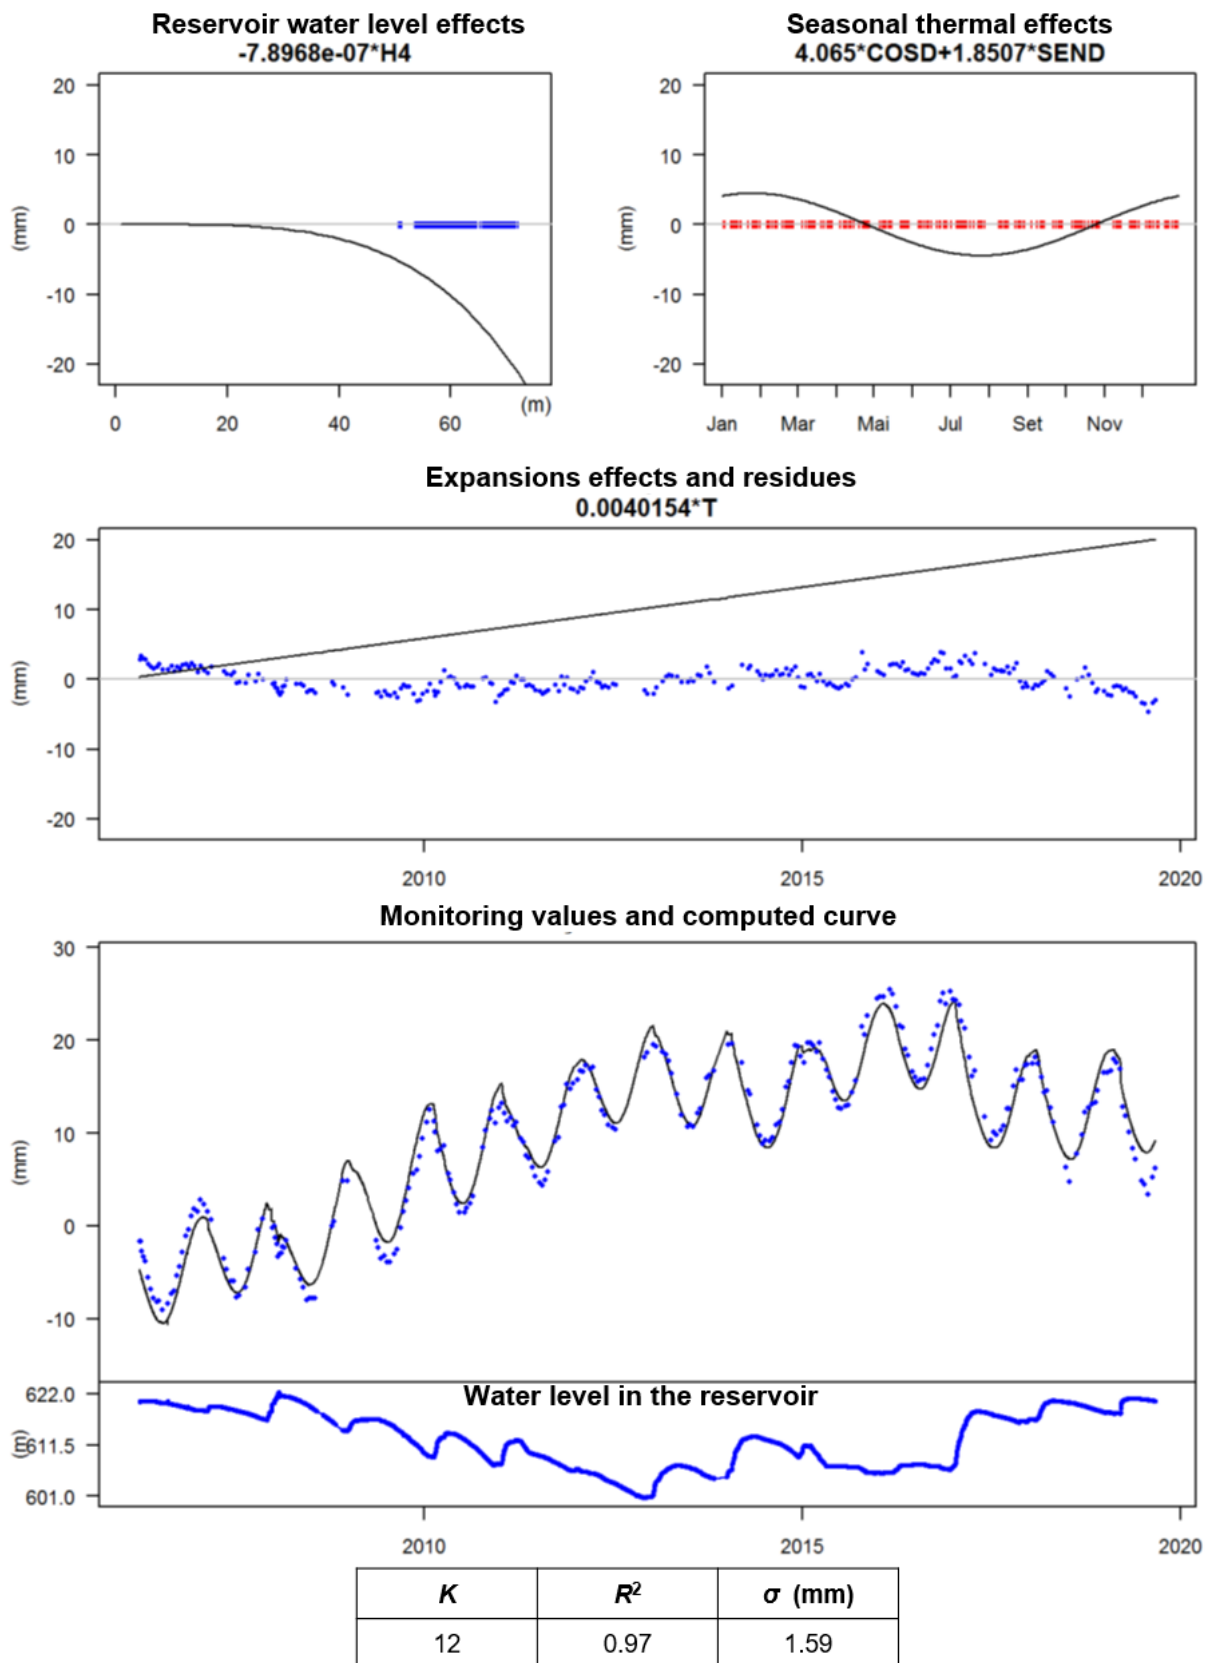
Fig. 13 to Fig. 15 show the graphical results obtained by quantitative interpretation of the radial displacements measured on the upper points of the three plumb lines (elevation 622.50 m). A good agreement between the observed results and the ones obtained by quantitative interpretation techniques is observed, which correspond to determination coefficients (R^2) close to the unity in the lateral plumb lines FP2 and FP3 (0.94 and 0.97, respectively) and of 0.82 in the central plumb line.

Fig. 13 – Quantitative interpretation of the radial displacements observed in the main arch at the measuring point at elevation 622.50 m of the plumb line FP1, between 2011 and 2019

Fig. 14 – Quantitative interpretation of the radial displacements observed in the main arch at the measuring point at elevation 622.50 m of the plumb line FP2, between 2011 and 2019

Fig. 15 – Quantitative interpretation of the radial displacements observed in the main arch at the measuring point at elevation 622.50 m of the plumb line FP3, between 2011 and 2019

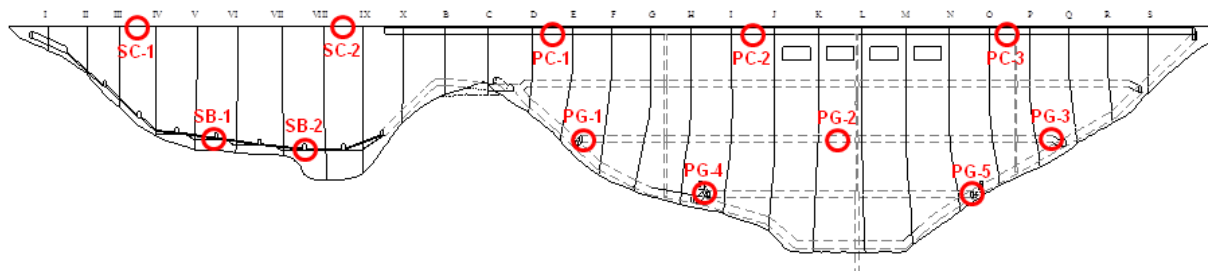
Fig. 16 – Elevation view of the dam with the planned locations of core extraction for the study of the concrete's pathology

To characterize the properties of the swelling processes on the dam's concrete, an experimental study is planned to be carried out in laboratory, which will require the previous extraction of a set of concrete cores from the dam's body (Fig. 16).

The laboratory tests will allow to assess the magnitude of the current expansions and the eventual depreciation of the concrete properties, and, additionally, to forecast the remaining expansion potential of the dam's concrete.
