Monitoring the Madeira airport protection breakwater using visual and Unmanned Aerial Vehicle observations

Keywords: visual monitoring, UAV monitoring, berm breakwater.

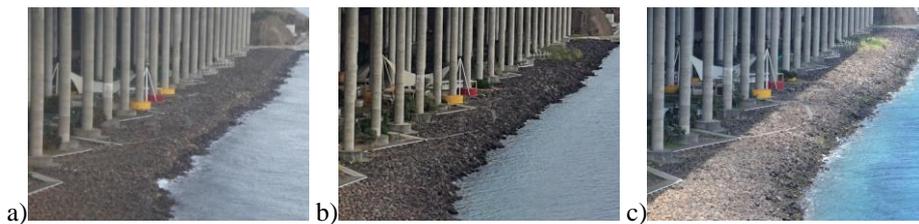
In Figure 3 one can observe the evolution of the berm breakwater profile at three instances in time: a) in December 2013; b) in October 2019 and c) in April 2021. Note, however, that tide level conditions are different (lower) in the last observation.

Figure 3. Berm breakwater in: a) Dec. 2013; b) Oct 2019; c) Apr. 2021.

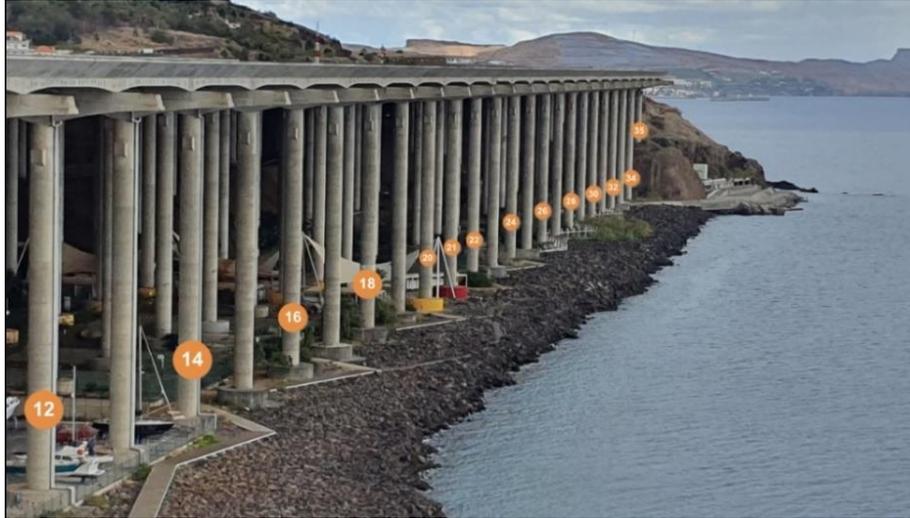
Figure 4. Reference points on the berm breakwater.

In August 2018 topographic and 3D Multibeam surveys were carried out, the results of which were presented in [3], together with the results of surveys conducted in February 2014 and June 1999. That report states that in two sections the crest setback exceeds the design safety line: from column 14 to 22 (central zone), with about 160 m and between columns 29 and 33, in the NE zone, with about 30 m (see Figure 4 for

identification of referred columns). The setbacks at the height of the survey were generally less than 2 m, occasionally reaching 3.5 m in the central zone.

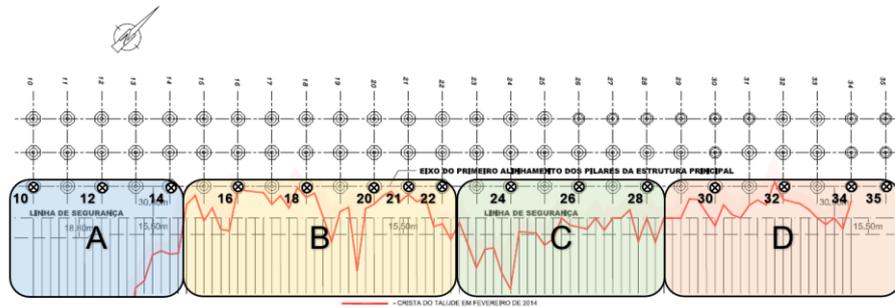
Figure 5. Identification of sections (A to D) and reference points (10, 12, 14, 16, 18, 20, 21, 22, 24, 26, 28, 30, 32, 34 and 35) - adapted from [3].

Section	Level
A	1
B	3
C	2
D	3

From the results presented, one should highlight the need to intervene on the structure, especially in sections B and D, to ensure compliance with the distance from the crest to the design safety line.

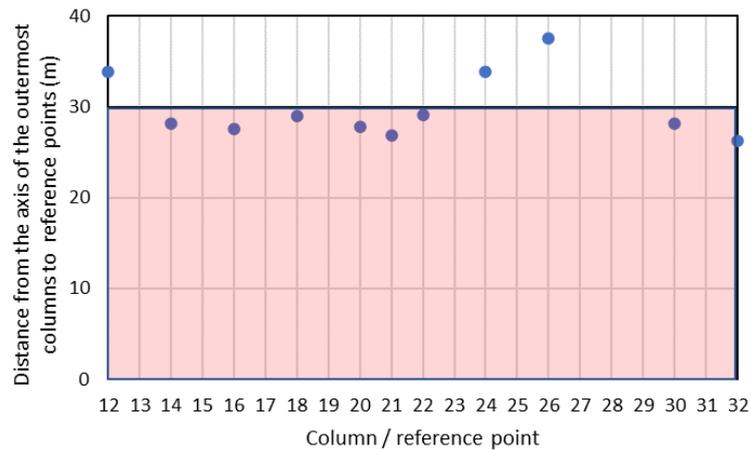
Also during the 2021 campaign, at certain points considered more relevant (see those in Figure 5), measurements were taken of the distance between the axis of the columns and the slope crest. The measurements are displayed in Figure 6, which shows the distances measured at each column and the 30 m line, considered in the project as the

Figure 6. Distances (in m) from the axis of the outermost columns to homonymous reference points.

- The slope shows a considerable number of rockfill elements moved in the area in sections A to D revealing some foci of degradation. In particular, in front of columns 16 and 21, the slope deterioration is readily apparent;

- There is a lack of blocks in the area to the east of section A and sections B and C;
- The safety margin has clearly been exceeded in front of columns 14, 16, 18, 20, 21, 22, 30 and 32, with an approximate value varying between 3.7 m (column 32) and 0.9 m (column 22), below the safety line;

- In front of column 18, rockfill blocks from the slope are still there, but there was no evolution compared to 2019.
- In front of column 35, on the existing retaining wall, the same anomalies referred to in October 2019 were also observed, namely distances between blocks on the order of 7 cm, an area with the corner of a degraded block and a distance between blocks on the order of 7 cm and three deteriorated slabs. These distances did not change in the observation performed in April 2021.

Presently, in June 2022, repair work is underway on this maritime structure to restore the originally intended project to ensure compliance with the distance from the crest to the design safety line. This work will likely be completed by November 2022, after which new inspections will be carried out both visual and aerial observations using the existing UAV System, described below.
