A CASE STUDY OF DESIGN, INSTALLATION AND LEAKAGE DETECTION SYSTEM OF A GEOMEMBRANE LINER

SUMMARY: A monolandfill (ash pond) for the ashes generated in the Sines thermoelectric power plant has been constructed, which has a geomembrane lining at its bottom to avoid impacts on the local groundwater. In order to verify the integrity of the geomembrane before the beginning of the ash disposal, a leakage detection system was installed. The paper describes the technical aspects related with the design and installation of the geomembrane liner, and presents the damage detection system used.

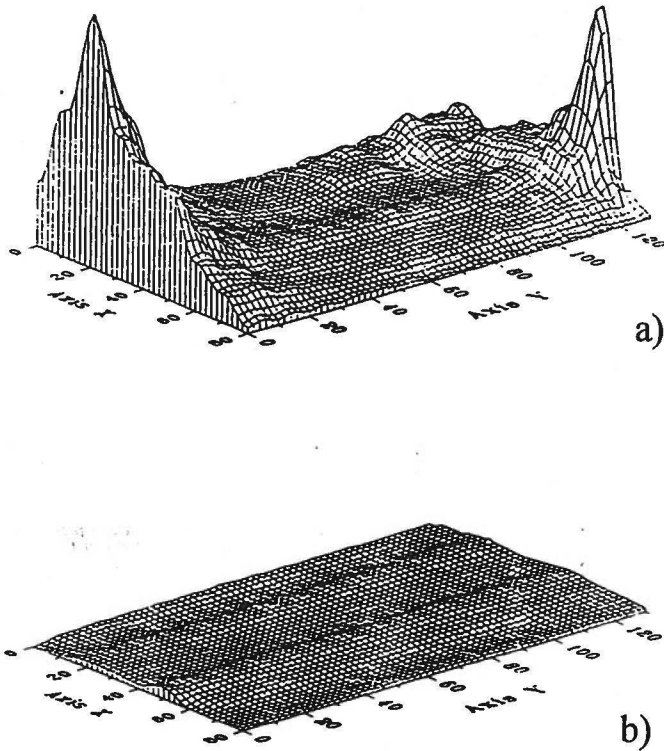
Figure 8. Three-dimensional current density diagram: a) before repair; b) after repair

As shown in figure 8a, two very strong anomalies located respectively, at the points $x=17$ m, $y=1,3$ m, and $x=56$ m, $y=128$ m showed up. These anomalies screen smaller ones, as the one shown as an example in figure 9, that may be hidden by their big effect.

After completion of the repairs, the site was resurveyed, to insure that there were no more damaged areas. This procedure was followed until the total integrity of the geomembrane was confirmed (figure 8b).

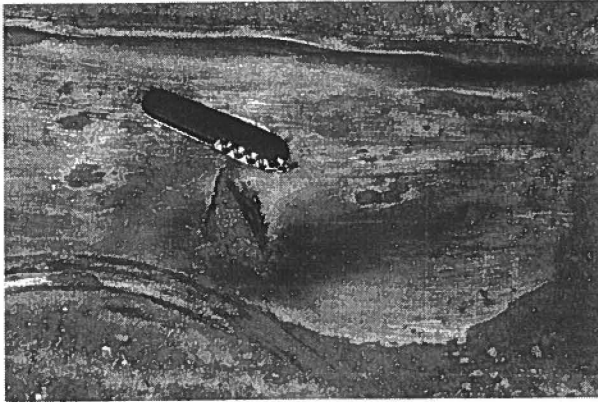
Figure 9. Example of geomembrane damage
