The effectiveness of "clay" liners as basal isolation of landfills: a case study

Keywords Fractured granite basement · Basal isolation · Clay flow and fracturing · High permeability · Pollution risks · NW Portugal · Braga

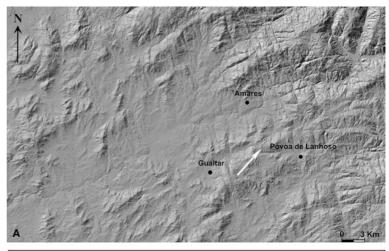
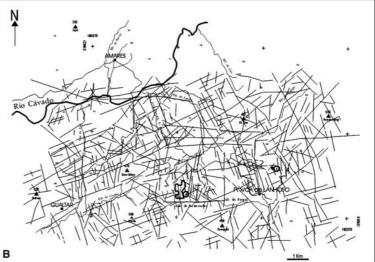
Fig. 1 a Shaded relief based on a Digital Terrain Model of the area surrounding the landfill facility (marked by white arrow). Note the abundance of lineaments, which correspond to fault zones (mostly) and major fractures. b Mapped fault network in the region around the landfill (whose perimeter is marked by b); c indicates an old, presently sealed, dump

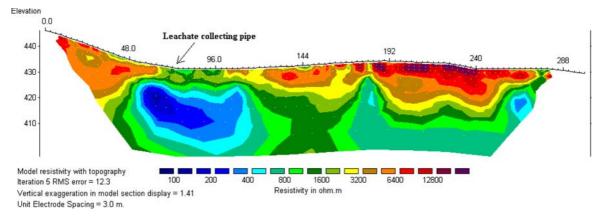
Fig. 2 Resistivity model considering the effects of topography obtained from inversion of Dipole-Dipole data. Note the low resistivity area just below the landfill, which is located in the topographic depression

measured resistivity of the leachate (0.41–1 Ω m) leads to a calculated bulk resistivity of 20–100 Ω m, assuming a fracture density of 1–2%. A more realistic modeling using a somewhat diluted leachate as the fluid circulating in fractures (resistivity 3 Ω m) gives an optimal agreement (147–287 Ω m) with the anomaly values quoted above (Mota et al. 2004).

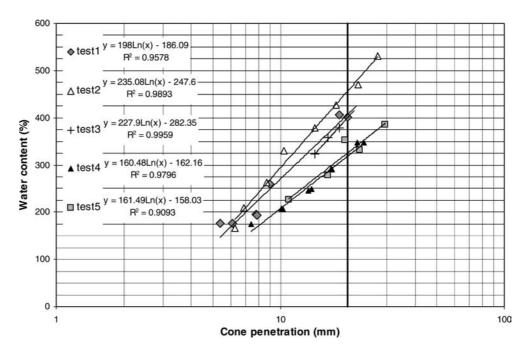
Liquid limit (w_L) test sets with the Casagrande apparatus (ASTM D4318-00 2000) were performed providing w_L values between 381 and 408. The regression of all data points in the n=15 to n=40 range provides a mean $w_L = 394$. The data scatter is small and within the $\pm 3\%$ range of expectable error (Bowles 1984) due to the natural limitations of this test. The liquid limit cone penetration method (BS 1377-2, 1990) provided a lower mean value, $w_L = 322$, (326; 319) for tests made 24 h after the specimen preparation, while tests made immediately after specimen preparation provided a higher mean value, around 420 (457; 407; 400), but with a slightly higher scatter of data points (Fig. 3). The latter data are comparable with the liquid limit found with the Casagrande apparatus, which is a dynamic test, although some difference arises. The former datum tends to express a static behavior of the studied clay, which is highly dependent on the nature of the applied loads. This datum suggests that a large amount of further work is needed to establish standard test procedures adequate to the characterization of these highly swelling materials for the purposes of GCL application.

Fig. 3 Results of liquid limit tests by the cone penetration method. Tests 1 to 3 performed one day after preparation and tests 4 and 5 performed immediately after preparation

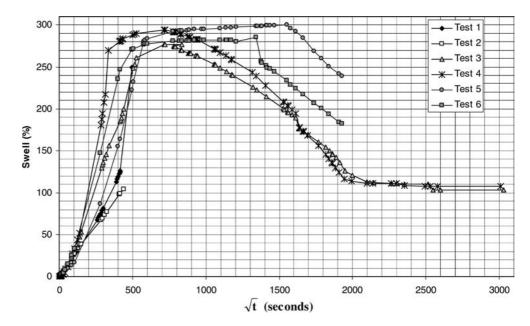
because the first saturation of the landfill bottom liner occurred probably with no waste placed on it, and thus under very low confining pressure. In this case, and because of the extreme swelling behavior of the clay, which exceeds the range of the measuring device, a specimen thickness of 5 mm was used, which is approximately the thickness of the clay layer included in the composite liner. Data obtained lies within a relatively narrow range, with the clay swelling up to 270–300% with complete saturation (Fig. 4). However, the saturation is highly irregular, with the clay forming separated flakes and is always accompanied by extensive

cracking that does not disappear with complete saturation, in spite of the fact that the entire base of the specimen is in contact with a highly permeable saturated porous stone. After saturation, drying of the specimens was also monitored to assess the shrinking behavior. Cracks formed during saturation persist and at the final dry state, the specimens still indicate a 100% swell mainly due to the presence of open cracks. This cracking behavior is an expected feature of these materials (Egloffstein 2001). However, the extent of observed cracking raises the following points: (1) The swelling behavior of the clay was not tested under a variety of overburden

Fig. 4 Results of the free swell tests performed with a LNEC apparatus

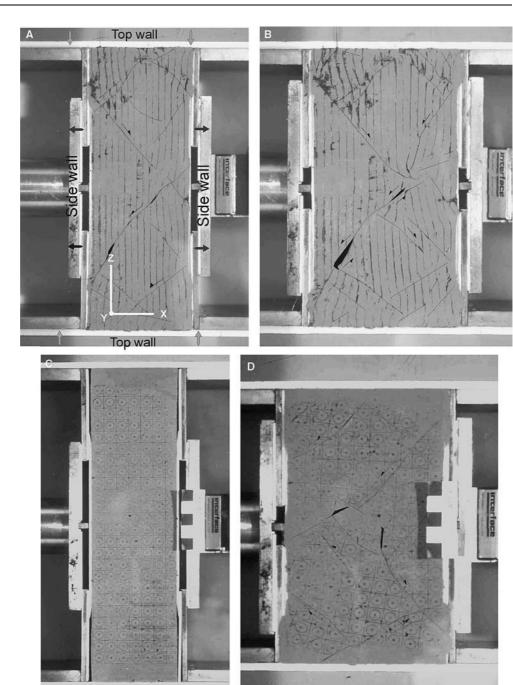
In the early stages of shortening (less than 10%), the clay cake showed very small fractures like open gashes, subparallel to the shortening direction. Some of these tension fractures continued developing throughout the experiment and gave rise to gashes with considerable opening (Fig. 6a, b). En échelon fracturing and their coalescence commonly preceded the later formation of faults. Other faults were born as small fractures that progressively increased in length by propagation at the ends. At the early stages of fracturing, two sets of conjugate faults formed. The intersection between conjugate

Fig. 6 Photographs of XZ plane (plan view) of results of pure shear tests. a and c are initial stages, a and b have lower water content, and c and d have higher water content

sets was typically a conflict zone, more or less complex depending on equal or unequal development of conjugate sets and timing of intersections. Fault geometry was very simple (Fig. 6), but variable according to water content and shortening percentage: they were (at least) initially rectilinear, and oriented at ± 30 –35° to σ_1 in the experiments with less water content in the clay (Fig. 6a, b), and at greater angles with higher water content (Fig. 6c, d). At later stages, some faults rotated and bent significantly. The central section of the fault gradually

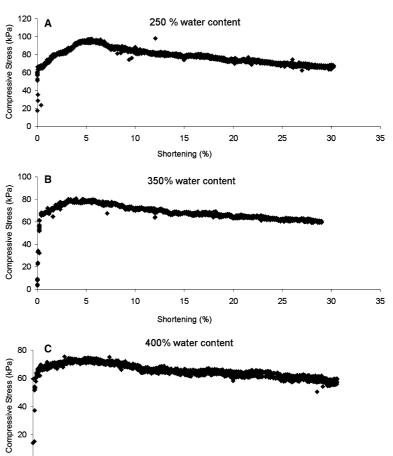
The analysis of the stress (σ_1) strain (% shortening) graphs (Fig. 7), at constant strain rate, shows an early rapid increase of σ_1 to a peak value. This part of the curve means that the early stages of deformation of the clay are accompanied by strain hardening (increase in σ_1 at constant strain rate). After the maximum of σ_1 is reached, strain softening slowly develops, deduced from the negative slope of the curve. From the analyses of the stress/strain graphs, at constant strain rate, only the behavior of the whole model is apparent, which is the sum of the behavior of the clay itself and faults. The initial strain hardening can be due to the elastic deformation of the clay, because there are no faults. But from the peak σ_1 onwards, the stress drop should be related with fracture/fault formation and ductile behavior of the clay. Coincidence of fault initiation with peak stress in the experiments suggests that faulting triggers strain

Fig. 7 Most typical σ_1 versus % shortening graphs of experiments, at constant ca. 30 kPa of side stress. a Initial strain hardening to ca. 100 kPa, and then strain softening. b Initial strain hardening to ca. 82 kPa, then strain softening. c Initial strain hardening to ca. 75 kPa, and then strain softening

softening. This should be equivalent to the drastic stress drop observed in experiments with natural rocks (e.g. Reches and Dieterich 1983). A more detailed look at the graphs shows two important features: (1) the peak σ_1 has an inverse dependence upon degree of water content; ca. 100 kPa at 250% water content and ca. 75 kPa at 400% water content (Fig. 7a, c, respectively); (2) the stress drop at ca. 5–10% shortening is sharper with less water content. Together, these two features seem to indicate an increasing ductile behavior of the analyzed clay with increasing water content.

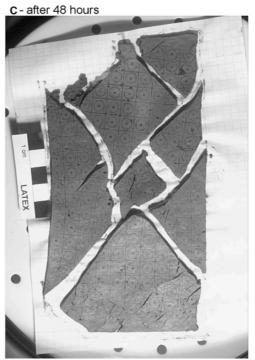
When left to dry after deformation, to simulate the effects of the dry season on the deformed Na-bentonite, it retracts significantly and the fractures become wide open (Fig. 8).

Fig. 8 Photographs of the deformed clay cake left to dry in the open air. a after 48 h; b after 216 h. c and d are similar, but cut to a thickness similar to that used in the GCL and between overlapping GCL. Note the great amount of widening of the faults during desiccation
