# Monitoring and assessment of *azulejo* panels decay: the 20<sup>th</sup> century façade *azulejos* from Manuel Rocha building

**Abstract.** This study investigates the deterioration of the 20<sup>th</sup>-century *azulejo* façades of the Manuel Rocha Building in Lisbon. A multi-technique approach, including SEM-EDS, XRD, GPR, thermography, and hyperspectral imaging, was used to characterise materials and assess decay. Photogrammetry and digital image processing enabled mapping of pathologies and reconstruction of the decay chronology. Results indicate rapid degradation, with some panels reaching a critical state of degradation if no intervention is undertaken. The presence of alkali-silica gels suggests that alkali-silica reactions may be a key factor in glaze detachment. Findings highlight the urgency of conservation measures and the value of integrated monitoring strategies for heritage preservation.

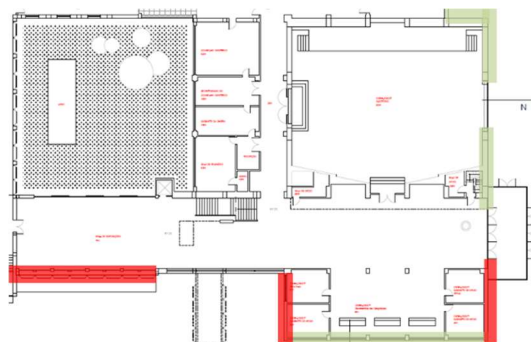
**Fig. 1.** Location of *azulejos* façade from Manuel Rocha Building. Green - tiles in relatively good conservation state; Red – façade with tiles showing considerable decay.

Some of the external tiled façades, but curiously not all of them, are showing alarming signs of decay (Fig. 1) [4]. The most prominent forms of degradation include extensive glaze detachment, fissures, and disaggregation of the ceramic body. In some areas,

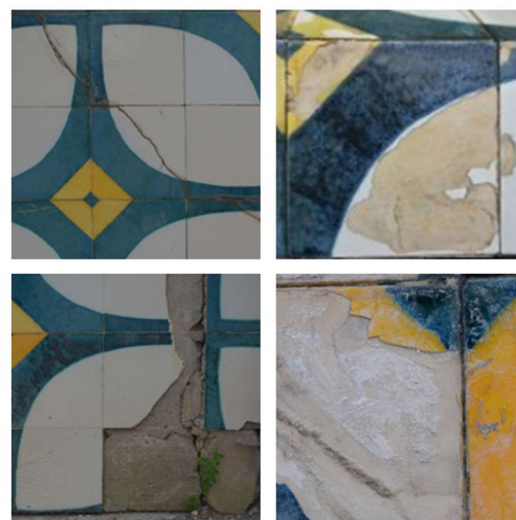
**Fig. 2.** *Azulejos* decay. From left to right and top to bottom: a) fracture; b) glaze delamination; c) lack of elements; and d) efflorescence deposits.

*azulejo* elements are missing, leaving some visible voids in the decorative composition (Fig. 2).
