LABORATÓRIO NACIONAL
DE ENGENHARIA CIVIL

FIRE PROTECTION OF WOODEN POLES

Summary of results from different protection solutions

REPORT 161/2022 – **DM/NQC**

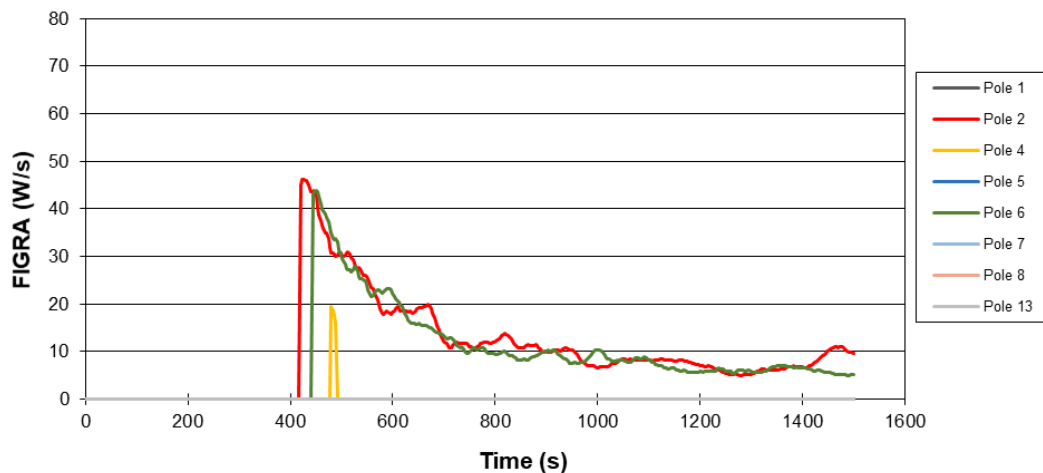
Figure 3.3 – Results regarding fire development rate

Regarding fire development rate, figure 3.3, the same observation was made (significant lower performance showed by the poles not protected). Pole 4 protected by an intumescent paint (product B) showed a peak point which was after test verified to be due to deposit (contamination) existing at the surface of the pole.

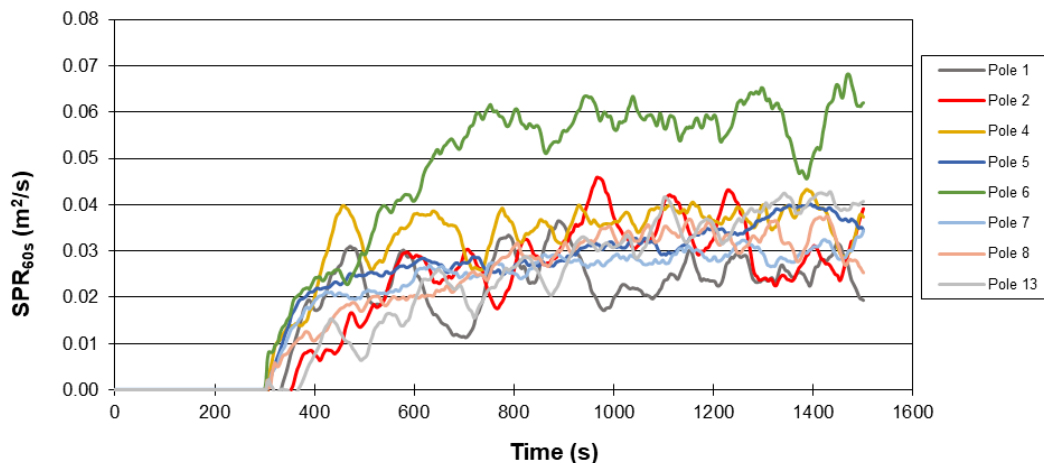
Figure 3.4 – Results smoke production rate average 60s (SPR_{60s})

The pole treated with a solution of copper showed a higher smoke production rate, noticeable higher than the rest of the poles tested. In the case of the pole showing no treatment, it was observed a similar behavior with the poles protected against fire, figure 3.4. This same result was obtained for total smoke production, figure 3.5.

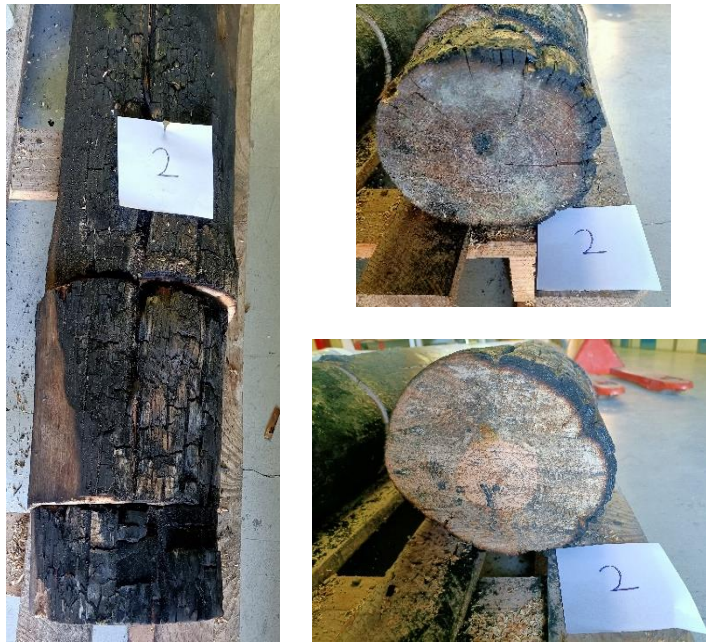
After testing, the poles were visually observed to assess the damage (loss of cross-section) at a distance of 10 cm and 30 cm from the bottom end of the pole. As expected the poles without protection showed a strong superficial degradation, figures 3.6 and 3.7, that could reach 4 cm in the face directly exposed to the fire.

Figure 3.6 – Bottom end of pole 2 – unprotected & untreated pole (left – bottom end of the pole; right up – Cross-section at 10cm of the end; right bottom – Cross-section at 30 cm of the end)

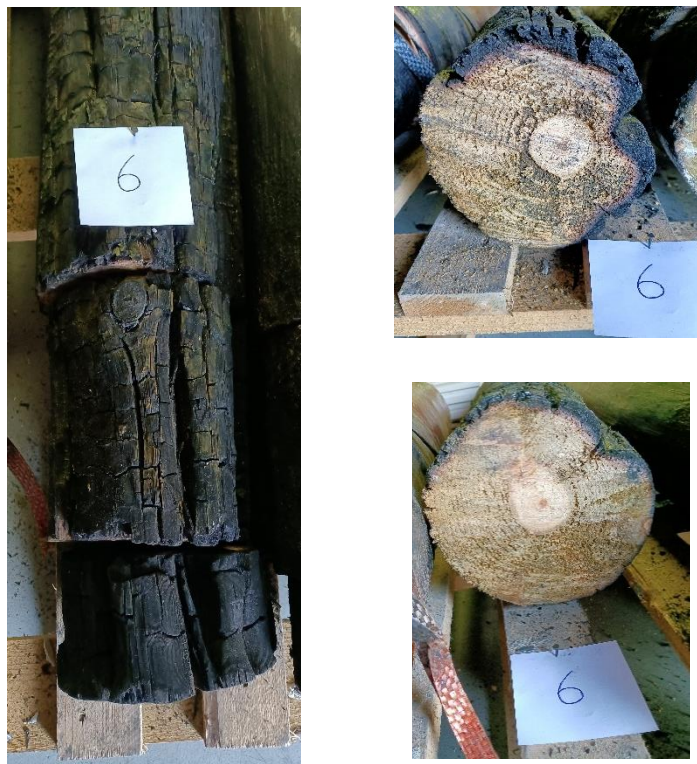
Figure 3.7 – Bottom end of pole 6 – unprotected & treated pole (left – bottom end of the pole; right up – Cross-section at 10cm of the end; right bottom – Cross-section at 30 cm of the end)

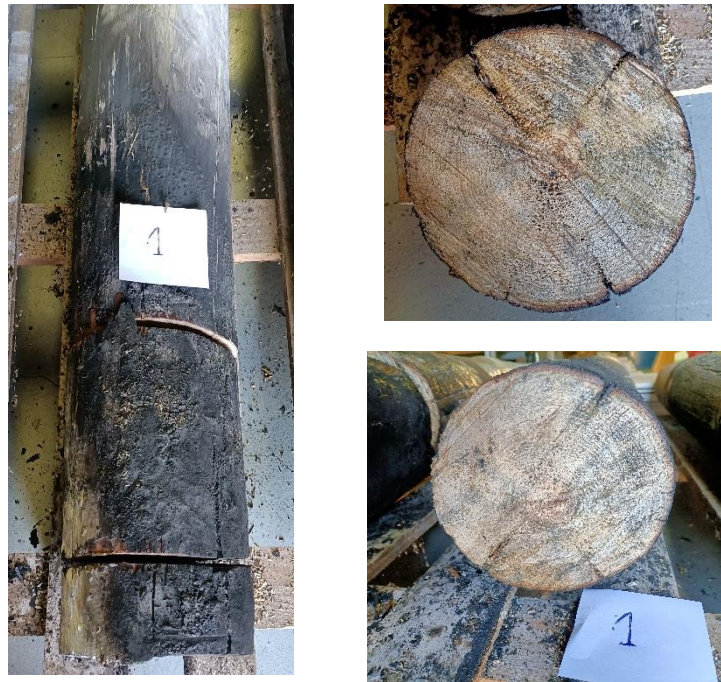
The application of the intumescent paint A provided a good protection against fire not being noticed any severe deterioration of the superficial layers of the poles after testing, figures 3.8 and 3.9. The same conclusion can be taken from the application of the intumescent paint B, figures 3.10 and 3.11. In both cases, a small layer of charred wood is observable, figure 3.12.

Figure 3.8 – Bottom end of pole 1 – Solution paint intumescent A & untreated pole (left – bottom end of the pole; right up – Cross-section at 10cm of the end; right bottom – Cross-section at 30 cm of the end)

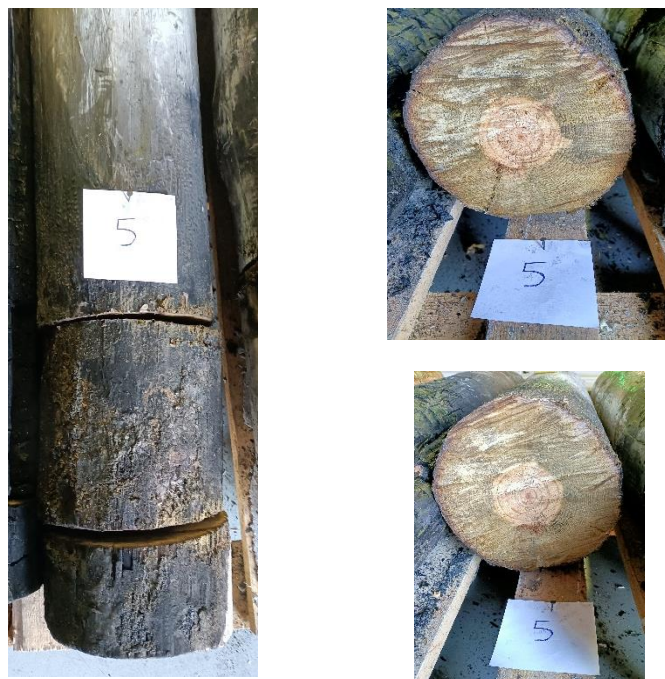
Figure 3.9 – Bottom end of pole 5 – Solution paint intumescent A & treated pole (left – bottom end of the pole; right up – Cross-section at 10cm of the end; right bottom – Cross-section at 30 cm of the end)

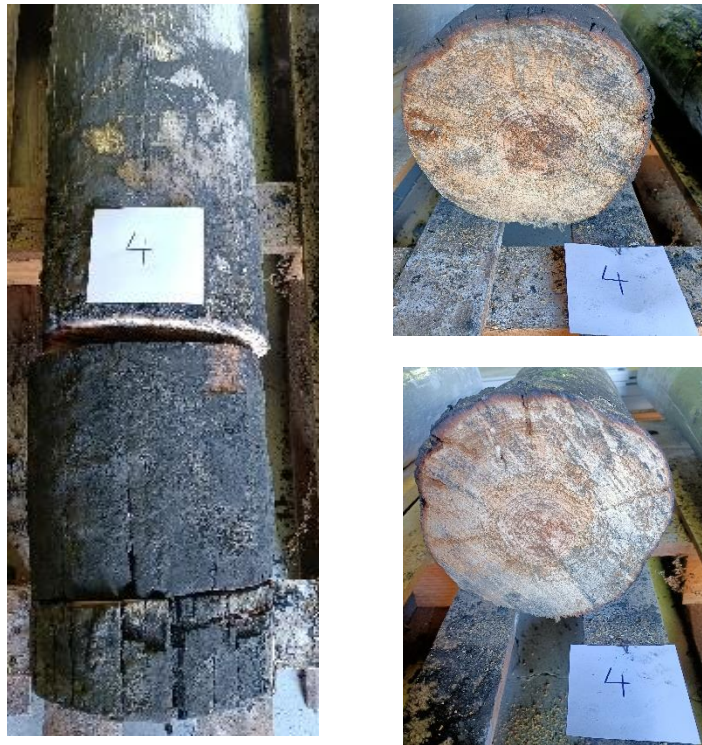
Figure 3.10 – Bottom end of pole 4 – Solution paint intumescent B & untreated pole (left – bottom end of the pole; right up – Cross-section at 10cm of the end; right bottom – Cross-section at 30 cm of the end)

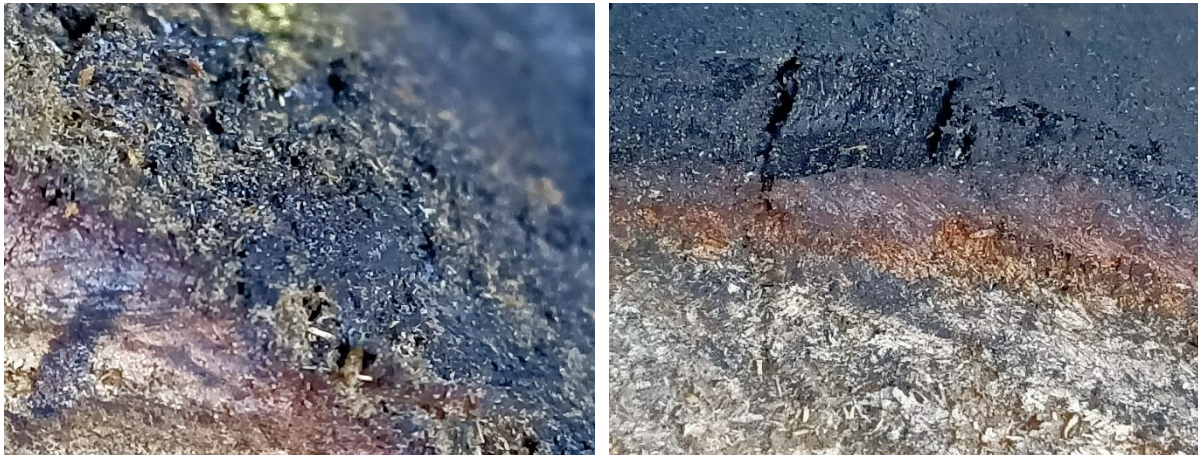
Figure 3.12 – Superficial degradation after testing (left – intumescent paint A; right – intumescent paint B)

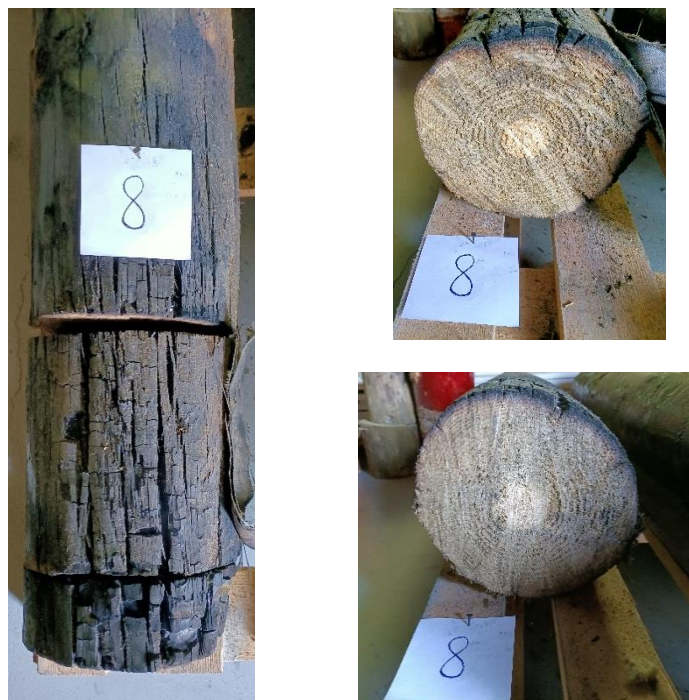
The solution C comprised the wrapping of the wooden pole using a fire retardant fabric, figure 3.13. Unfortunately, in this case due to a defect of the wooden pole the protection to prevent the exposure of the bottom end of the pole was not sufficient. It was decided then to extend the test (subject the pole to the test) to verify if any deterioration of the fabric was observable. As result of this second test the integrity of the fabric was maintained showing however a more brittle behavior. For this solution only a treated pole was tested, since the sample provided by the manufacturer only turn possible one test.

Figure 3.13 – Bottom end of pole 8 – Solution fire retardant fabric & treated pole (left – bottom end of the pole; right up – Cross-section at 10cm of the end; right bottom – Cross-section at 30 cm of the end)

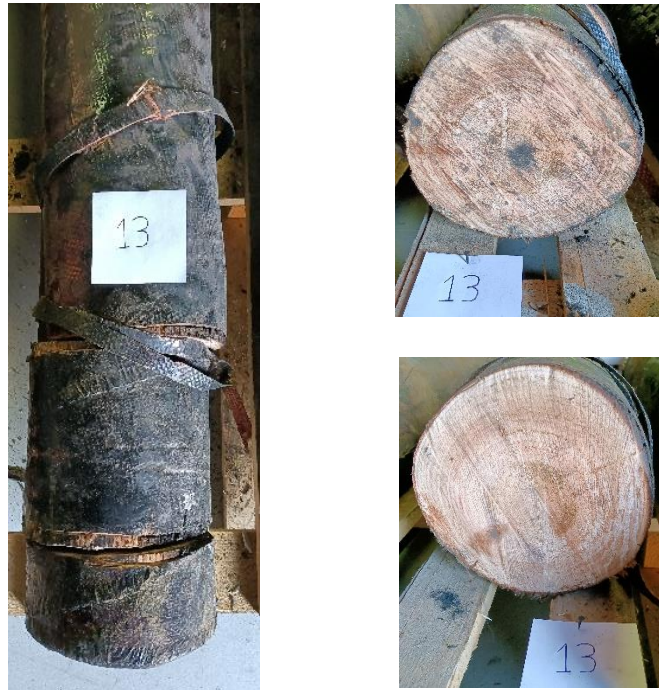
The last solution tested was a wooden pole coated with a composite – solution D, figure 3.14. After testing, the pole was also cut in order to evaluate the degradation of the superficial layers of wood below the matrix. The results showed that, as for solution A and B, a small amount of charred is observable at 10 cm, figure 3.15, but the degradation at 30 cm of the bottom is insignificant. For the purpose of the test only the results at 30cm of the end are regarded as important since at this height eventual problems of insulation at the base of the pole does not affect the performance of the solution.

Figure 3.14 – Bottom end of pole 13 – Solution fire retardant fabric (left – bottom end of the pole; right up – Cross-section at 10cm of the end; right bottom – Cross-section at 30 cm of the end)

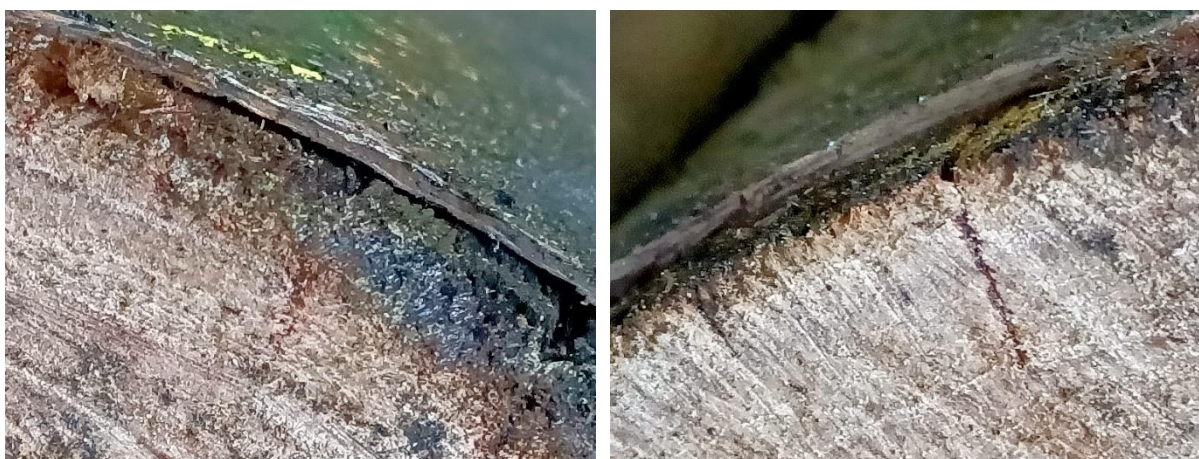
Figure 3.15 – Superficial degradation after testing (left – at 10cm of the bottom; right – at 30cm of the bottom)
