FMEA of a tailings dam

Ricardo Neves Correia dos Santos ^a , Laura Maria Mello Saraiva Caldeira ^a & João Paulo Bilé Serra ^a

^a Laboratório Nacional de Engenharia Civil, Lisbon, Portugal

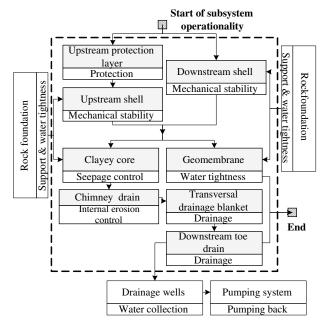
Figure 8. FBD for the dam body subsystem.*

Figure 8 illustrates the functionalities associated with the dam body subsystem, namely the mechanical stability and the seepage control. The global stability (sliding) is provided by the upstream and downstream shells and by the dam foundation (external subsystem). The functionality of the upstream shell, on the other hand, depends on the proper performance of the upstream protection layer. The seepage control is essentially guaranteed by the clay core, the geomembrane and the dam foundation (watertightness), and by the drainage system, constituted by the chimney filter and drain, the drainage blanket and the downstream toe drain. The null discharge philosophy, in turn, requires the seepage water to be collected by the drainage well and pumped back into the reservoir (external subsystems).

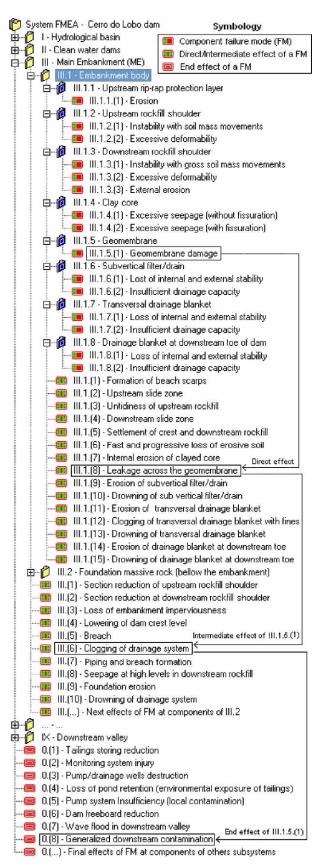
Figure 9. Component failure modes of the dam body and their sequence effects.

As an example, Figure 9 shows the considered failure modes and their subsequent effects, highlighting the effects induced by geomembrane cracking. The direct effect in this component is the occurrence of the concentrate leakage of water through the geomembrane, possible with a large flow of water downstream, which can cause internal erosion, inducing the clogging of the drainage system (intermediate effect) and, if the wells and the pumping system are not able to return this water into the reservoir, generalised downstream contamination will be produced (end effects), not complying with the null discharge requirement.

Another example is the sequence associated with the internal or external instability of the drainage blanket. The following direct effects can be named: internal erosion, due to the outside entrainment of its particles, and clogging, due to the entrainment of the fine particles from the foundation. These direct effects correspond to the failure modes of the subsystem of the level immediately above (the dam body). The intermediate effect associated with the drainage blanket erosion is the foundation erosion, by loss of the material into the drainage blanket. The blanket drainage clogging prevents progressively the water flow, making the operation of the drainage system impracticable and causing seepage at higher levels in

the downstream shell. To complete the effects sequence, it is necessary to identify the end effects. Those are the pumping system insufficiency (local contamination), caused by its incapability to treat all the downstream flow, and generalised downstream contamination induced by foundation seepage and water exit downstream of the pumping wells.
