16th International Conference on Alkali-Aggregate Reaction in Concrete Lisboa | LNEC | Portugal | 31 May - 2 June 2022

Monitoring of ASR/ISR structural effects in Aguieira bridges

Luís Oliveira Santos⁽¹⁾, Min Xu⁽²⁾, António Santos Silva⁽³⁾

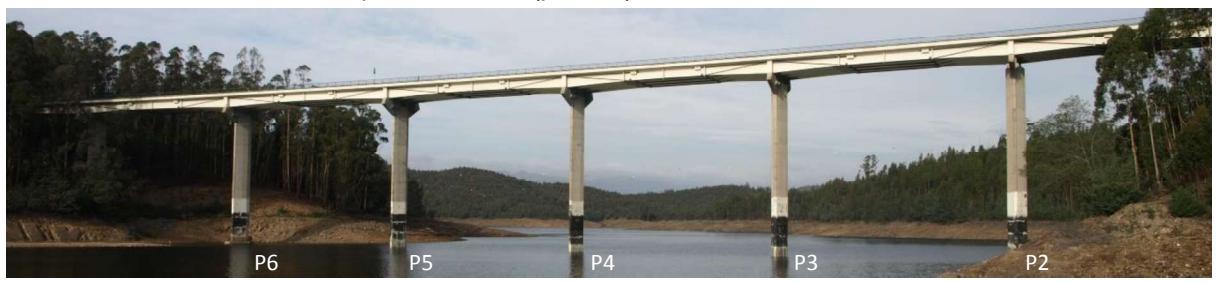
Figure 2.3: Criz II Bridge before the before the piers and foundations rehabilitation

The height of the piers varies between 27 m and 70 m. The piers P2 to P6 are founded inside the reservoir (Figure 2.3), with a maximum foundation depth of about 35 m.

The first rehabilitation works were carried out between 2007 and 2010, involving the abutments and the deck, including the application of external prestressing in the deck, due to the poor performance of the original prestress system, as well the replacement of the bearing devices and the installation of damping devices in one abutment to improve seismic (pier P3).

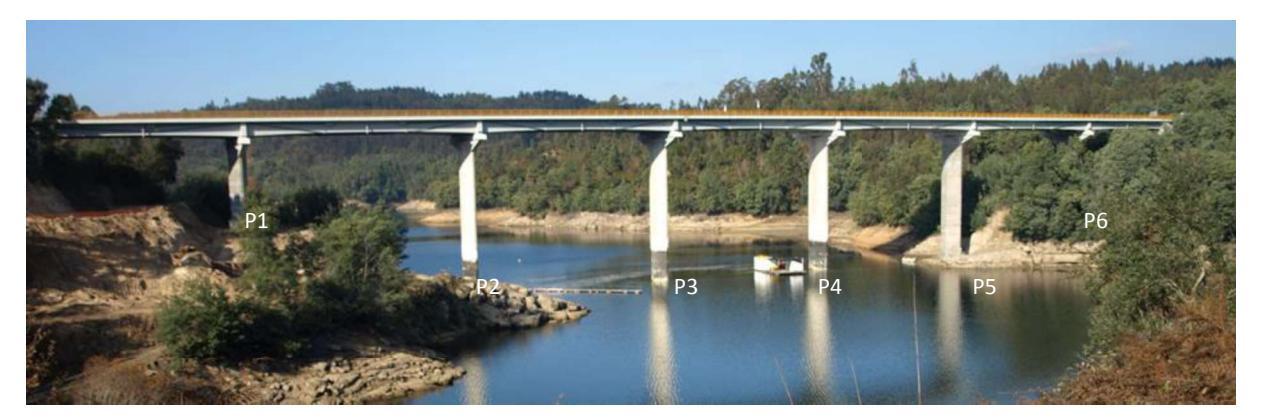
Figure 2.5: São João das Areias Bridge before the rehabilitation of the piers and foundations

The design for the rehabilitation of piers and foundations was mainly focused on the piers P2 to P5 [5], which are in the riverbed and were damaged by swelling reactions. Six piles with a diameter of 1,20 m

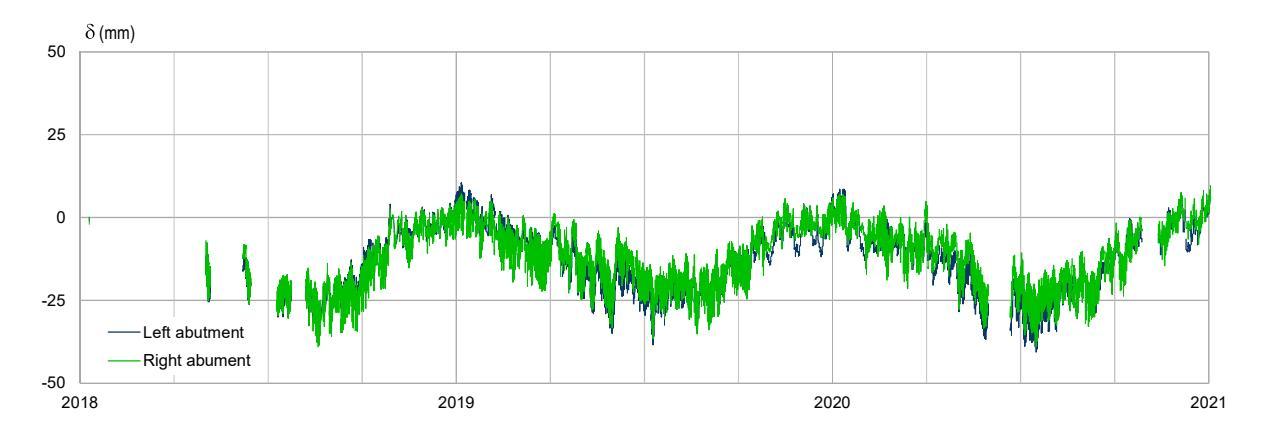
Figure 4.5: São João das Areias Bridge: movements of expansion joints

The behaviour of the joints is, of course, strongly associated with temperature variation, no other behaviour change was identified.

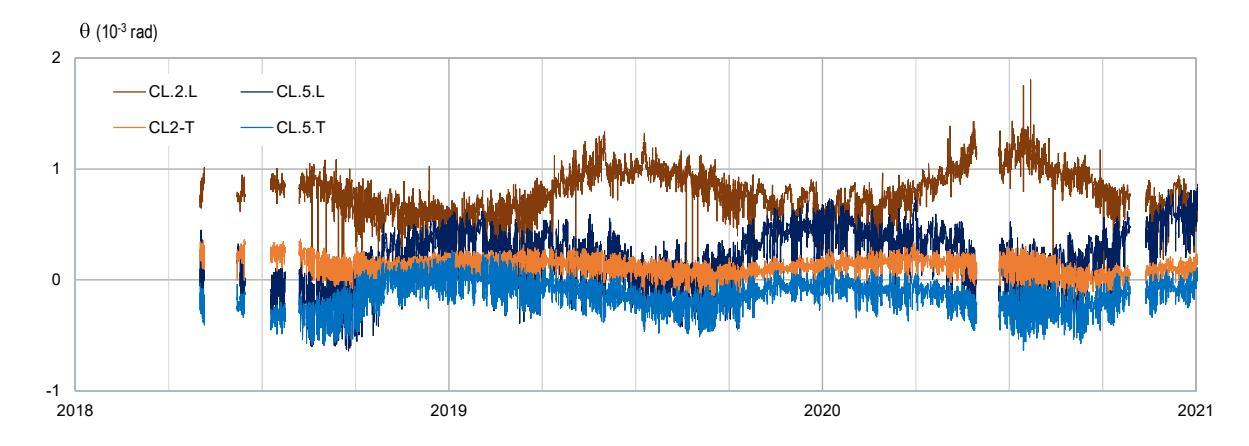
Figure 4.6: São João das Areias Bridge: rotations at the top of piers P2 and P3

Regarding the rotations at the top of the piers, two situations are distinguished: the transverse rotations remain stable over time, while the longitudinal rotations present greater variations but, fundamentally, associated with the seasonal cycle. An interesting point is the symmetry of the longitudinal rotations at these two piers, arranged symmetrically in relation to the centre of the bridge.

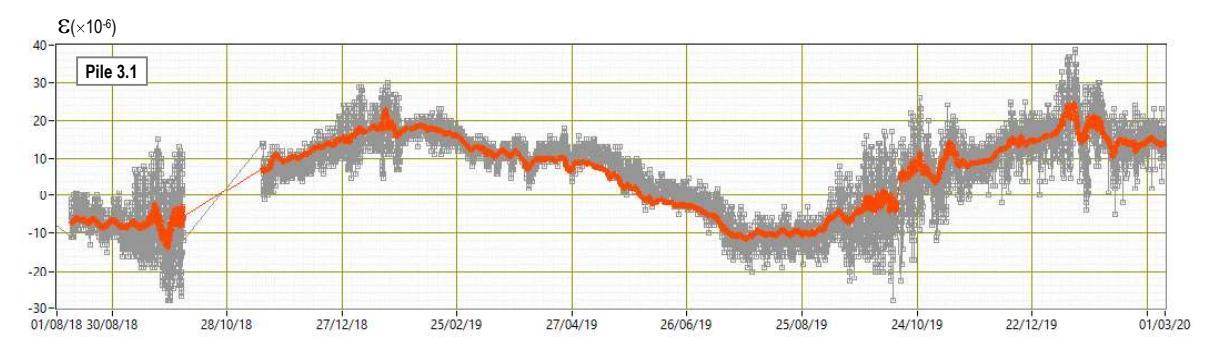
Figure 5.1: Strains in pile P3.1 of Criz II Bridge: measured values and values estimated by MLR model

In Figure 5.1, the strains variations measured in the pile 3.1 of Criz II Bridge are represented, as well as the corresponding values estimated by the MLR model. Using this model to remove the temperature effects, the residual values of MLR, meaning the difference between the measured values and the values estimated by the model, are shown in Figure 5.2.

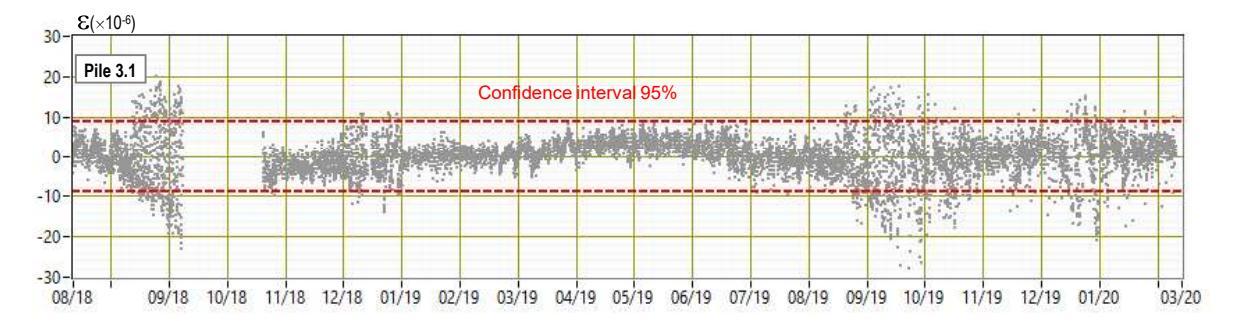
Figure 5.2: Strains in pile P3.1 of Criz II Bridge: residual values of MLR

The analysis of these figures allows concluding that after the period of little more than a year of monitoring, it is not yet possible to identify variations in behaviour that can be clearly associated with stiffness losses resulting from the swelling reactions of the concrete.

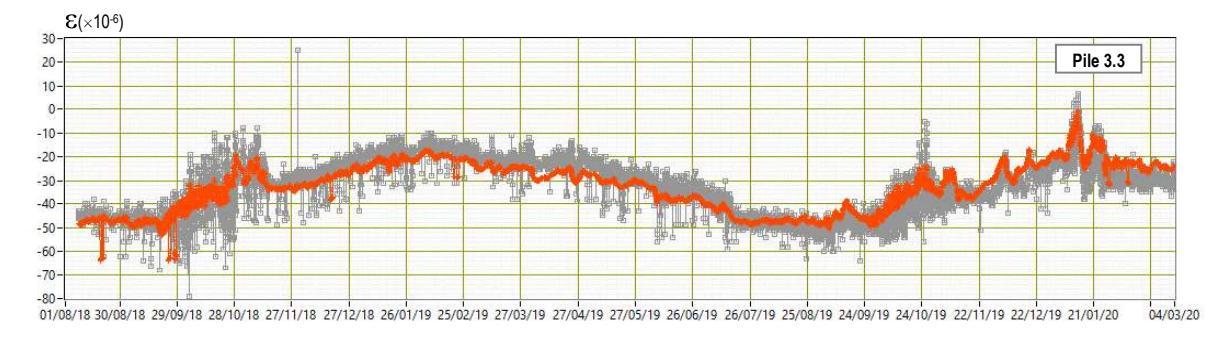
Figure 5.3: Strains in pile P3.3 of S.J.A. Bridge: measured values and values estimated by MLR model

Similarly, the strains variations measured in the pile 3.3 of São João das Areias Bridge and the corresponding values estimated by the MLR model are represented in Figure 5.3. The resultant residual values are shown in Figure 5.4.

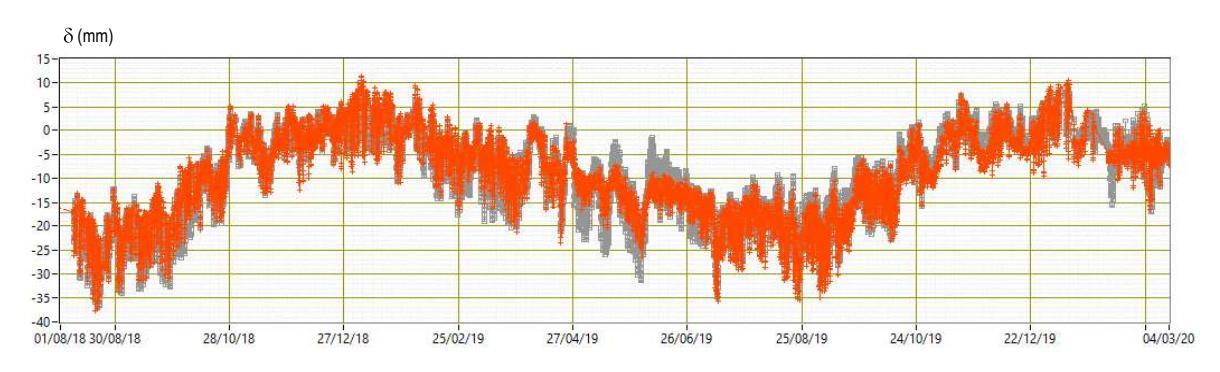
Figure 5.5: São João das Areias Bridge: measured values of the variation of the gap at the right abutment and values estimated by MLR model

Finally, the same procedure was applied to the values of the variation of the gap at the right abutment of São João das Areias Bridge. Thus, the measured values and the values estimated by MLR model are represented in Figure 5.5. The corresponding residual values are shown in Figure 5.6.
