# Characterisation of mortars from Tróia Archaeological Site

This paper presents results obtained in the European project PRODOMEA (PROject on high compatibility technologies and systems for conservation and DOcumentation of masonry works in archaeological sites in the MEDiterranean Area). The aim of the project was to create a new approach for assessment of the compatibility of conservation treatments on masonry architectural assets and elements present in Roman age archaeological sites in the Mediterranean Basin.

This paper presents the characterization procedure applied to the Roman mortars employed in the archaeological site of Tróia, Portugal, one of the project case-studies. The characterization procedure and results are presented and discussed.

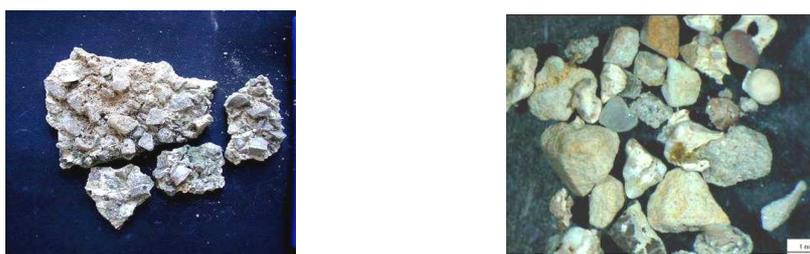
Mortar sample 5 collected at Tpi was a plaster preparatory layer collected in a *cetariae*. In the late Roman period this *cetariae*. was subdivided in three parts. The plaster preparatory layer belongs to a second layer of a bedding mortar and has aggregates with different composition, sizes and shapes, where limestone aggregates prevail (Figure 3).

Figure 3- Sample 5 and fraction of 5mm of lime aggregate.

Mortars contained quartz limestone and brick as aggregates and the binder was calcitic lime and calcitic lime with brick. The binder aggregate ratio for samples 2 and 20 was 1:1 and for sample 5 a higher amount of aggregates (1:9) was determined. This higher ratio may be explained by the erosion of the binder and the higher dimension of the aggregate (8mm) (Figure 3).

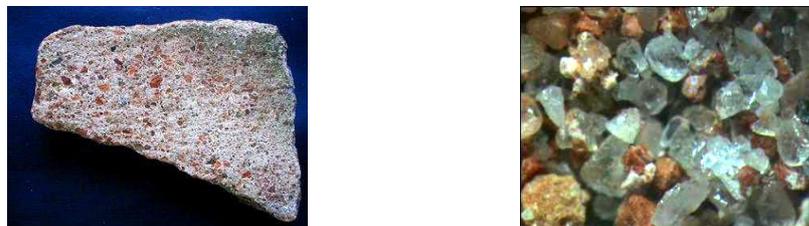
Mortar sample 20 collected at Tph was a plaster preparatory layer from the bottom of a *cetariae*, representing a typical *cocciopesto* mortar in texture and composition and has high cohesion. This sample contained brick fragments, well sorted limestone and quartz aggregate and an incipient biological colonisation on its exposed surface (Figure 4).

Figure 4. Sample 20 and fraction of 5mm aggregate with brick and quartz particles.
