OVERTOPPING PHYSICAL MODEL TESTS FOR THE REHABILITATION OF SINES WEST BREAKWATER

M.T. Reis¹, M.G. Neves², M.R. Lopes³ and L.G. Silva⁴

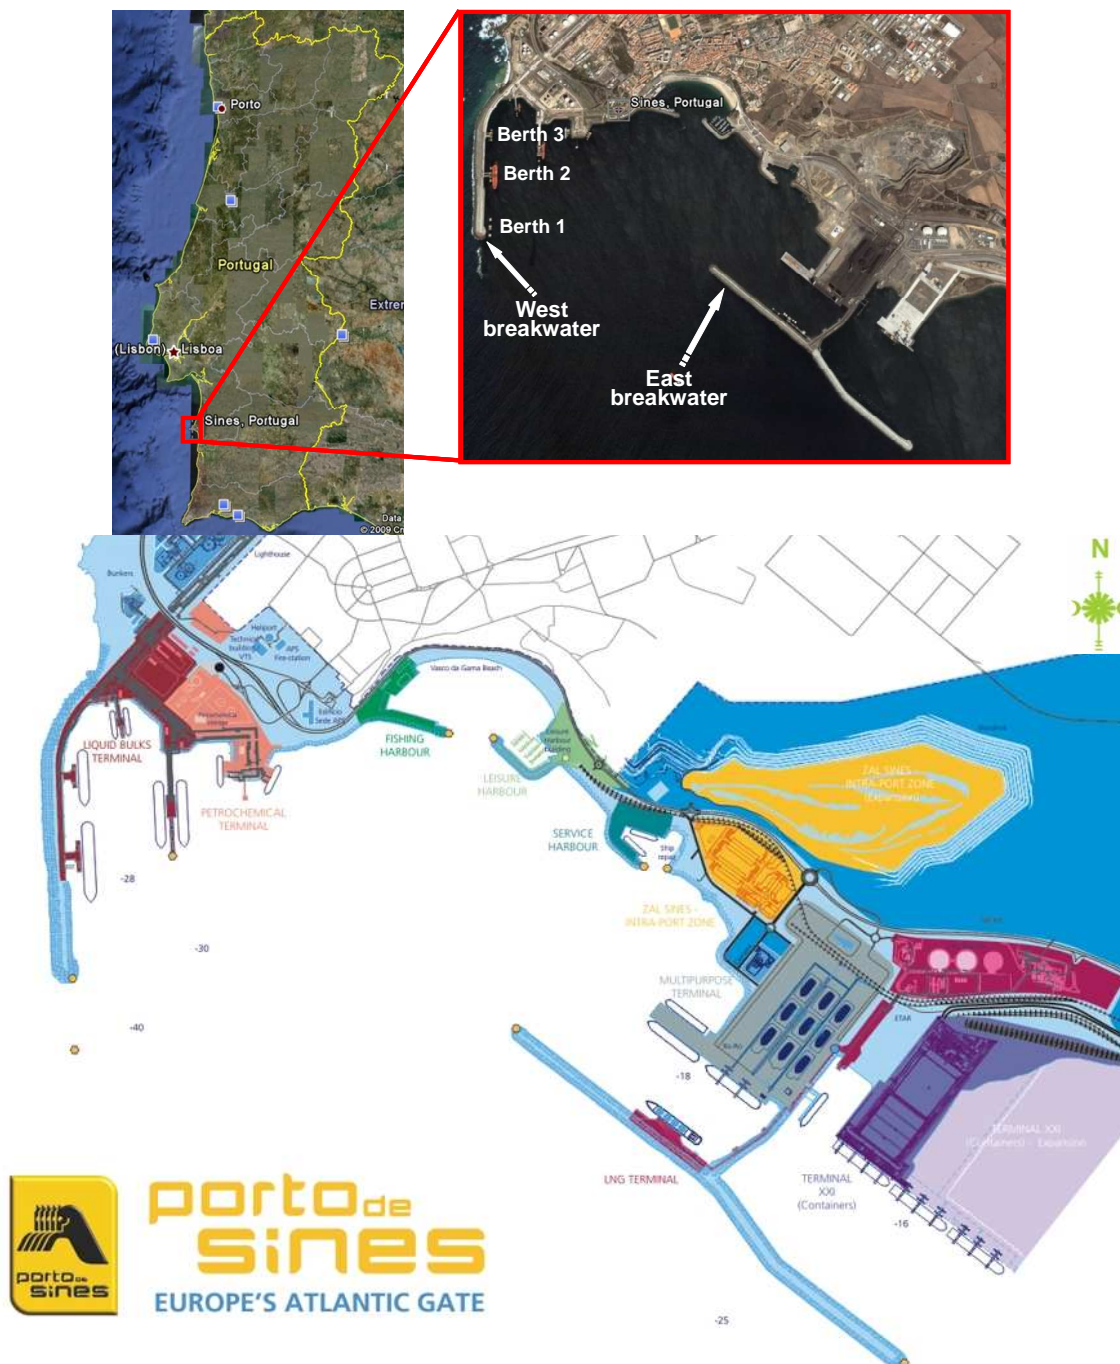
Figure 1: Port of Sines: location and current layout

The Port of Sines is located on the west coast of Portugal, sheltered by two breakwaters: the west and the east breakwaters (Figure 1). The West Breakwater is the main one and shelters berths for deep water oil tankers and four main terminals (for liquid bulks, petrochemical products, multipurpose and ro-ro, and LNG).

At present, only two of the three oil tanker berths are in operation: Berth 2 and Berth 3 (Figure 1). Studies are now being conducted for Sines Port Authority with the primary objective of reactivating

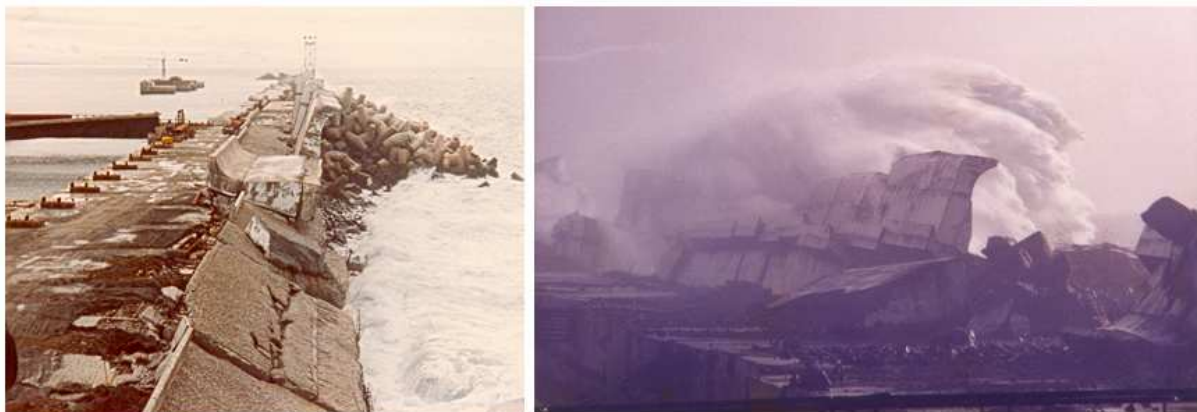
Figure 4: Port of Sines: failure of armour layer and superstructure

The breakwater was originally designed for the 100-year return period significant wave height, H_{sd} , of 11 m (Table 1), being the largest structure of its kind in such an exposed environment. Construction was nearly complete when, on 26 February 1978, critical damage occurred during a storm with waves thought by most to be below 11 m significant wave height. There was loss of about two-thirds of the armour layer and severe damage to the superstructure at a few locations. In December 1978 and February 1979, storm action caused failure of almost the entire armour layer and superstructure (Figure 4).

Several investigations were conducted to understand and identify the cause(s) of failure. The following list provides examples, noted in the literature, of possible factors that may have contributed to the failure (e.g. Zwamborn, 1979; Anon., 1979; Port Sines Investigating Panel, 1982):

- shortcomings in the selection of design waves (conception deficiency);
- communication problems between owner-designer-contractor (deficiency in project management);
- differences between the constructed breakwater and the design specifications (deficiency in construction and in construction supervision);
- the breakwater was hit by storms when construction was not fully complete (inevitable);
- low structural strength of Dolosse (structural deficiency);
- removal of the 16 ton-20 ton toe stones (structural deficiency).

Failure was most probably a consequence of a combination of different factors, some more relevant than others. It led to urgent repair works to protect and reactivate Berths 2 and 3 (the so-called Emergency Repair, carried out between Berths 3 and 2 just after the accidents of 1978/79) and to the subsequent rehabilitation works, performed between 1989 and 1992 (Figure 5). These included the rehabilitation of the Root Portion of the breakwater (the length of breakwater nearest to the shore, also known as the Dolosse Portion, north of Berth 3), improvements to the Emergency Repair works, the rehabilitation of its Outer Portion (the stretch beyond the Emergency Repair towards the south) and the construction of the New Head. The layout of the breakwater after the last rehabilitation works is shown in Figure 6.

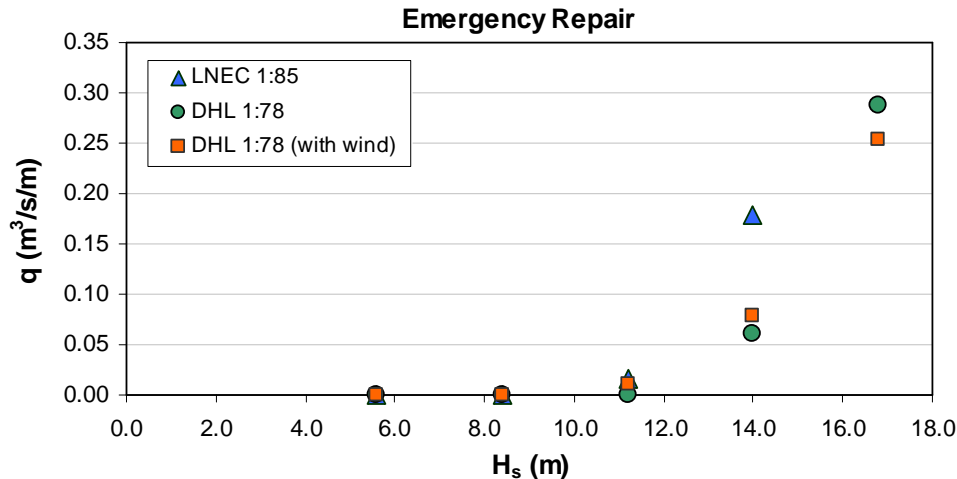
Figure 7: Mean overtopping discharges (prototype values) for tests carried out at DHL (with and without wind) and at LNEC (without wind) for the standard cross-section of the Emergency Repair for $T_p=20$ s and + 4.0 m (CD)

Table 3 summarizes the main differences between the tests undertaken at LNEC and at DHL. The table shows that one of the tests was carried out for the same wave and water level conditions in both laboratories: the test for the Standard Solution and $T_p=20 \text{ s}$. Figure 7 presents a comparison of the mean overtopping discharges measured for this test at both laboratories, together with the results for the corresponding DHL test performed with wind. The results of the DHL tests suggest that the influence of the wind was not very important. However, a significant difference was obtained between LNEC's and DHL's overtopping discharge measured for $H_s=14.0 \text{ m}$, with LNEC's measurement being almost three times that of DHL.

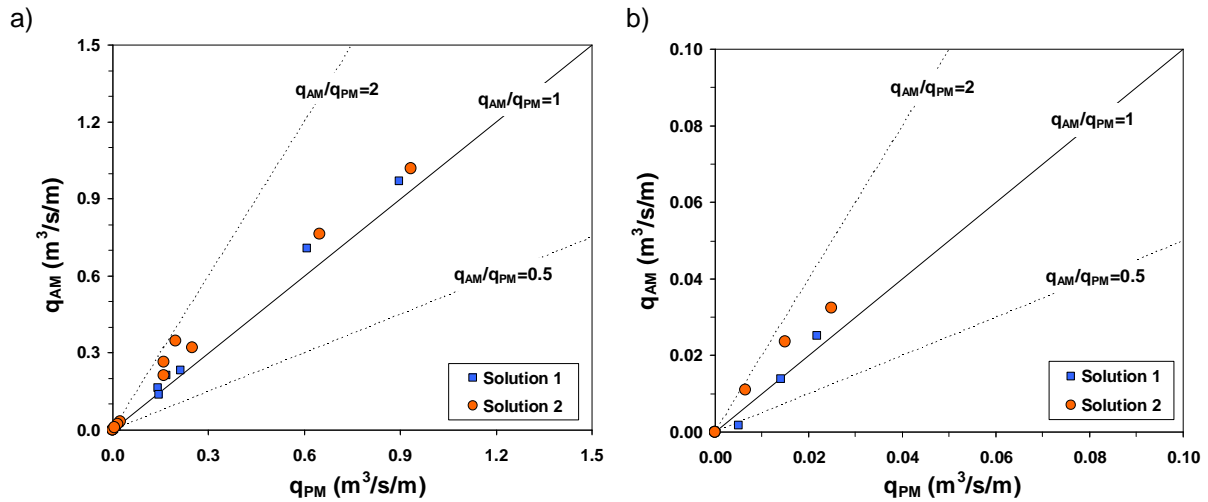
Figure 11: Comparison between the AMAZON, q_{AM} , and the physical model, q_{PM} , mean overtopping discharges obtained for Solutions 1 and 2 (all values scaled up to prototype) using the Darcy equation with $IP=0.125$ m/s and $n=0.4$: a) all results; b) results for discharges less than 0.1 m³/s/m

Figure 11 shows the AMAZON results versus the physical model results, all scaled up to prototype values. Most data points are within the range $0.5 \leq q_{AM}/q_{PM} \leq 2$. However, $q_{AM}/q_{PM} < 0.5$ for Test 16, Solution 1. Figure 11 shows that there is a good agreement between the AMAZON results (obtained for $IP=0.125$ m/s and $n=0.4$) and the physical model data, although AMAZON tends to slightly over-predict the discharges, especially for Solution 2. These results are rather promising, given the different approximations made for modelling the porous breakwater (such as using the Darcy equation rather

than the Forchheimer equation to govern the internal flow and employing only one porous layer to represent a multi-layered structure) and AMAZON's inherent restrictions (mainly relating to the shallow water assumptions and the fact that waves entering the computational domain will already have broken or will begin to break).

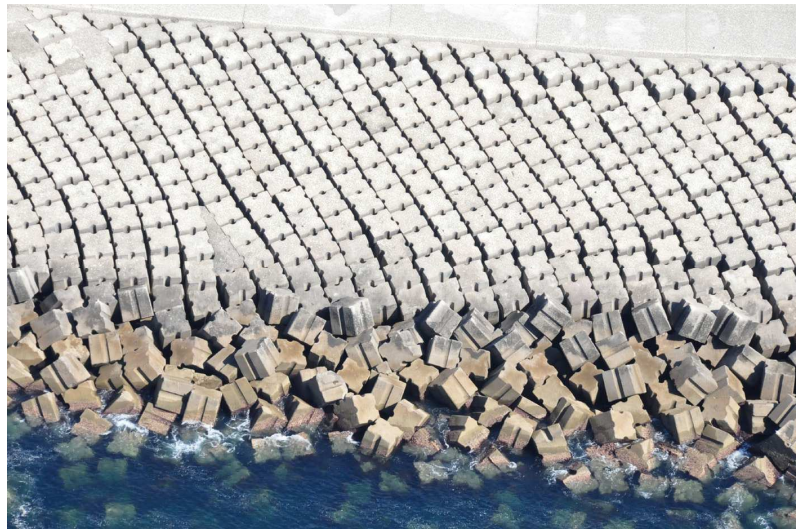
Figure 12: Sines West Breakwater: detail of Antifer placement at the upper part of the armour slope and at the crest berm

The literature (e.g. Coeveld *et al.*, 2005; Pullen *et al.*, 2007) suggest values for the roughness/permeability factor, γ_f , of 0.47 or 0.5 for Antifers, but they have been based on physical model tests carried out with 2 layers of Antifer blocks placed randomly on a 1:1.5 slope (Pearson *et al.*, 2004). At Sines West Breakwater, the Antifers have a regular placement at the upper part of the slope and at the crest berm (Figure 12), which increases run-up and overtopping considerably. A sensitivity analysis was performed on γ_f , considering values between 0.5 and 0.8 for the different slope sections of the breakwater.

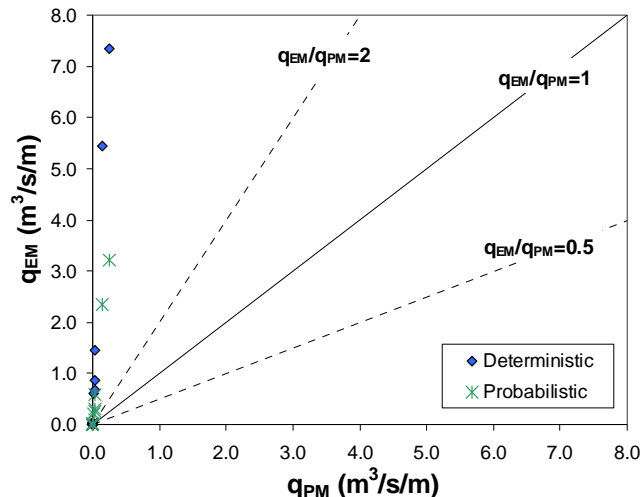
Figure 14: Comparison between the Empirical Method, q_{EM} , and the physical model, q_{PM} , mean overtopping discharges obtained for Solution 3 (all values scaled up to prototype)

The mean overtopping predictions for the twelve test conditions using the Empirical Methods were carried out, as for the Neural Network, with γ_f calculated using the method presented by Pullen *et al.* (2007) to combine the effect of slope sections with different roughness/permeability. The results again show that γ_f has a major influence on the predicted discharges. The mean overtopping discharges obtained with the Empirical Methods for Solution 3 are presented in Figure 14. Note that as far as the Empirical Methods are concerned, representations 3B and 3C are the same.

The results show that the Empirical Methods over-predict the physical model results both for deterministic and probabilistic calculations, despite the fact that, as expected, this over-prediction is more noticeable for deterministic calculations. As mentioned in Pullen *et al.* (2007), for comparison with measurements undertaken or to predict a measurement in a laboratory (or in real situations), probabilistic calculations should be adopted, whereas for deterministic design or safety assessment, deterministic results should be used.
