Accelerated Ageing Tests of Clay Roofing Tiles under Salt Mist Atmosphere

ABSTRACT

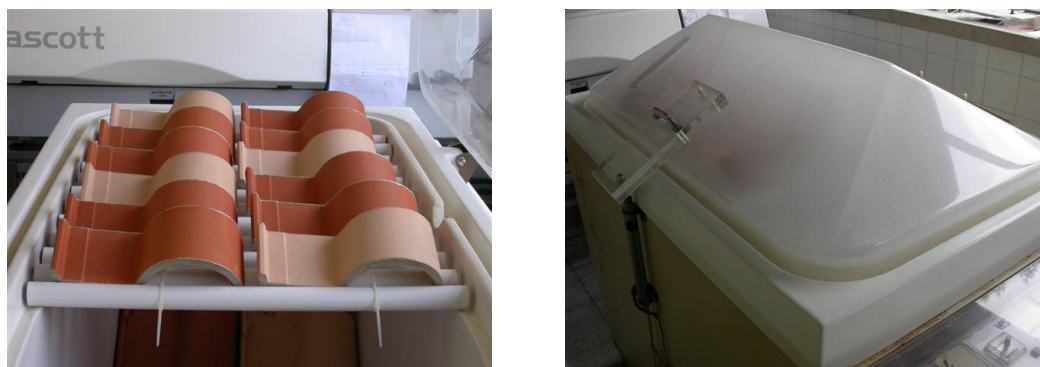
The specimens were prepared through transversal cuts of the tiles. Specimens cut from the mid transversal area of the roofing tiles were preferentially used, having the width of the tile and circa 9 cm length (Fig. 1). The cut faces of the specimens were sealed with epoxy resin. Roofing tiles of two manufacturers (F1 and F2) were used. From manufacturer F1 three types of tiles of the same model 1 were used: F1 NH - model 1, non-hydrophobic red tiles; F1 B - model 1, non-hydrophobic white tiles and F1 H - model 1, hydrophobic red tiles. From manufacturer F2 five types of tiles of three models were used: F2 NH - model 1, non-hydrophobic red tiles; F2 B - model 1, non-hydrophobic white tiles; F2 H - model 1, hydrophobic red tiles; F2 T2 NH - model 2, non-hydrophobic red tiles and F2 T3 NH - model 3, non-hydrophobic red tiles. The tiles were fired at a maximum temperature between 950 °C and 1050 °C, with thermal cycles of 15 hours to 48 hours. They have thicknesses of 10 mm to 14 mm.

Figure 1. Specimens before and during tests

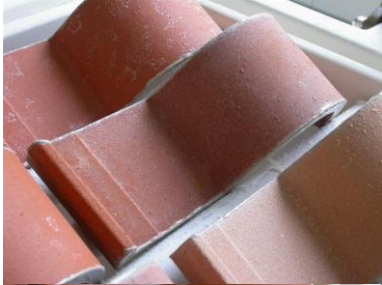
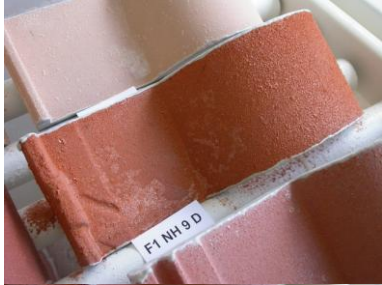
<i>Specimens</i>	<i>Cyclic test</i>	<i>Composite test</i>
F1 NH

Table 1. Alteration and degradation examples of manufacturer 1 specimens.

In the cyclic test non-hydrophobic tiles, both red and white, showed low to medium degradation levels characterized mainly by pitting, some disaggregation and peeling, with a slightly higher level in the white ones.

In the composite test all of the specimens tested (only the non-hydrophobic ones) suffered higher degradations levels than in the cyclic test. Regarding F2 B specimens, they showed lower level of pitting, granular disaggregation and peeling than in the cyclic test, but they had other types of degradation that are localized and are potentially more severe.

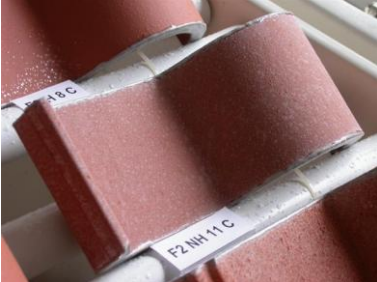
<i>Specimens</i>	<i>Cyclic test</i>	<i>Composite test</i>
F2 NH

Table 2. Alteration and degradation examples of manufacturer 2 specimens.
