Durability of Clay Roofing Tiles under Salt Mist Atmosphere

Cláudio Cruz¹
M. Rosário Veiga²
Victor M. Ferreira³

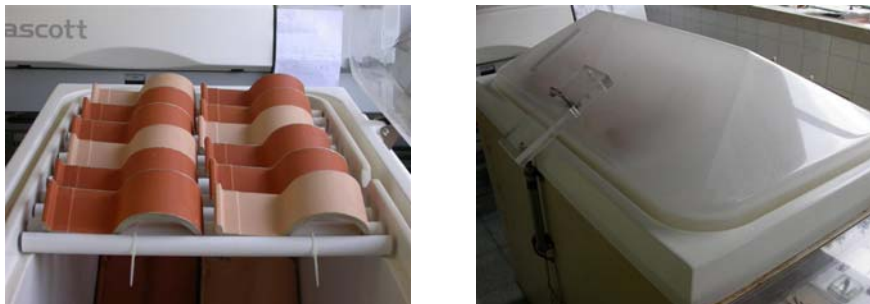
Figure 1. Specimens before and during tests.

5 specimens from each tile were prepared through transversal cuts. In these tests the specimens cut from the mid transversal area of the roofing tiles were preferentially used, having the width of the tile and circa 9 cm length (Fig. 1). The cut faces of the specimens were sealed with epoxy resin. Roofing tiles from two manufacturers (F1 and F2) were used:

Tests were designed based on the European Norm EN 14147:2003 and adapted to what was thought to be realistic conditions for this product [Cruz et al, 2007]. These tests were carried out in a climatic chamber where the specimens are subjected to sets of cycles of wetting under salt mist atmosphere and subsequent drying, the temperature in the chamber maintained at 35°C. Salt mist is produced by spraying a salt solution into the chamber with a concentration of 110g of sodium chloride per litre of de-ionised water. The results of two preliminary tests with cycles of 48 h (10 h of salt fog + 38 h of drying) and 24 h (8 h + 16 h) allowed the selection of the 24 h cycles for the final tests. For each type of tiles, one or two specimens were subjected to 10 cycles, another one or two to 20 cycles and three or four to 30 cycles.

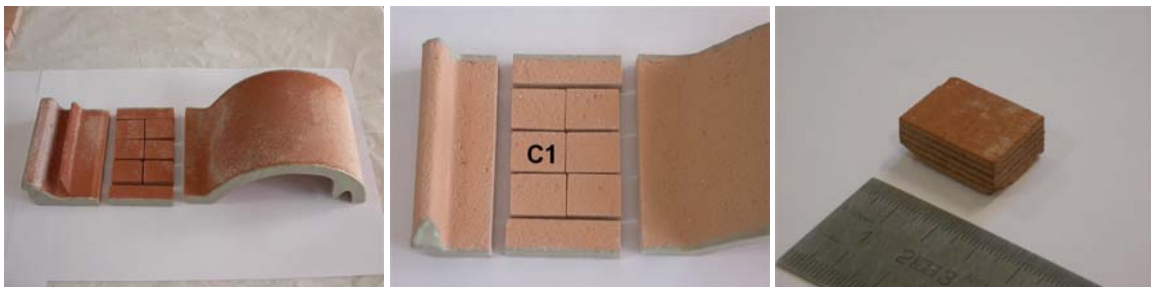
Figure 2. C1 samples.

During the weathering tests, the specimens were visually inspected. After desalinization, they were submitted to water absorption, and samples of some specimens were subjected to Mercury Intrusion Porosimetry. These tests were carried out for comparison of results and evaluation of their sensitivity to the degradation suffered by the specimens. To determine the depth of salt crystallization, salt content profiles were obtained on weathered and non-desalinised samples of two different kinds of specimens, using the hygroscopic moisture content (HMC) method [Gonçalves T. D. and Rodrigues J. D. 2006]. After being submitted to 30 cycles of salt mist wet/drying, one specimen of F2T3NH and another of F2B4 were dry cut and, in this way, two C1 samples were obtained (Fig. 2). In each of the C1 samples 5 layers were marked and from them 5 samples were obtained using sandpaper (from the upper face to the under face: C1 A, C1 B, C1 C, C1 D and C1 E), control samples with sodium chloride by itself and with new tile powder were also used (Fig.3). All the samples were dried at 60°C and then inserted in a climatic chamber at 20°C 85%HR, their weights were measured to constant mass and HMC values were calculated.

Figure 5 shows the Hygroscopic Moisture Content over time of the five grounded layers (Fig. 3) of each of two C1 samples (Fig. 2) obtained from weathered non-desalinated specimens F2T3NH7C and F2B4C.

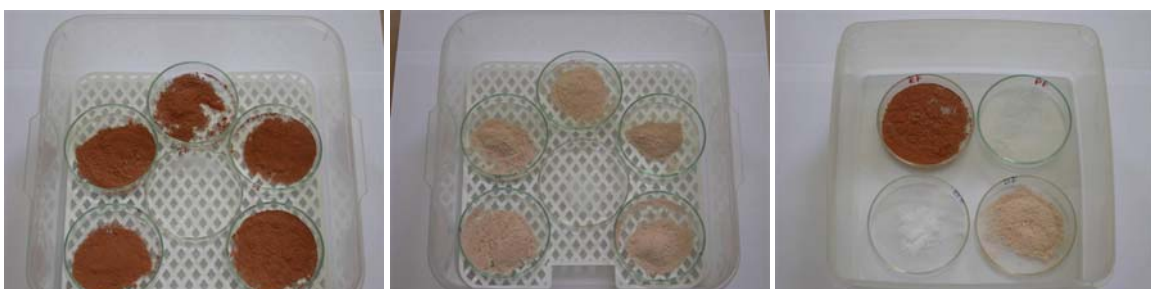
Figure 3. Grounded layers and control samples.

Figure 6 shows the same HMC over time of the grounded layers, but now together with the HMC of sodium chloride control samples (Fig. 3). The last chart shows the HMC over time of control samples with powder from new tiles (Fig. 3).

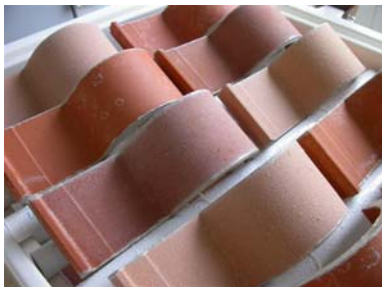
<i>Specimens</i>	<i>Degradation</i>	<i>Examples</i>	
F1 NH	Pitting Granular disaggregation

Hydrophobic specimens didn't show immediate defects but some of them suffered huge degradation following the access of the salty solution to the material under the protected surface. Hydrophobic tiles from manufacturer 2 seem to be more resistant to weathering than those from manufacturer 1. Non-hydrophobic tiles, both red and white, showed low to medium degradation levels characterized mainly by pitting, some disaggregation and peeling, with a slightly higher level in the white ones.

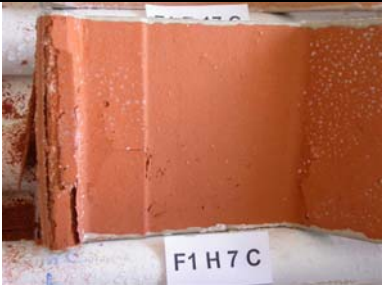
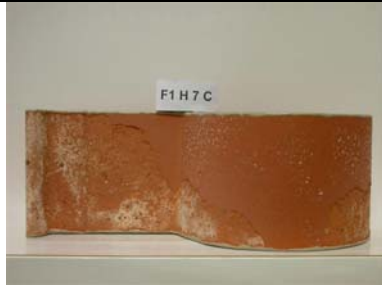
F1 B	Pitting Granular disaggregation Peeling		
F1 H	None Bowling Plaques

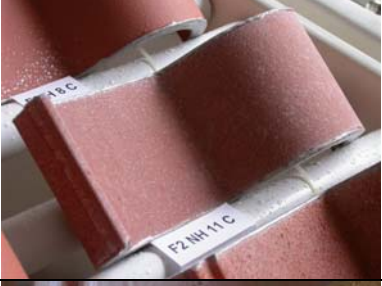
F2 NH	Pitting Granular disaggregation

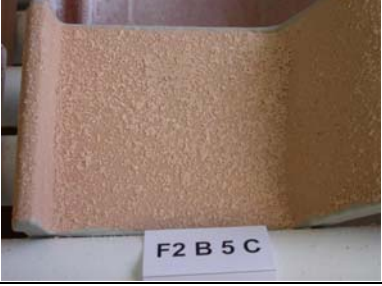
F2 B	Pitting Granular disaggregation Peeling

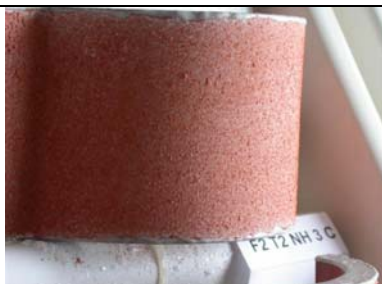
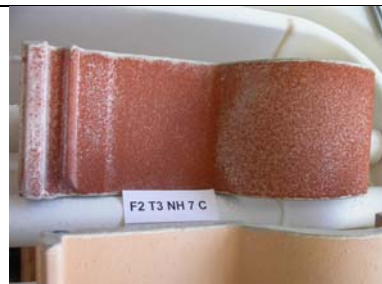
F2 H	None	---	
F2 T2 NH and F2 T3 NH	Pitting Granular disaggregation Peeling

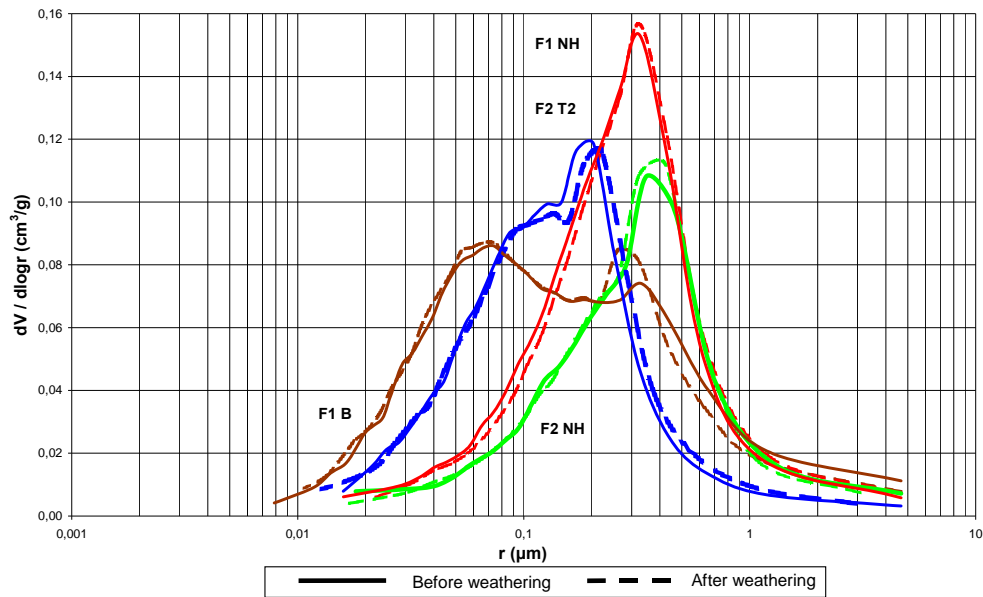
The pore size distributions obtained (Fig. 4) show some differences among the various tiles: the red non-hydrophobic model 1 tiles of both manufacturers F1 and F2 have the largest pores within a very thin range of values (around 0,2-0,5 μm); the white tiles from manufacturer F1 show a large range of pore dimensions, including the finest pores around 0,05-0,09 μm and some larger pores of the range 0,2-0,4 μm ; the non-hydrophobic tiles of the model T2 from manufacturer F2 have finer pores than the other non-hydrophobic red tiles (mainly in the range 0,1-0,3 μm).

The curves also show that the deterioration didn't provoke significant changes on the pores dimensions. Possibly, the type of degradation obtained is still rather superficial and only longer tests will produce the rupture of pores due to salt crystallisation.

Figure 4. Pore size distribution.

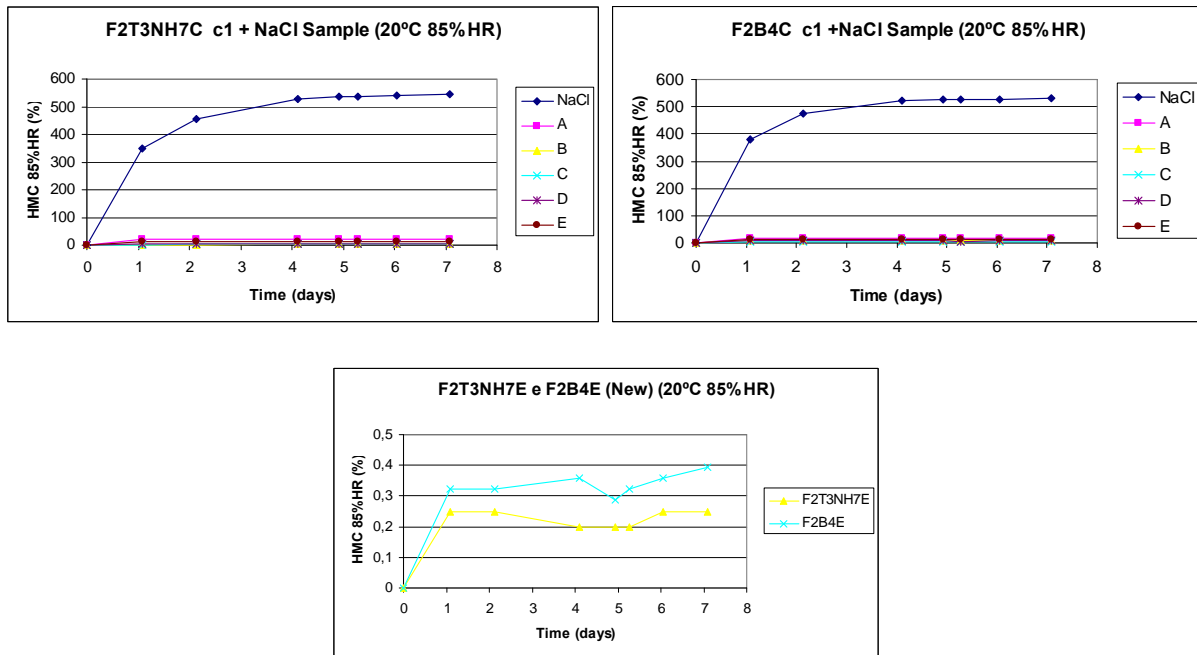
Figure 6. HMC graphics of grounded layers and of control samples.

From HMC values on day 7 the NaCl content of each layer was obtained (Table 3). In both types of samples, NaCl content is much higher in the outer layers. In the inner layers of the white sample the content of NaCl is higher than in the inner layers of the model 3 red tiles.
