## Novel fiber optic transducers embedded into concrete mass applied to the New Alto Ceira Dam

The New Alto Ceira Dam is a concrete arch dam, 41 m high and 133 m long at the crest, located in the middle region of Portugal. Its objective is the replacement of the existing dam located about 200 m upstream, which is highly deteriorated due to swelling phenomena.

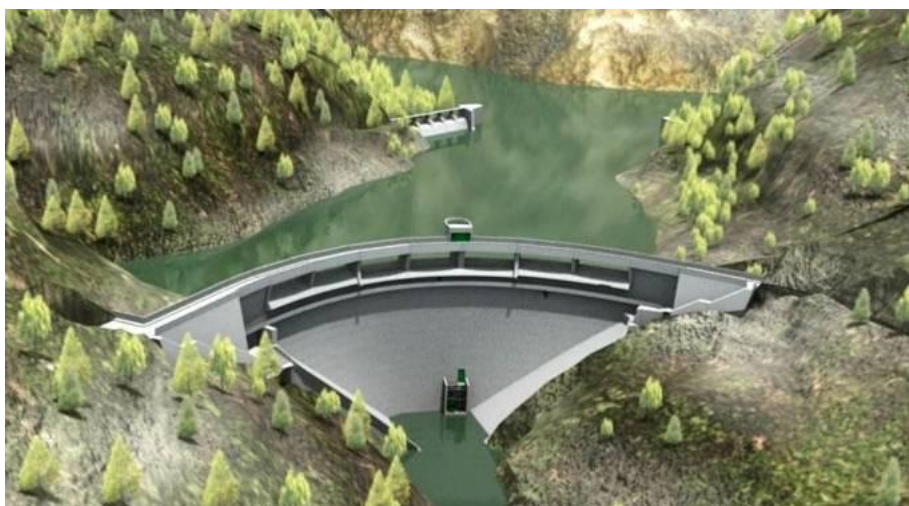
Figure 2 – Preview of the new Alto Ceira dam.

The construction of the new dam, previewed in Figure 2, started in 2009 and will be completed in the end of 2012.

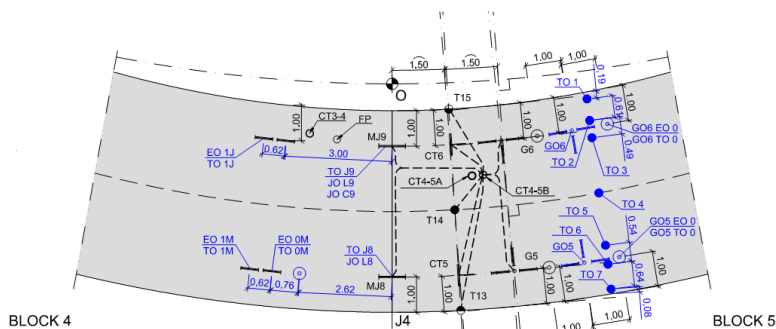
Figure 10 – Fiber optic instruments location and respective nomenclature.

The monitoring plan based on fiber optic technology applied to the new Alto Ceira dam is focused on the measurement of representative parameters at selected points of the structure. The previously presented transducers were used for measuring the strain variations in the concrete mass, the joints displacements (relative opening or closing movements between adjacent concrete blocks) and the temperature changes. The fiber optic instruments location is shown in Figure 10. Two separated zones of the structure were selected, both at the center part at level 646.00, comprising two different concrete cast blocks (B4 and B5).

In concrete block B5, two 2D-strain groups were installed 1 m away from the upstream (GO5) and downstream (GO6) faces of the dam. These two groups are in correspondence with the position of two alternative groups of conventional gages (G5 and G6). The Figure 11 presents a general view with the sensors installation (left), and shows the arrangement of the spatial pre-aligned fiber optic strain transducers (right). The groups of extensometers were involved with concrete whose aggregates have a maximum dimension of 62 mm.

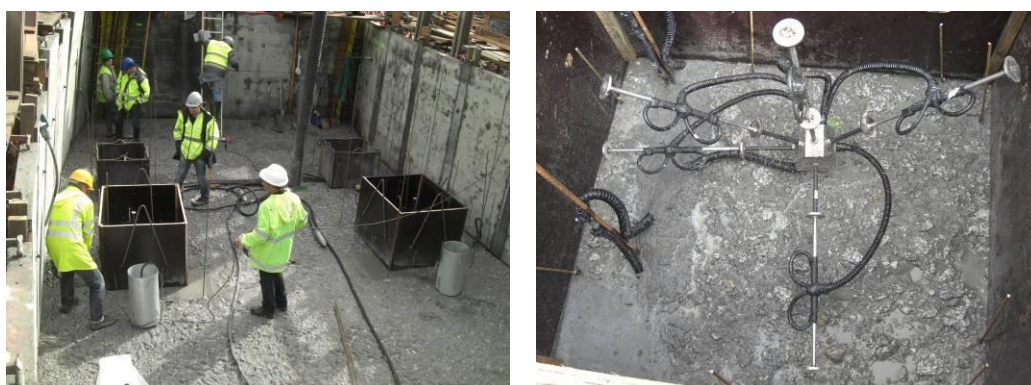
Figure 11 – General view with the strain group relative location (left), and detail five strain transducers group arrangement (right).

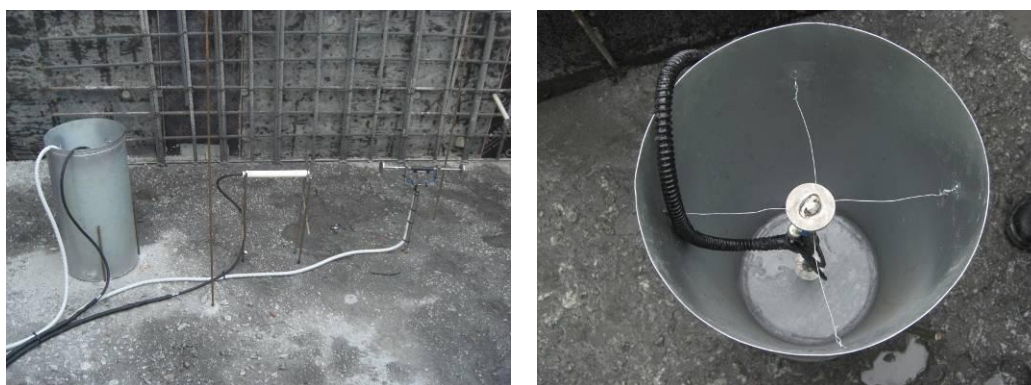
Figure 12 – Double-wall bucket for no stress concrete monitoring (left), and single strain transducer (right).

Beside the strain gages, also embedded in concrete mass, double-wall buckets were installed allowing the characterization of the deformation evolution in no stressed

specimens. In Figure 12 (left) it is presented the respective bucket near the strain gages. The Figure 12 (right) depicts the bucket with the internal optic strain transducer in detail.

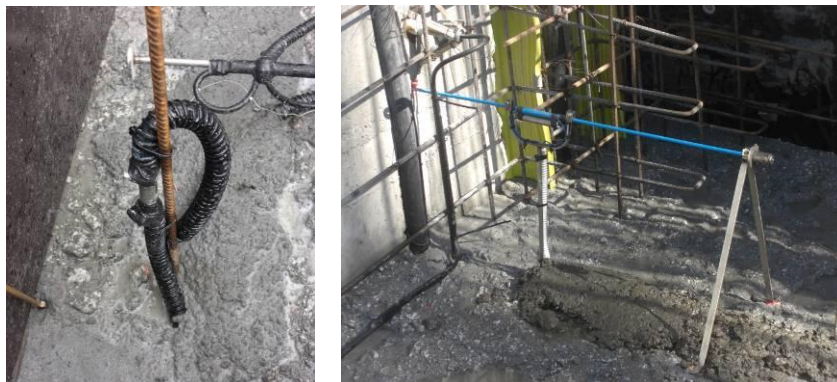
Figure 13 – Detail of the embedded temperature array (left), set up for joint meter gage (right).

An array of seven fiber optic thermometers was installed for assessing the temperature profile along a transversal dam alignment. This set of sensors is connected in a single string which is encapsulated in a flexible corrugated tube. Temperature sensors were positioned at the mid-point, and 0.1 m, 0.7 m, and 1.2 m away from each face of the dam (Figure 13 (left)). A second set of temperature sensors was placed coupled to the strain transducers allowing the temperature compensation.

Figure 13 (right) depicts the fiber optic joint meters installation. It is possible to observe the fiber optic joint transducer at position with one end anchored in the casted block and the other one ready to be embedded in the new concrete phase. A conventional Carlson joint-meter is placed close to the novel transducer for comparison.

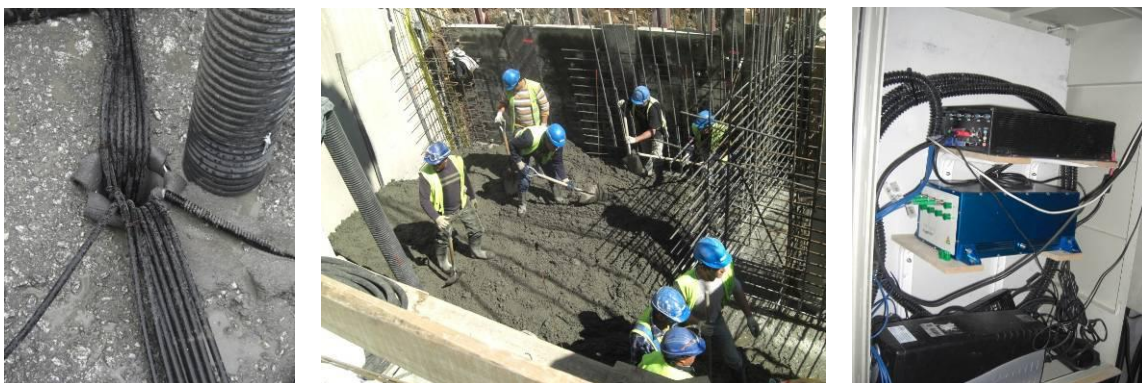
Figure 14 – Details of field installation: contrast between electrical cables and optical fiber conduct (left); concrete cast around sensors (center); fiber optic instrumentation acquisition point and respective equipment (right).

Additional details of the installation scenario are shown in Figure 14.

It is patent the difference in terms of complexity and economy concerning the cable conduction in Figure 14 (left). The signal of a similar number of sensors is transmitted in three optical fibers, here inside a corrugated tube, instead of 16 electrical cables. The concrete cast works around the sensors is illustrated in Figure 14 (center) being important to refer the integrity and serviceability of all the devices after concrete placement. Last, Figure 14 (right) shows the central fiber optic acquisition point composed of a UPS unit, a compact PC and the 8-channel BraggMeter unit (FiberSensing FS2200).

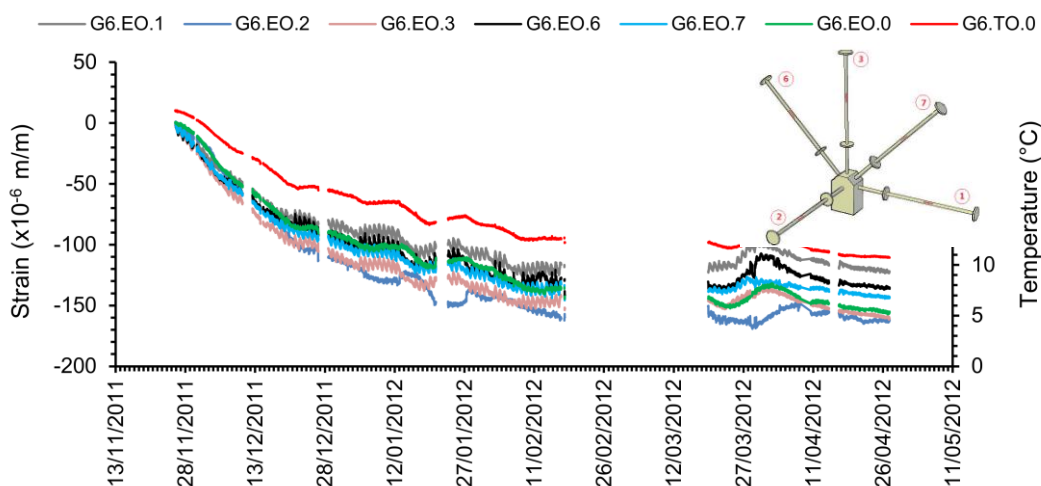
Figure 15 – Strain evolution at the G6 2D strain meters group (refer to Figure 10 for sensors location).

Figure 15 plots the strain evolution on a 2-D strain group. Six different strain transducers are represented together relating to the indicated schematic orientation. The coupled temperature is also presented. Concerning the plotted strains it is important to refer that these results represent the total deformation state combining the thermal, the shrinkage and the mechanical components of the concrete deformation. The concreting of the instrumented zone occurred at November, 4<sup>th</sup> and the readings started 20 days after.

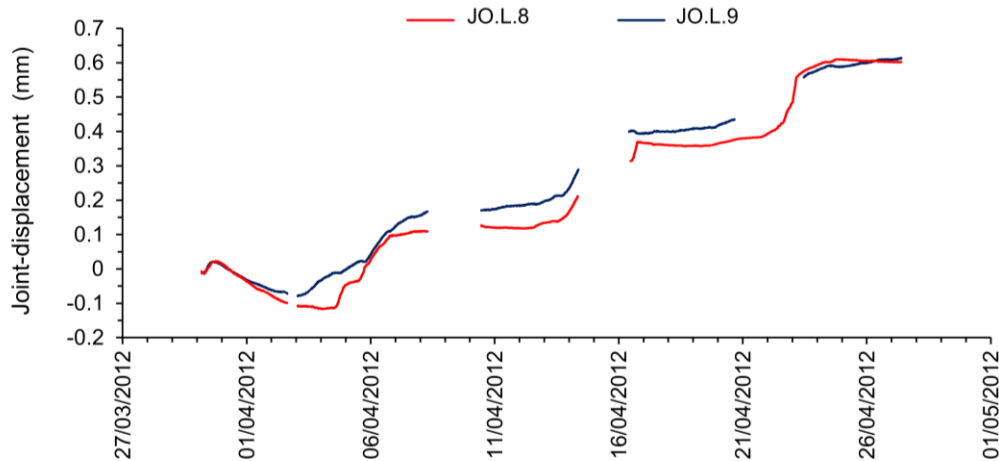
Figure 16 – Joint-displacement evolution in the interface between concrete block B5 and B6 (refer to Figure 10 for sensors location).

The two displacements between concrete blocks are shown in Figure 16. Each measurement point is 1m away from the downstream and upstream dam face,

respectively. The joint-meters readings have started at the beginning of the concrete hydration of the corresponding concrete pouring phase of Block 4.
