### **Salt crystallization in plastered or rendered walls**

Thesis carried out at the Laboratório Nacional de Engenharia Civil (LNEC) for the purpose of obtaining a PhD degree in Civil Engineering at the Universidade Técnica de Lisboa, within the scope of a partnership contract between Instituto Superior Técnico and LNEC

**Lisbon, July 2007**

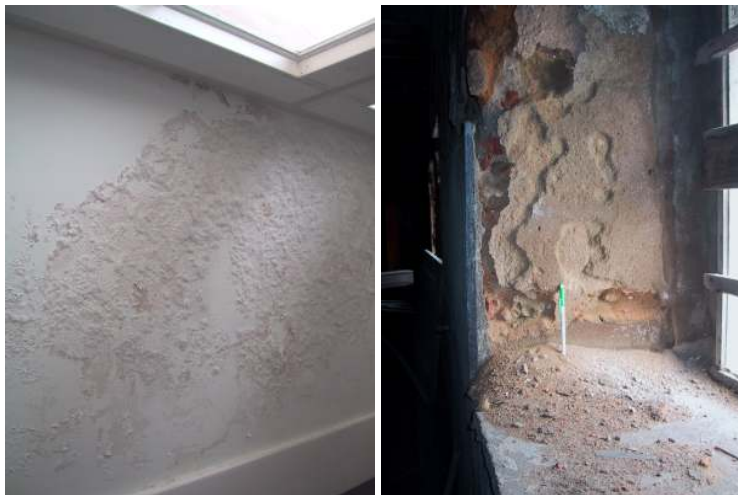
Fig. 1.1 - Two typical salt-damage patterns. Left: efflorescence and damage to paint, temporary exhibition gallery, south wing of Alcobaça Monastery, 2002. Right: sanding of lime plaster and of the lime bedding mortar leading to masonry disintegration, Paulistas tide-mill, Corroios, 2004.

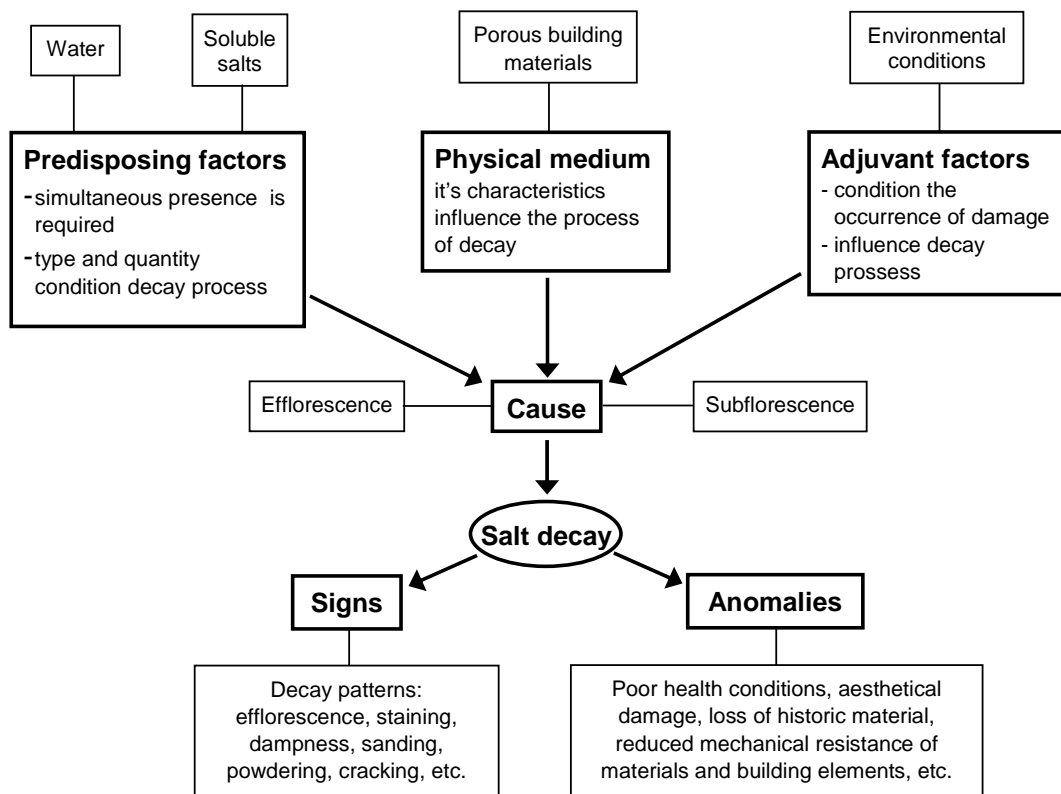
Fig. 2.1 - Salt decay pathology

Salt decay requires the simultaneous presence of soluble salts and water in the pores of building materials, as well as appropriate environmental conditions. Although these deterioration processes are very complex, the pathology can be generically described (Fig. 2.1).

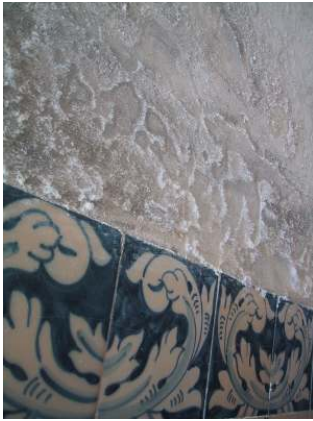
(a) Efflorescence – New See basement, Coimbra, 2003

Some examples of common salt decay patterns are shown below in Fig 2.2. These were observed on traditional plastering / rendering systems during preliminary inspections carried out within this thesis on 31 buildings and monuments. Other patterns will be presented in Chapter 6 when describing the five case-studies selected out of these 31.

The damage patterns in Fig. 2.2 occur when soluble salts crystallize on or close to the surface of the wall and, thereby producing efflorescence, dampness problems or physical damage to the surface layer of the plaster or render. But salts may also deposit deeper in the wall. In this case, damage may arise without being immediately visible as, for instance, detachment of plaster/render coats from each other or from the substrate. This sort of damage can often be detected, even while there are no visible signs of it, simply by tapping the surface: a hollow sound indicates that detachment has occurred.

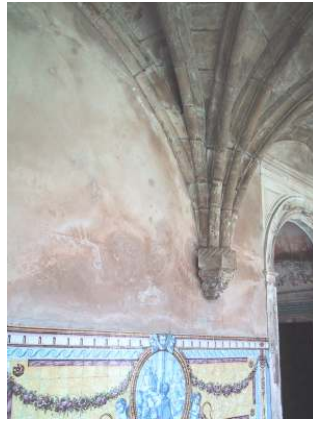
(b) Salt-damp – Cloister of Sta. Cruz Monastery, Coimbra, 2002

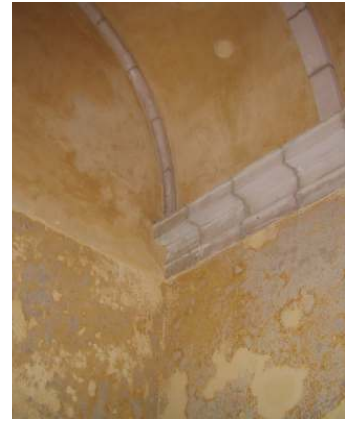
(c) Salt damp and staining – Alcobça Monastery, 2002

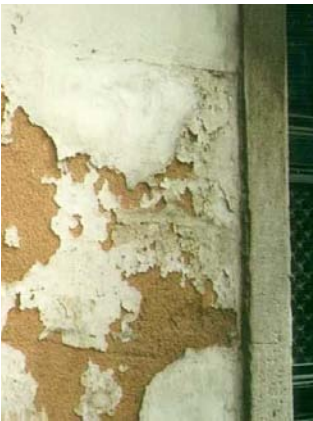
(d) Paint peeling – building in the historic centre of Santarém, 2003

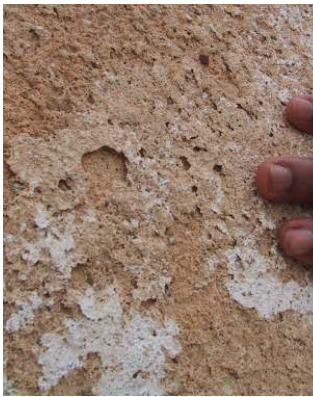
(e) Scaling of lime-wash / lime-render system – Torre das Cabaças, Santarém, 2002

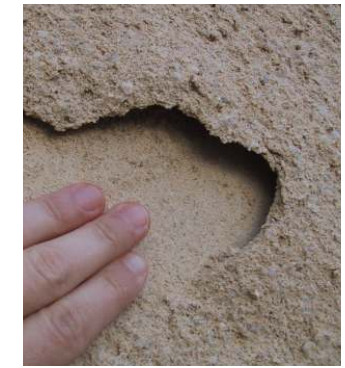
(f) Delamination (layering of material with laminated structure, in this case, a render applied in different coats) – Tibães Monastery, Braga, 2002

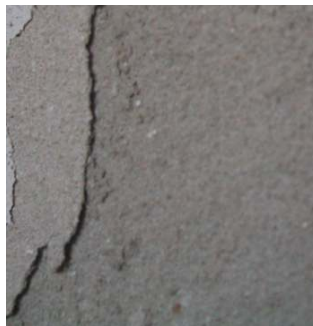
(g) Exfoliation (layering of material with non-laminated structure, in this case, the surface coat of the render) – Sta. Clara-a-Nova Monastery, Coimbra, 2005

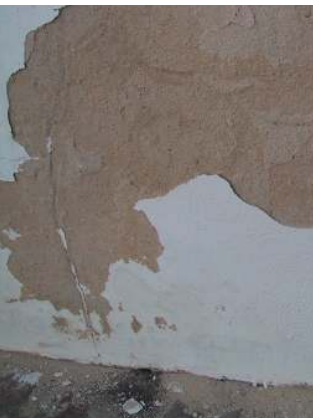
(h) Sanding of render – Salvas Church, Sines, 2003

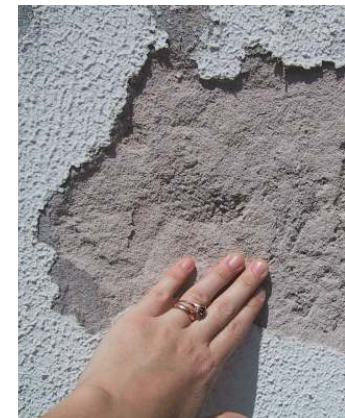
(i) Erosion – Arouca city hall library, 2002

Fig. 2.2 – Some common salt decay patterns of plasters and renders. Damage pattern definition according to the Plaster Damage Atlas (TNO 2005).

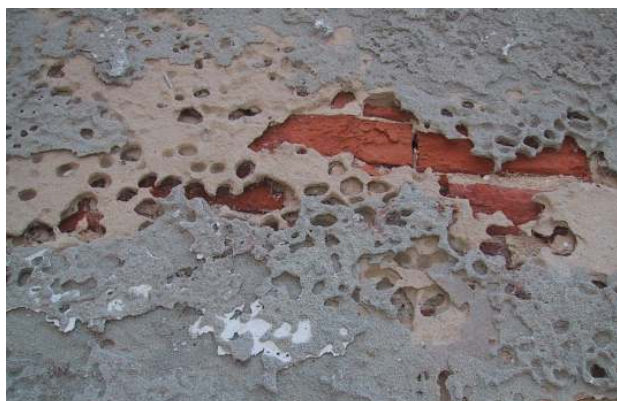
Fig. 2.3 - Alveolar decay – building adjacent to a branch of the Tagus river, at less than 10 km from the open sea, Alhos-Vedros, 2002

In plastered/rendered walls, salt decay patterns are typically observed on the plaster or render but, especially when those have already suffered extensive damage, can affect the masonry as well, as seen in the examples of Figs. 2.3 and 2.4.

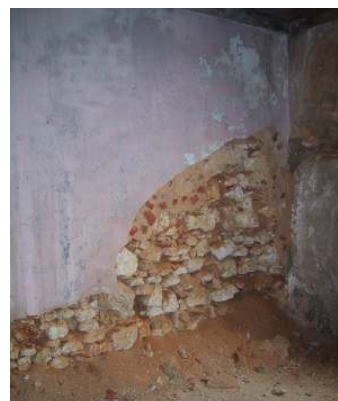
Fig. 2.4 - Masonry disintegration – Paulistas tide mill, Corroios, 2004

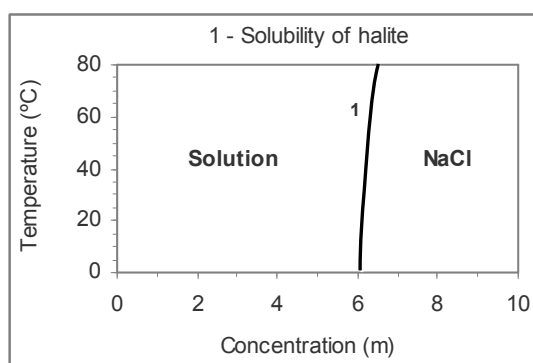
Fig. 2.6 – Solubility diagram of sodium chloride. Data from Steiger (2006).

Sodium chloride (Figs 2.6 and 2.7) is perhaps the simplest and best known of all soluble salts involved in the decay of old buildings. Above 0°C, sodium chloride possesses only one crystalline form, the anhydrous halite (NaCl). The solubility of sodium chloride practically does not vary with the temperature. Normally, sodium chloride does not reach high supersaturations and, hence, it readily crystallizes at a concentration of around 6 molal.

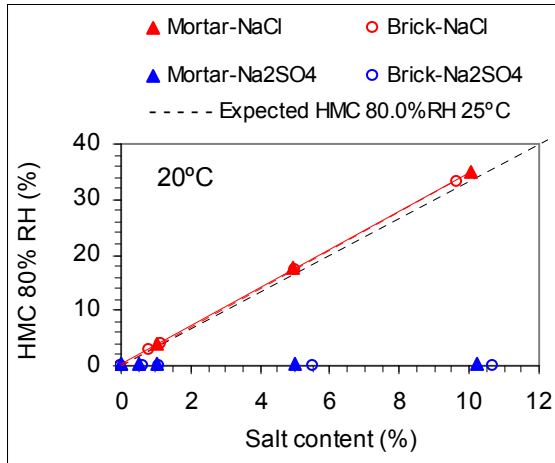
Fig. 3.16 - HMC of NaCl or Na<sub>2</sub>SO<sub>4</sub> loaded mortar or brick samples at 80% RH

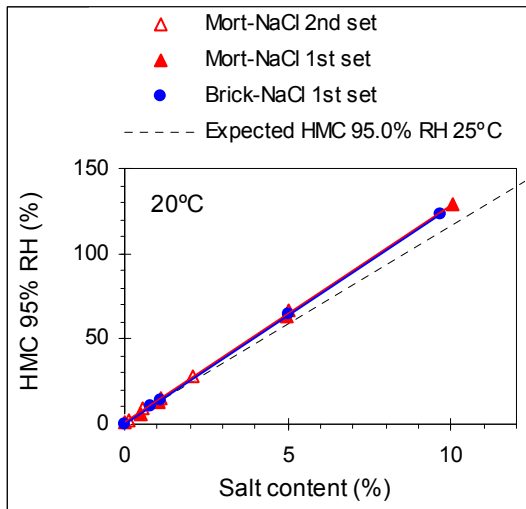
Fig. 3.17- HMC of NaCl-loaded brick or mortar samples at 95% RH

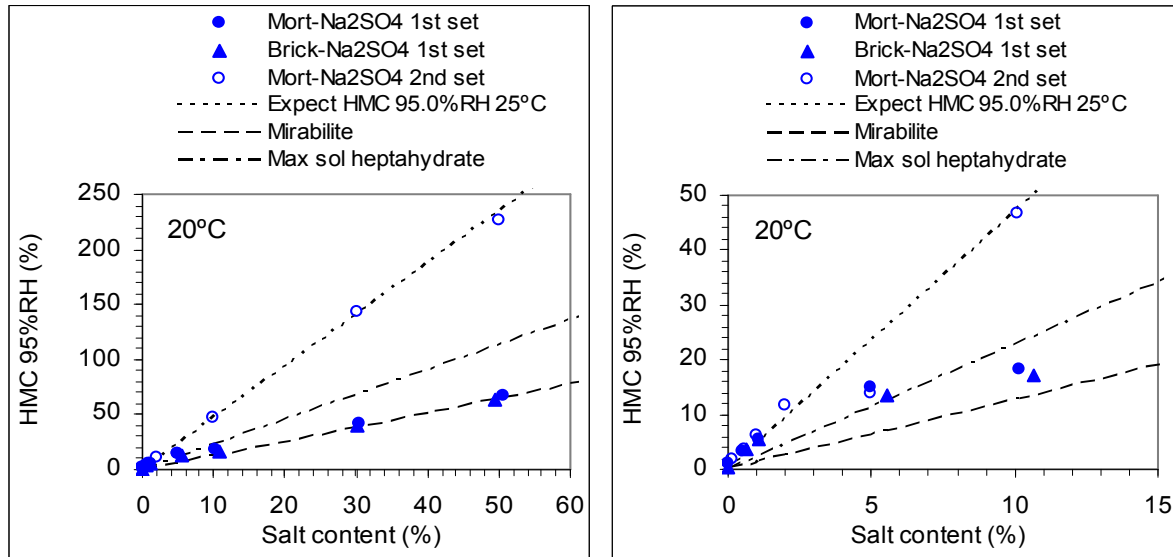
Fig. 3.18 - HMC of Na<sub>2</sub>SO<sub>4</sub>-loaded brick or mortar samples at 95% RH: higher (left) and lower (right) salt contents.

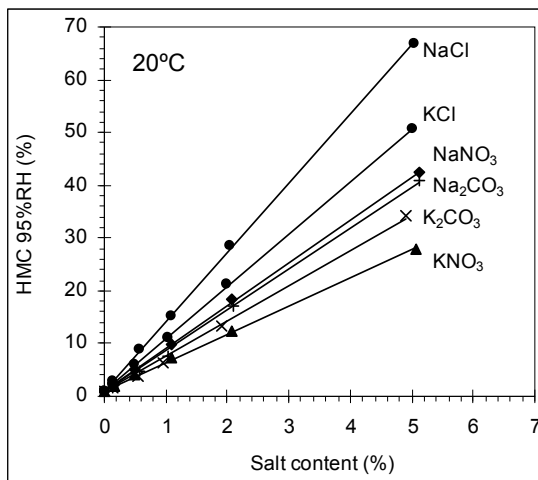
Fig. 3.20 - HMC at 95% RH of mortar samples loaded with each of six distinct salts

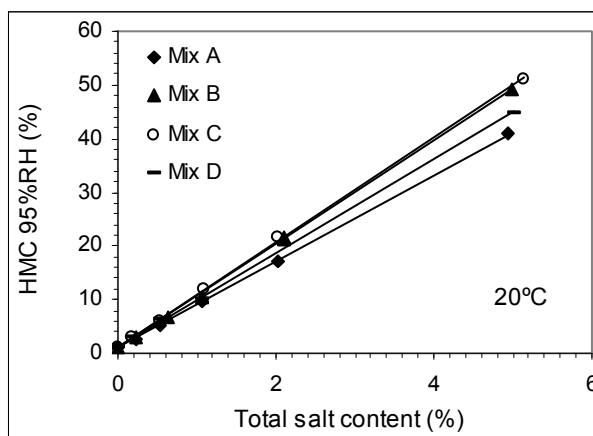
Fig. 3.21 - HMC at 95% RH of mortar loaded with four different salt mixtures

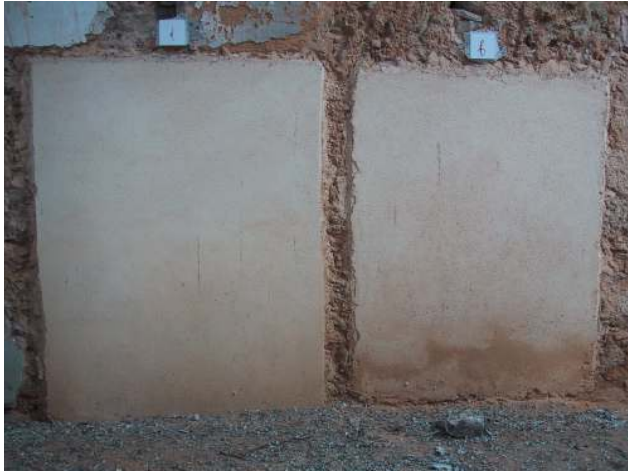
Fig. 5.2 – Test panels on the interior of S. Sebastião church, Almada, one year after their application. Each panel is made of two similar plaster coats composed by a mortar with volumetric composition of 1:1.5:1.5 (dry-hydrated lime: sand from Tagus river : yellow pit sand from Corroios). In the panel on the right a commercial air-lime with hydrophobic properties was used. In contrast to the panel on the left, where ordinary air-lime was used, more severe dampness and sanding of the mortar at the base of the panel were observed here.

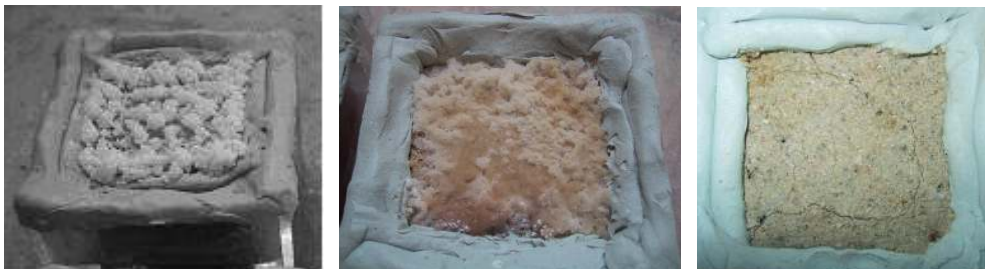
Fig. 5.9 - Preliminary crystallization tests by continuous immersion on lime-plaster/brick specimens. Abundant efflorescence occurred under all environmental conditions both for the 1.9 molal sodium chloride (on the left) and the 0.39 molal sodium sulfate (on the centre) solutions. Its removal systematically revealed wet undamaged plaster surfaces. The only exception were the tests with high temperature periods (constant or cycles) on sodium sulfate, where cracking of the specimens was observed (on the right).

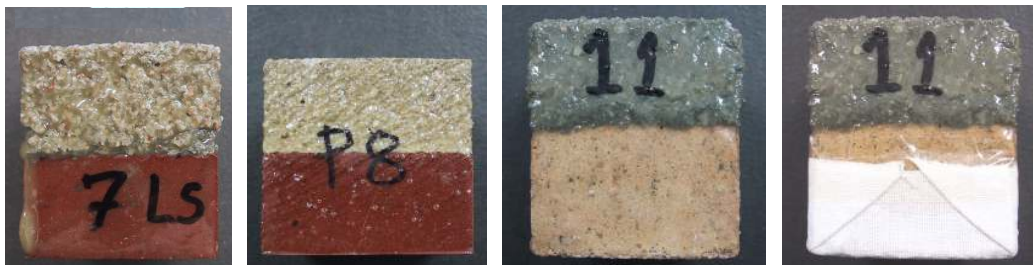
Fig. 5.10 - Specimens (side view) used in set 1 tests: LNEC on brick (specimen 7LS), Parlumière on brick (specimen P8) and LNEC on lime mortar (specimen 11) without or with protective tissue

The drying tests were carried out in a conditioned room with a low air velocity at approximately 20°C and 65% RH. Plaster slabs of around 45 mm x 45 mm x 20 mm, laterally sealed with an epoxy resin, were used. The slabs were detached from plaster/brick specimens similar to those in Fig. 5.10 but where filter paper was interposed between the plaster and the substrate. They were previously saturated by total immersion in pure water until constant weight. During drying, their bottom face was sealed with polyethylene film. Three specimens of each kind were used.

The plaster/substrate specimens (Fig. 5.10) have flat dimensions of 40 mm x 40 mm to 50 mm x 50 mm. MEP and Parlumière plasters are composed of a single mortar coat with a thickness of 20 mm. LNEC plaster is composed of a 5 mm adherence coat and a 20 mm base coat. Brick or lime mortar bases with a thickness of 20 mm or 30 mm, respectively,

were used as substrate. Preparation of the specimens is described in Annex II. At around the two months of age they were laterally sealed with an epoxy resin. The bottom face of the lime mortar substrate was protected with cotton tissue (Fig. 5.10) to avoid material loss during absorption or while handling the specimens.

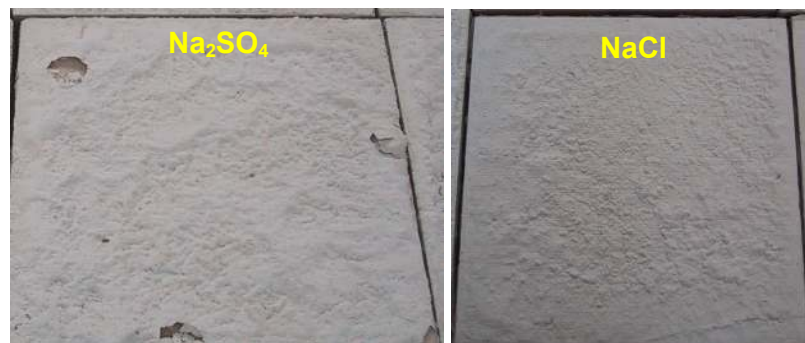
Fig. 5.36 - Damage on the acrylic paint at the end of the first crystallization experiment

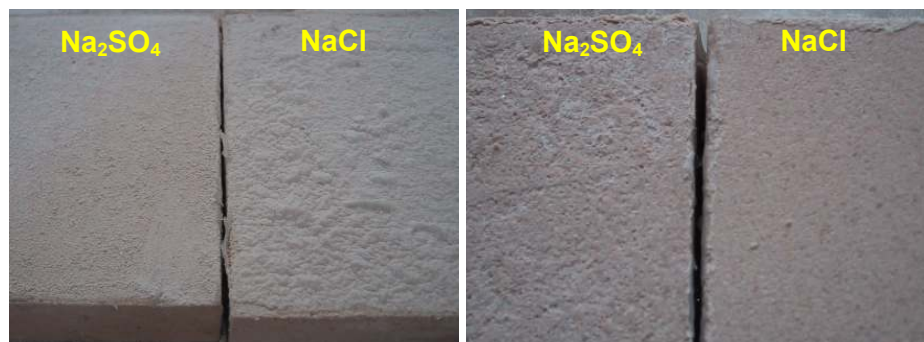
Fig. 5.37 - Damage on the unpainted stone specimens at the end of the first crystallization experiment: efflorescence (left), cleaned stone surface (right)

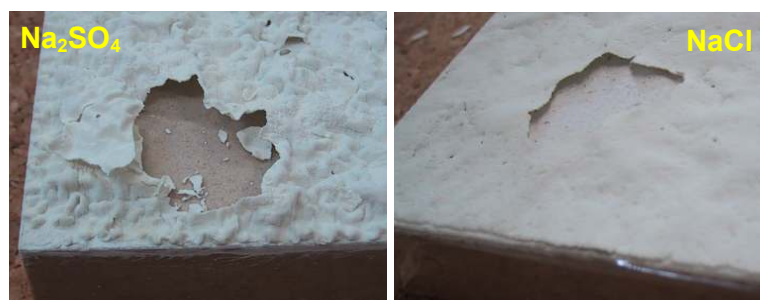
Fig. 5.38 - Damage to the acrylic paint during the second crystallization experiment: for sodium sulfate, after one hour soaking in the second cycle (left); for sodium chloride, at the end of the third cycle drying (right). The paint layers were intentionally perforated to allow observing the stone surface.

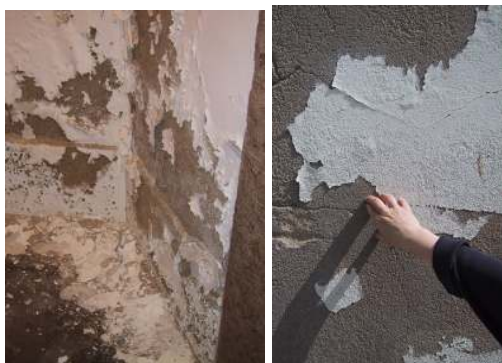
Fig. 5.39 – Paint damage arising without the presence of efflorescence: interior of Ajuda Palace, Lisbon (left) and exterior of building in Almada, Portugal (right).

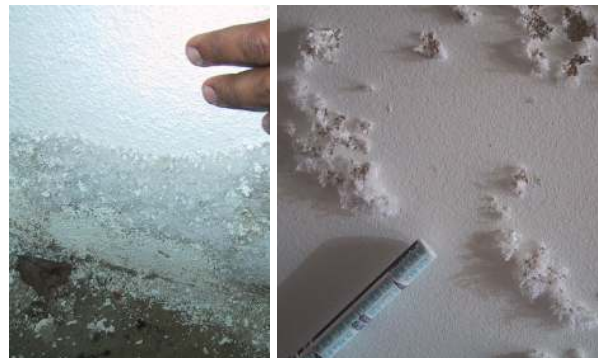
Fig. 5.40 – Paint damage by subflorescence pressure: Alhos-Vedros tide-mill (left) and interior of Despacho House, Pereira, Portugal (right).

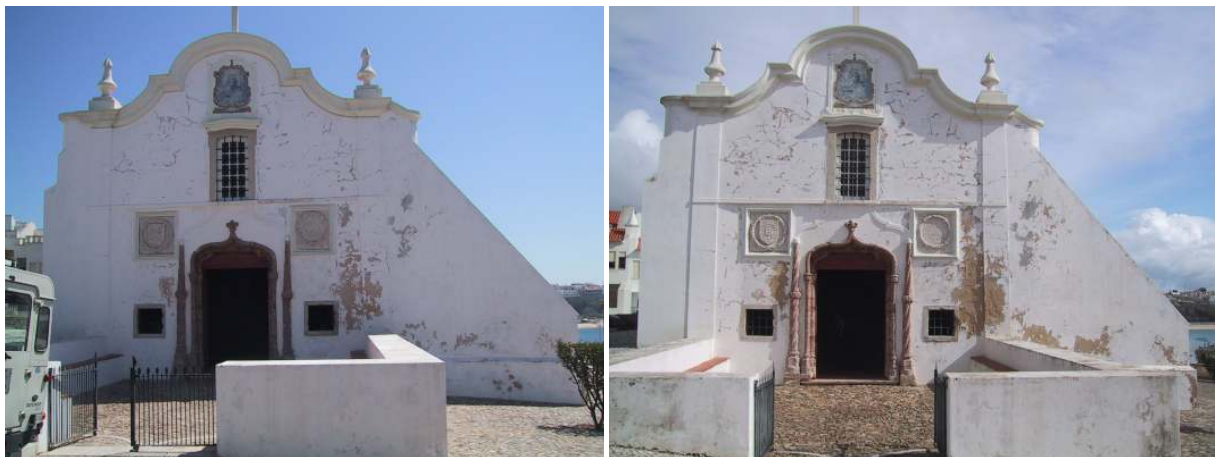
Fig. 6.1 – Salvás Chapel, SW (front) façade: July 2002 (left), October 2003 (right)

The external façades of the chapel showed large decayed spots which reached more than 4m in height from the ground (Figs. 6.1 to 6.4). Damage progressed quickly, as seen in Figs. 6.1 and 6.2.

In October 2003, around 50% of the total rendered area was damaged. The main decay patterns were sanding of the render and further erosion of the render/paint system (Fig. 6.5). No efflorescence was visible. Decayed spots were seen near the ground, but in general degradation occurred mainly at the middle height of the walls (Fig. 6.1 to 6.4). Damage apparently started at the cracks or other singular points of the render (Fig. 6.5).

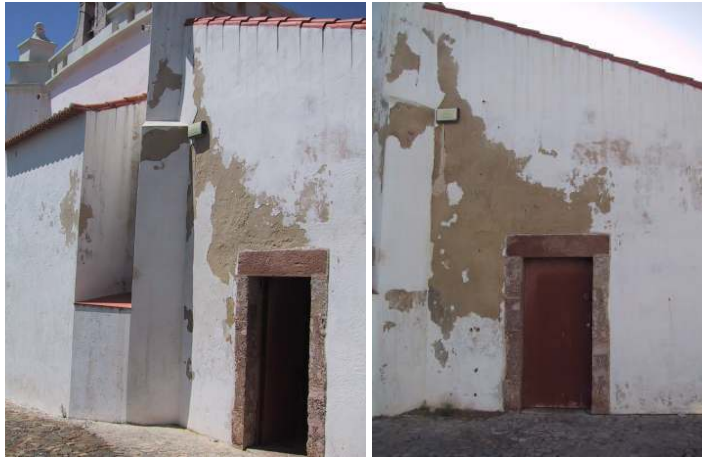
Fig. 6.2 - Salvas Chapel, NE (rear) façade: July 2002 (left), November 2003 (right)

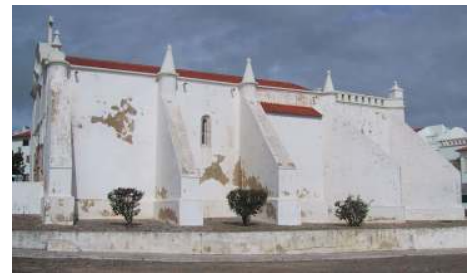
Fig. 6.3 –Salvas Chapel, SE façade, which faces Sines harbour, October 2003

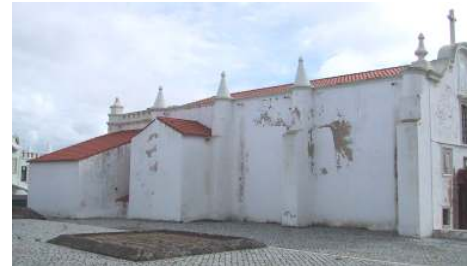
Fig. 6.4 - Salvas Chapel, NW façade October 2003

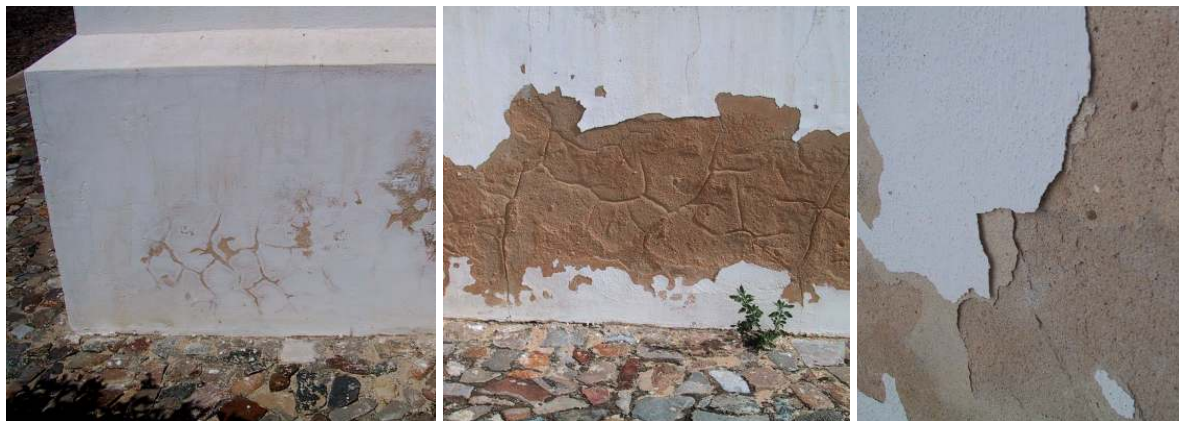
Fig. 6.5 – Salvas Chapel, damage spots on the SE façade. On the left: cracking of paint/render system and start of erosion, October 2003. On the centre; area in more advanced stage of degradation due to further sanding and crumbling of the paint/render system, October 2003. On the right; detachment of paint and of superficial coat of render, June 2002

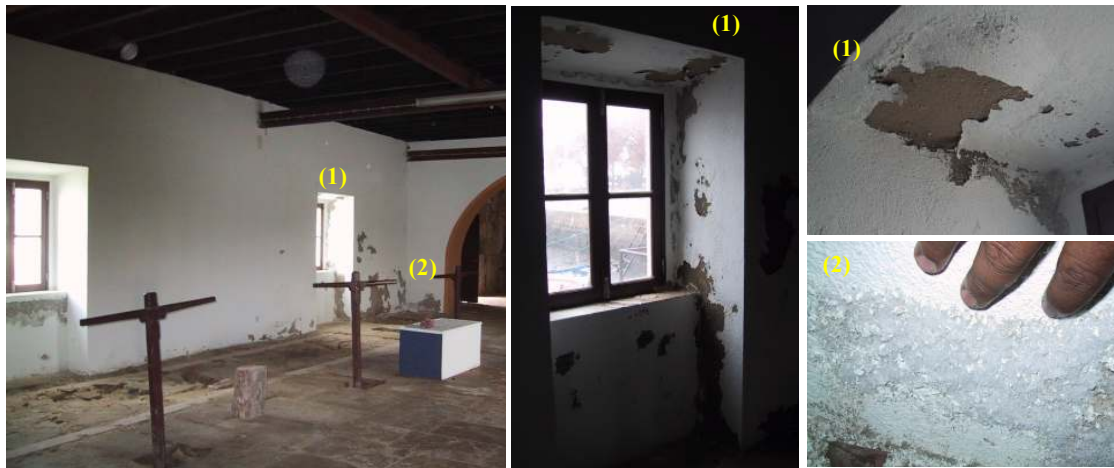
Fig. 6.8 – Tide-mill, damage at the northern wall of the milling room (ground floor). Left: general view showing that damage increases towards the N corner and appears mostly close to the ground or around the windows. Centre: peeling of the plastic paint around window. Right: damage to paint occurs either without (window frame in the top picture) or with (wall base in the bottom picture) efflorescence.

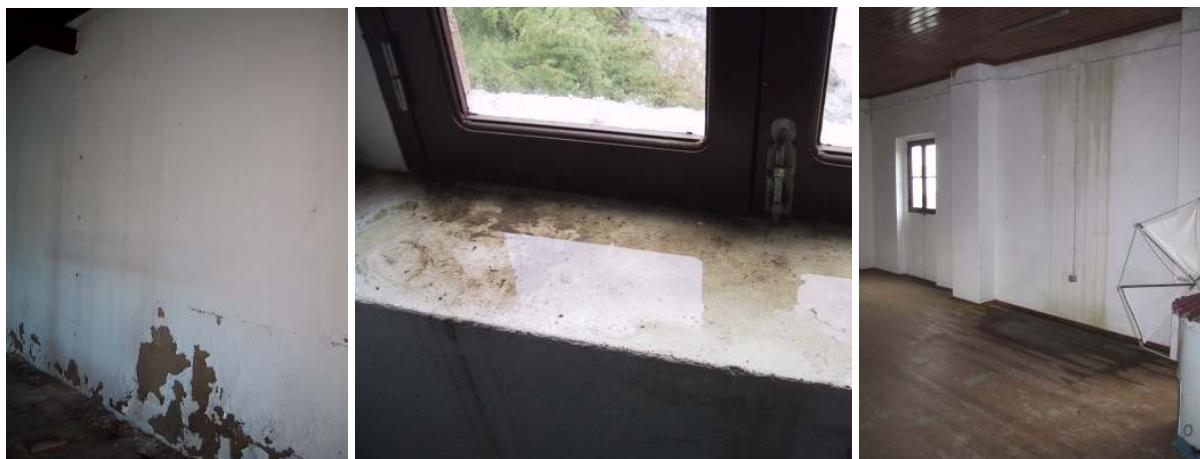
Fig. 6.9 – Tide-mill, damage on the southern wall. On the left: at the ground floor, salt damage appears mostly on the new hydraulic plaster. On the centre: lack of water tightness of the ground floor windows does not give rise to salt damage. On the right: infiltrations from the roof at the upper floor do not cause salt damage either.

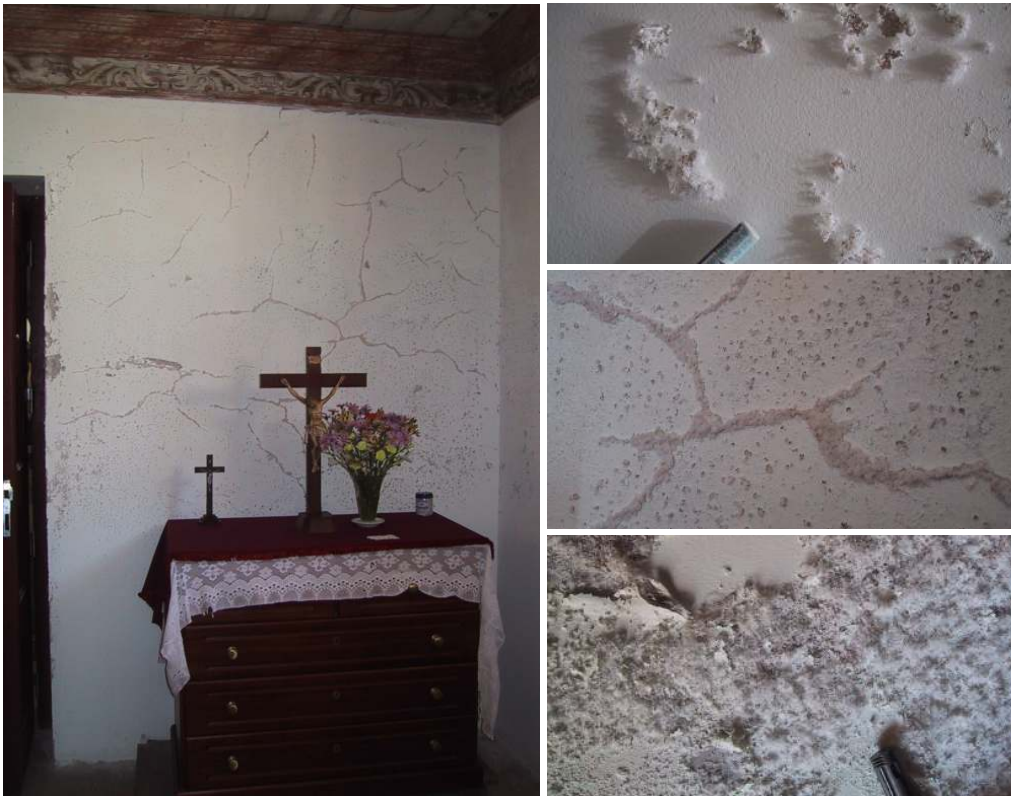
Fig. 6.12 – Extensive damage at the interior of Despacho House. On the left: cracking of the plaster/paint system and efflorescence is observed from around 70cm height from the pavement up to the top of the wall. On the right: damage details showing that salt crystallization at the plaster/paint interface causes rupture of the paint layer and further sanding of the underlying plaster (top), that efflorescence develops preferentially, though not only, on the cracks (centre) and that large areas are eventually covered with efflorescence (bottom).

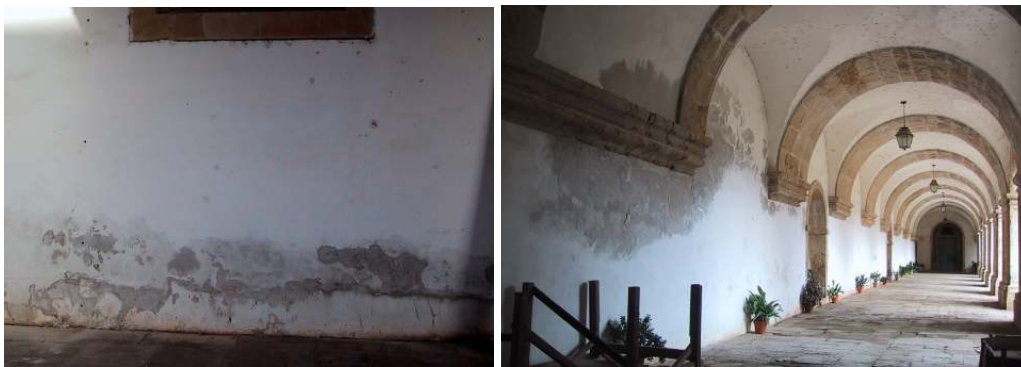
Fig. 6.14 – Sta. Clara: damage appears either close to the ground (NE wall, on the left) or higher on the walls, next to stone elements (NW wall, on the right).

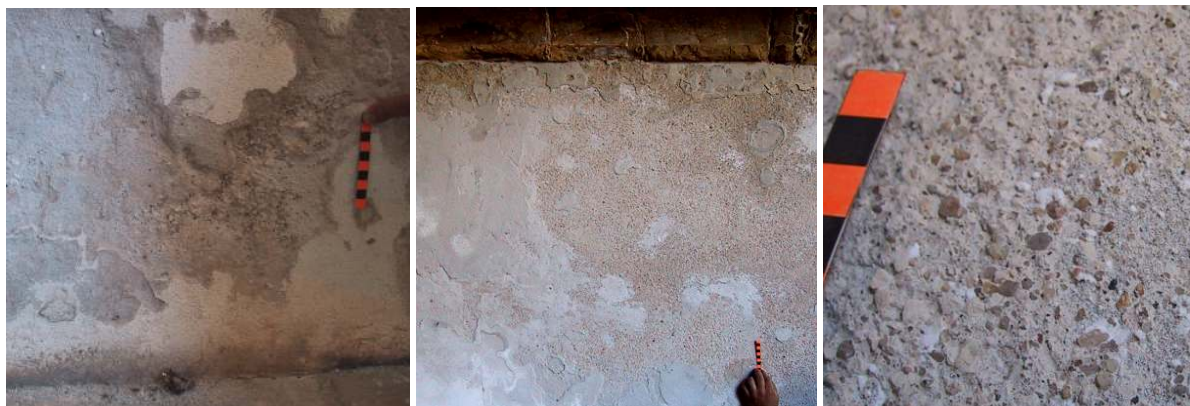
Fig. 6.15 – Sta. Clara: details of lower (on the left) and upper (on the centre) damage spots. Efflorescence agglomerations are observed on the upper spot (on the right)

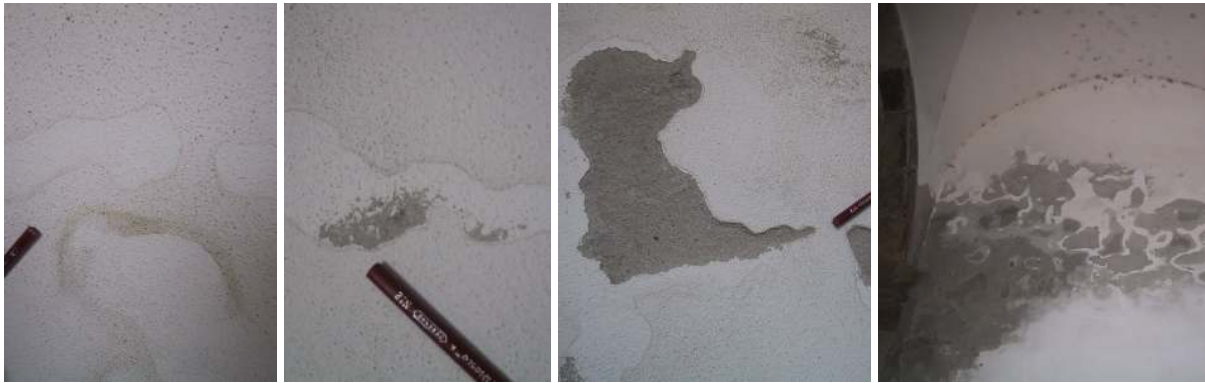
Fig. 6.16 – Sta. Clara: damage development. It is not known whether the borderlines between wet (darker) and dry (lighter) areas and, eventually, between damaged and non-damaged areas correspond to micro-cracks.

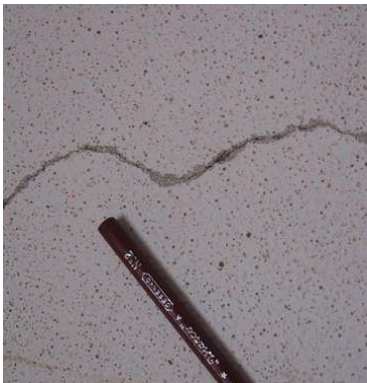
Fig. 6.17 – Sta. Clara: sporadic cracks are observed

The damage is mainly sanding of the render and further crumbling of the render/paint system (Figs. 6.15), often preceded by detachment of the paint layer or of a thin superficial render layer which apparently corresponds to the paint penetration depth (Fig. 6.18). Sporadic cracks in the render/paint system are visible (Fig. 6.17) but do not seem to be a general damage enhancement factor. Damage appears to progress according to the sequences in Figs. 6.16 and 6.18.

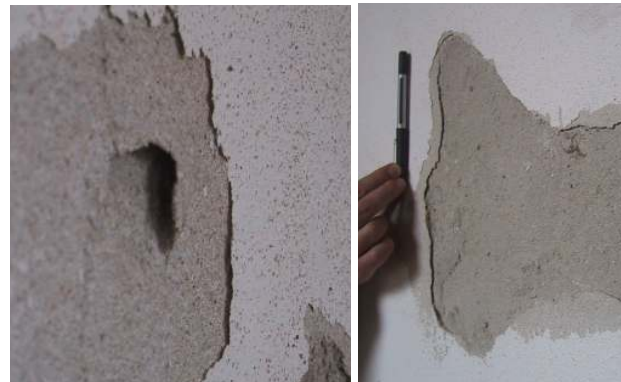
Fig. 6.18 – Sta. Clara: in some cases, damage starts by the bulging and further detachment of a thin surface layer of the render, accompanied by peeling of the paint, without the presence of efflorescence

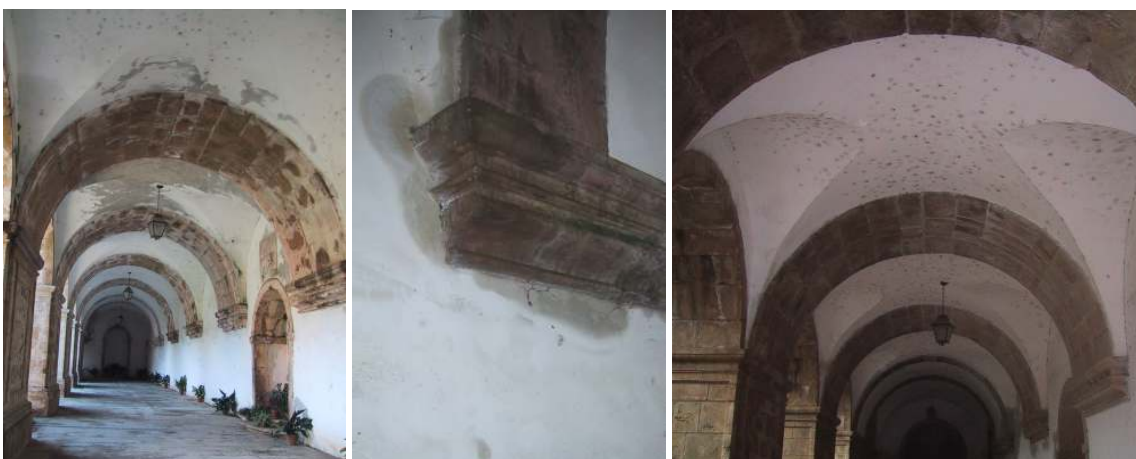
Fig. 6.19 – Sta. Clara: moisture spots on the stone (left), moisture spots and biological growth on the render (centre and right, respectively). On February 2004, on a sunny day that followed several cold rainy days, spots of liquid water were observed in the gallery, mainly on the surfaces of the stone columns and arches (left) with further absorption by the render (centre), which suggested the occurrence of dew point condensation. Biological growth is significant on the sheltered parts of the walls and vaults (right), which corroborates this hypothesis.

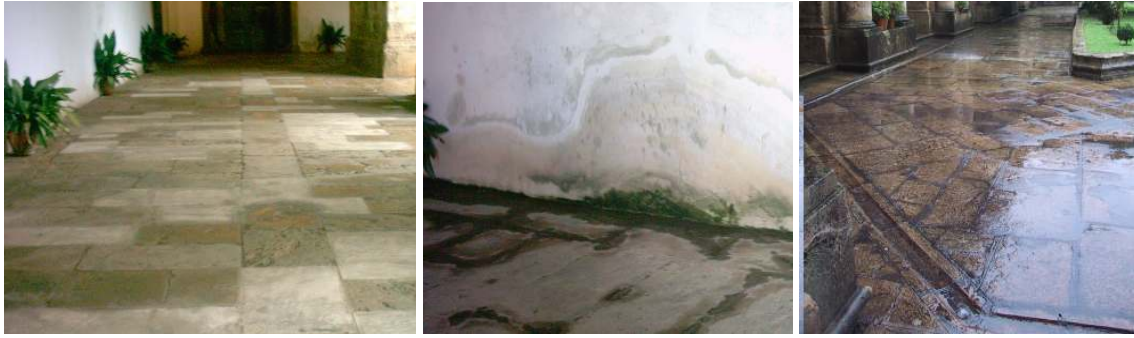
Fig. 6.20 – Sta. Clara: on the same day in February 2004 probable dew point condensation events were also observed on the stone floor (left and centre). Accumulation of water in the cloister garden (right) had been observed during a previous inspection, in January 2004.

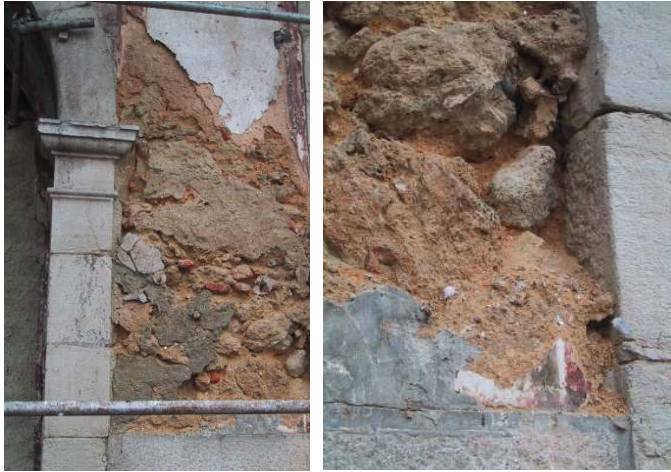
Fig. 6.22 – São Sebastião: masonry damage progresses as follows: (i) lime plasters and renders disappear due to progressive sanding and crumbling; cement repairs, apparently undamaged, detach; (ii) sanding and crumbling of the bedding mortar progresses on the exposed masonry, as seen in these pictures; (iii) fall of the stone elements eventually leads to masonry disintegration, as seen in the picture on the right.

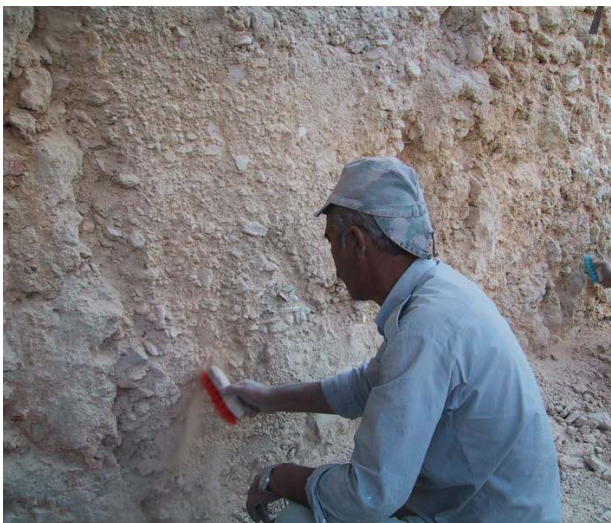
Fig. 6.32 – Before making the panels, the substrate was prepared as follows: (i) the old lime render, in poor condition and with many lacunas, was removed; (ii) the old lime mortar in the joints between masonry stones was removed up to a depth of around 15mm; (iii) the masonry was brushed to eliminate as much loose material as possible; (iv) all recesses deeper than 30 mm were filled with lime mortar A and small stones of the original masonry stone type.

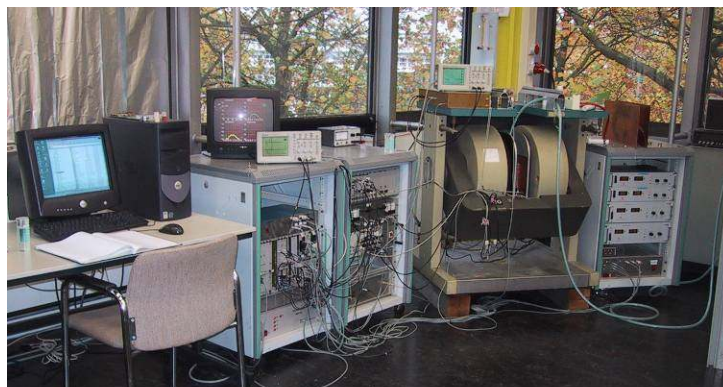
Fig. I.6 – NMR set-up for 2D measurements at TUE composed by, from left to right: computer; data acquisition and RF transmitter; RF receiver; electro magnet; power supplies.

The 2D MRI set-up (Fig. I.6) was used to monitor the drying experiments presented in Chapter 4 and in sections 5.7 and 5.8. In these experiments, only the H<sup>+</sup> ion, hence water, was measured. This set-up incorporates an iron-cored electromagnet operating at a field of 0.8 T.

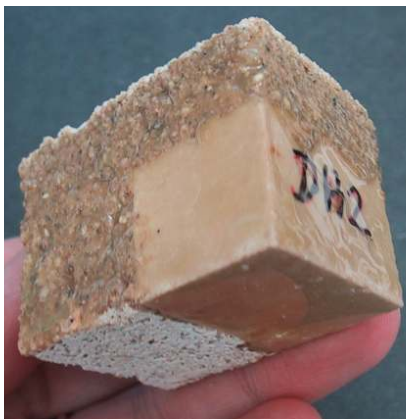
Fig. I.7 – Test-specimen made of plaster on mortar/stone substrate

- Chapter 4 and section 5.8: specimens made of a lime plaster on composite substrate of the same lime mortar and stone (Fig. I.7) and filled with pure water, NaCl solution or Na<sub>2</sub>SO<sub>4</sub> solution;
- Section 5.7: painted and non-painted stone specimens filled with pure water.

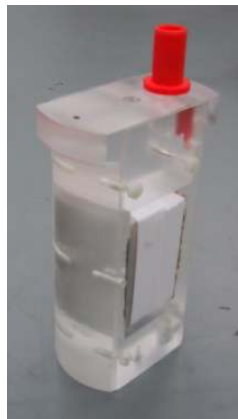
Fig. I.8 - Sample-holder with specimen inside

Immediately after contamination, the bottom face in the case of plaster/substrate specimens (their lateral faces were already sealed with epoxy resin) or bottom and lateral faces in the case of stone specimens are sealed with Parafilm M® plastic film laterally fastened with Teflon tape. The specimen is afterwards inserted in the sample-holder (Fig. I.8) which then is placed in the RF-coil of the NMR set-up (Fig. I.9). Drying proceeds under an airflow at 0%RH (temperature ≈ 18°C).
