## FIRE RESISTANCE TESTS ON BEAM-TO-COLUMN SHEAR CONNECTIONS

**Abstract.** *This paper presents the results of an extensive experimental campaign on the fire behaviour of beam-to-column timber connections loaded perpendicular-to-the-grain. The experimental campaign addressed the fire behaviour of beam-to-column timber shear connections in a systematic way, testing a wide range of common connection typologies, significantly enlarging their experimental background.*

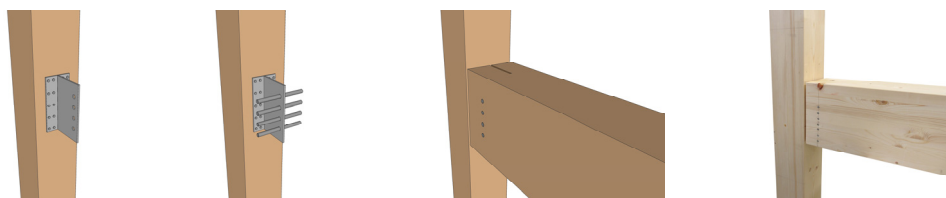
Figure 1. Typical beam-to-column connection loaded in shear (beam end-loaded in tension perpendicular to the grain)

End-grain to side-grain connections, such as beam-to-beam and beam-to-column shear connections (Figure 1), are prevalent situations where members are loaded perpendicular to the grain by connections.

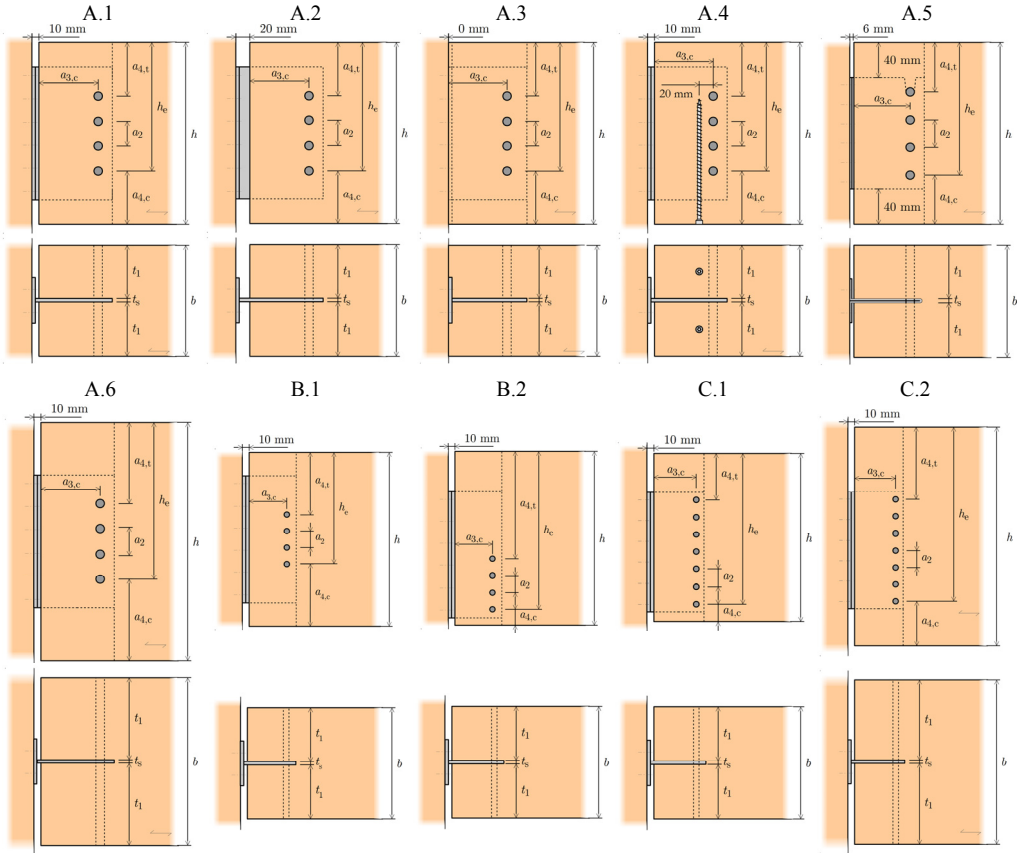
Figure 2.1. Geometries of the tested dowelled connections.

Figure 2.2. Aluminium dovetail connection

Connection typologies A.1 to C.2 are steel-to-timber dowelled connections, on the beam-side (Figure 2.1). In connection A.5, a common commercially available concealed beam-hanger was used, with a geometry that is very similar to the A.1 custom made connection. Typologies A.6 and C.2 are similar to connections A.1 and C.1, respectively, but the beams' cross-section was increased by 40 mm all around. Therefore, connections A.6 and C.2 are rated as R60 (thickness greater than 240 mm) and all the other connections (except D.1) are rated as R30 (thickness greater than 160 mm) [8]. Finally, typology D.1 is a commercially available aluminium dovetail connection, composed by two interlocking parts that are separately screwed to the column and to the end surface of the beam (Figure 2.2).

Table 2. Geometries of the tested dowelled connections.

Connection typology	$b \times h$ [mm <sup>2</sup> ]	$d$ [mm]	$n_d$	$h_c/h$ [ ]	$a_2$ [mm]	$a_{3,c}$ [mm]	$a_{4,t}$ [mm]	$a_{4,c}$ [mm]	$s$ [mm]
A.1, A.4	160×260	12	4	0.71	36	84	76	76	10
A.2	160×260	12	4	0.71	36	84	76	76	20
A.3	160×260	12	4	0.71	36	84	76	76	0
A.5	160×260	12	4	0.73	40	80	70	70	6
A.6	240×340	12	4	0.66	36	84	116	116	10
B.1	160×260	8	4	0.64	24	56	94	94	10
B.2	160×260	8	4	0.91	24	56	164	24	10
C.1	160×260	8	7	0.91	24	56	92	24	10
C.2	240×340	8	7	0.81	24	56	132	64	10
D.1	160×260	-	-	-	-	-	-	-	18

$b$  and  $h$  are the width and the height of the cross section;  $d$  is the dowel diameter and  $n_d$  is the number of dowels;  $h_c$  is the distance from the most distant fastener to the loaded edge;  $a_2$ ,  $a_{3,c}$ ,  $a_{4,t}$ , and  $a_{4,c}$  are the dowel spacing, unloaded end distance, loaded edge distance, and unloaded edge distance, respectively; and  $s$  is the gap between the beam and the column.

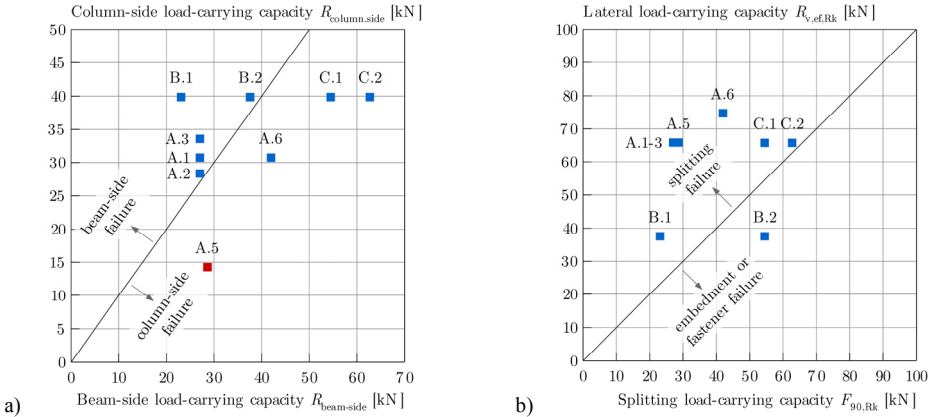
Figure 4. Estimated load-carrying capacities of the tested dowelled connections: a) beam-side and column-side capacities; b) beam-side failure modes.

The estimated and experimental load-carrying capacities of the tested connections are presented in Table 3 and Figure 4. Most connections were expected to exhibit splitting failures (A.1-3,5-6, B.1, and C.1-2); only connections B.2 and, possibly, A.4, were expected to display ductile dowel failures. Regarding the estimated splitting capacities of the beam-side of the connections, it has to be mentioned that EN 1995-1-1 does not have specific rules for end-loaded members loaded perpendicularly to the grain, but only to mid-span loaded members. However, both the former German code for timber structures DIN 1052:2004 [6] and A. Leijten [14] (who developed the calculation model for mid-span loaded members in EN 1995-1-1) state that for connections at the end of a cantilever the splitting strength is half of the strength of mid-span loaded members.

The results show that the beam-side load-carrying capacity is substantially underestimated by current design methods, even taking into account that  $R_{k,\text{estimated}}$  are characteristic 5% percentile values and  $R_{\text{mean,experimental}}$  are mean values. Also worth noticing is that the column-side load-carrying capacity seems to be significantly underestimated, as no failure in the column-side was observed in the full connection tests performed on typology A.5.

The common commercially available concealed beam-hanger (A.5) had gap of only 6 mm between the beam and the column (Figure 2.1 and Table 2), but a much lower estimated load-carrying capacity of the column-side of the connection (Table 3 and Figure 4a), although it failed on the beam-side at normal temperature. This commercial connection exhibit a fire resistance 5 minutes lower than the custom A.1 connection and failed in the column-side, with a failure mode similar to that of the connections A.2. However, the load in connection A.5 during the fire test was about 40% of the load-carrying capacity of the beam-side at normal temperature, instead of the 30% in connections A.1-3.

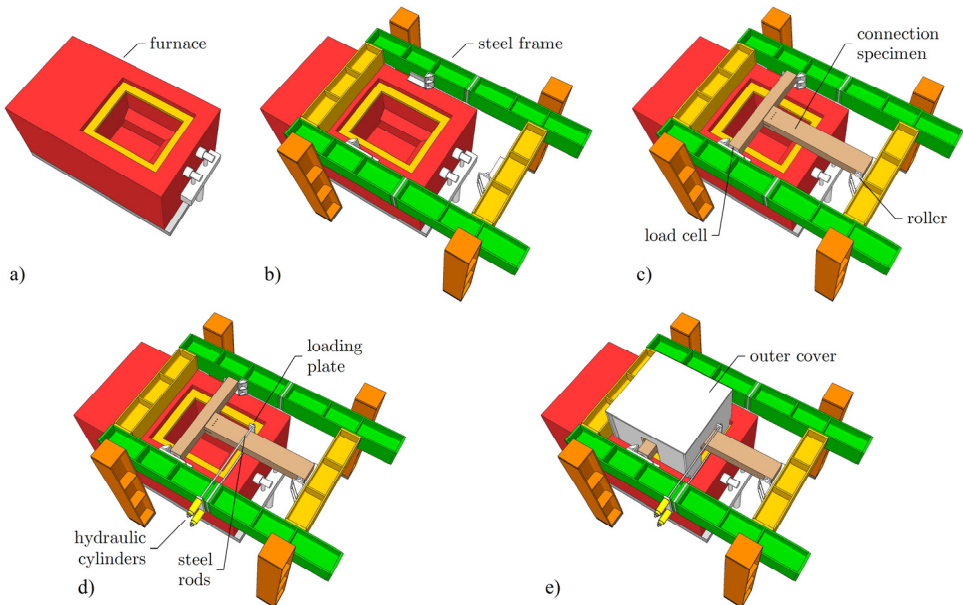
Figure 5. Schematic overview of the fire resistance tests set-up: a) horizontal furnace; b) steel frame over the furnace; c) connection specimen inside the frame; d) loading apparatus; e) outer cover.

As previously described (Figure 3b), the test set-up used in the fire tests is very similar to one used in the tests at normal temperature. The same horizontal steel frame was positioned over the furnace, in such a way that the connection area was centred above the furnace's opening. In its plane, the connection was supported on a load-cell, placed at the bottom of the column-member (to measure directly the shear load in the connection, transferred as a compression force in the lower half of the column), and on a roller, located at the opposite end of the beam-member. The load was applied through a loading plate positioned on the top-side of the beam (which during the test it's on its side), connected by two steel rods to the

hydraulic cylinders. Since no equipment could be exposed to fire, only the displacements of the loading plates were measured, not the relative displacements between the members in the connection. The connection specimen was then partially enclosed by an insulated outer cover that allows the timber members to deform. The test set-up is presented in Figure 5.

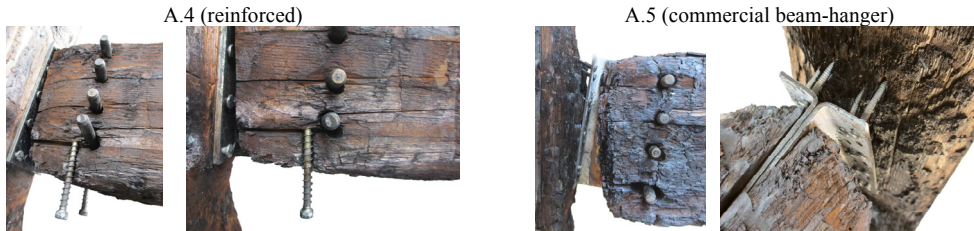
Figure 8. Connections A.4 and A.5 after the fire tests.

The connection reinforced with self-drilling screws (A.4) exhibited a fire resistance 5 minutes lower than the corresponding unreinforced connection (A.1). The reinforcement with self-drilling screws is an effective and widespread way to deal with the brittle splitting failures of the unreinforced connections loaded perpendicularly to the grain. However, as observed in a previous experimental campaign performed by the authors on the fire resistance of tension connections reinforced with self-drilling screws [7], the reinforcement screws also conduct heat into the cross-section (Figure 8), which in some cases compromises the fire resistance.

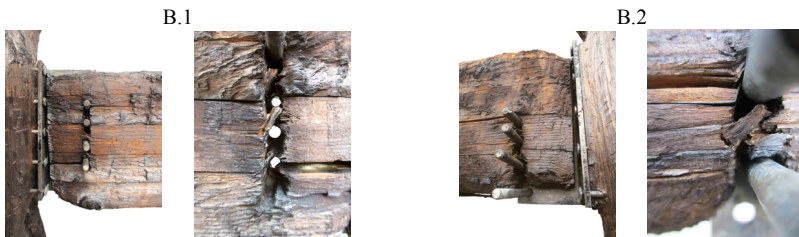
Figure 9. Connections B.1 and B.2 after the fire tests.

The influence of the failure mode can be analysed in the connections B.1 and B.2. These connections had smaller sized dowels (diameter of 8 mm) and showed brittle splitting (B.1) and ductile embedment/dowel failures (B.2) at normal temperature. In the fire tests, however, both typologies exhibited similar extensive embedment failures, followed by splitting. In fire, the smaller minimum dowel spacing perpendicular to the grain prescribed by EN 1995-1-1 (only  $3 \cdot d$ , compared to  $5 \cdot d$  parallel to the grain) leads to a premature failure when all the wood between the dowels is charred (Figure 9). Also the smaller minimum unloaded edge distances (connection B.2) perpendicular to the grain (only  $3 \cdot d$ , compared to  $7 \cdot d$  parallel to the grain) result in the complete charring of the wood surrounding the outermost dowels. Regardless of the failure mode at normal temperature, both connection typologies exhibited approximately the same fire resistance.

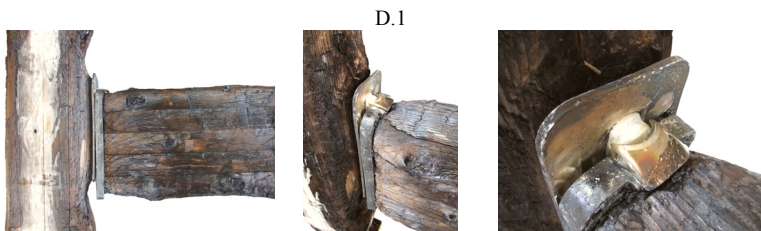
Figure 12. Connection D.1 after the fire test.

Finally, the commercial aluminium dovetail connection D.1 also reached more than 30 minutes of fire resistance, failing in the connector itself after 36 minutes. This connection had a gap of 18 mm between the beam and the column (thickness of the connector), which is larger than the 10 mm of most of the other connections.
