# Building vulnerabilities to fires at the wildland urban interface

João Laranjeira<sup>a</sup>, Helena Cruz<sup>b</sup>

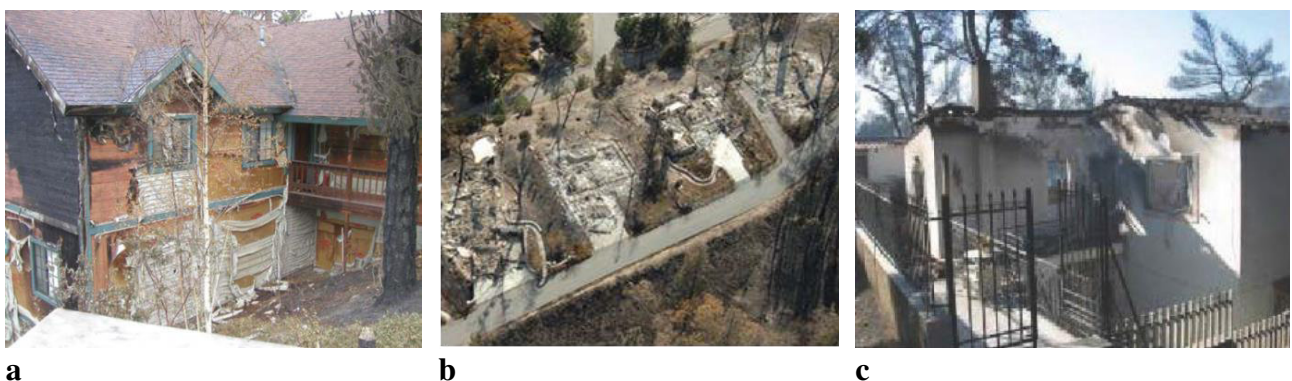
**Figure 1.** Influence of the construction materials characteristics on building vulnerabilities to wildland fire threats: a) building envelope damage due to the combustible construction materials (U.S.A.) (Cohen and Stratton, 2008); b) buildings destruction due to house-to-house fire spread (U.S.A.) (Cohen and Stratton, 2008); and c) building destruction due to its combustible contents (Greece) (Xanthopoulos *et al.*, 2011).

When compared with the reality in the U.S.A. and Australia, a high density of buildings in Mediterranean Europe generally entails a reduction of the available fuel loads (Xanthopoulos *et al.*, 2011) to fire propagation, due to the construction material characteristics used in the building envelope components. Notwithstanding this, buildings in Mediterranean Europe have also been damaged or destroyed during fires in the WUI, but in most cases, it is a consequence of the ignition of the materials inside it, as the fire managed to enter the buildings through openings or breakthrough weak points (Figure 1c) (Caballero, 2004; Xanthopoulos *et al.*, 2011).
