Assessing the Quality of an UAV-based Orthomosaic and Surface Model of a Breakwater

Maria João HENRIQUES, Ana FONSECA, Dora ROQUE, José Nuno LIMA, João MARNOTO, Portugal

Key words: UAV, mapping, coordinates, quality control, monitoring, breakwater

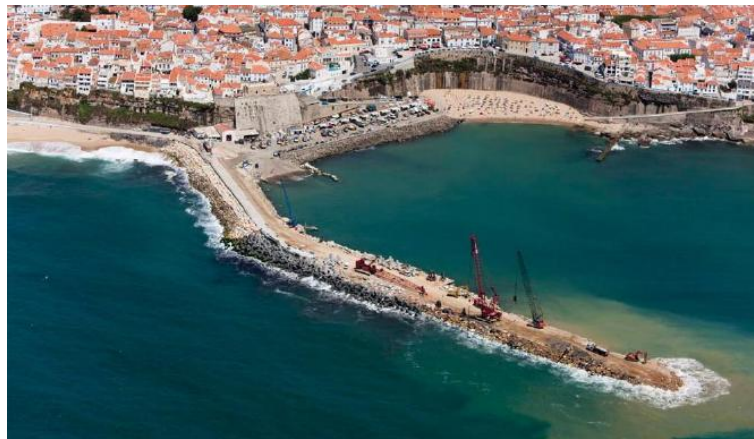
Figure 1 – Reconstruction of the breakwater of the port of Ericeira.

The port of Ericeira is mostly used by the local fisherman community. The advanced deterioration of the original protection of the quay (built on the 1970's) was a consequence of the effect of the highly energetic north-westerly Atlantic Ocean waves on a underdimensioned breakwater. A comprehensive study made by the National Laboratory for Civil Engineering (LNEC) in the 2000's focused on the analysis of the status of pier under the perspective of its reconstruction and development of the port. The first stage of rehabilitation is already completed (Figures 1 and 2) and focused on rebuilding the breakwater and constructing new areas and buildings to support fishing activity.

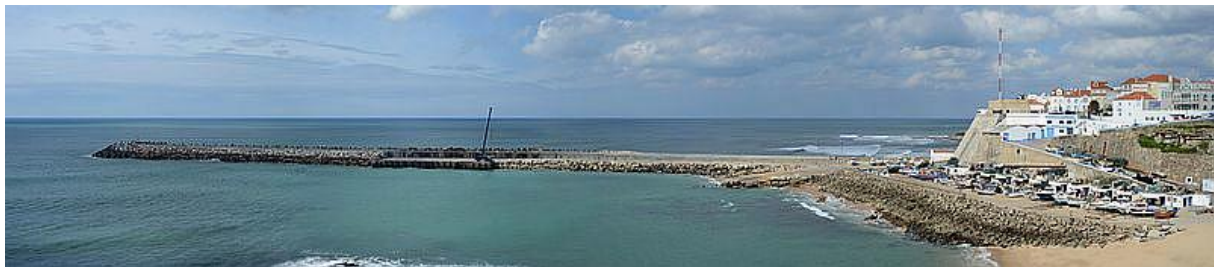
Figure 2 – Breakwater of the port of Ericeira after the rehabilitation.

The new rubble mound breakwater (RMB), longer and much stronger, has created a wider area of waters sufficiently calm to allow safe operations of berthing, cargo transfer, vessels manoeuvre and the protection of port infrastructures. The breakwater is 440 m long and 35 m wide. It consists of two straight lengths, angled of 147° to each other. The crest is 6.5 m wide and has an altitude of 9 m (referred to the hydrographic zero). The main elements of this breakwater are a core of finer material covered by big blocks (armor layer). Beneath the armor layer it was placed a filter layer, called underlayer, to prevent the finer material of being washed out through the armor layer.

Along the entire crest and on half of the leeside are two superstructures in concrete, being that the lowest one includes a quay. The most exposed slope of the breakwater (facing the northwesterly waves) is covered with tetrapods; the southwest extremity, which has on the top a small lighthouse, is covered with grooved cubes; the remaining areas are covered with large stones.

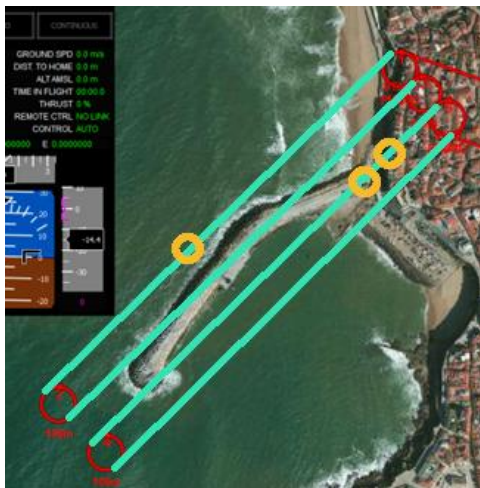
Figure 4 – Flight path over Ericeira breakwater.

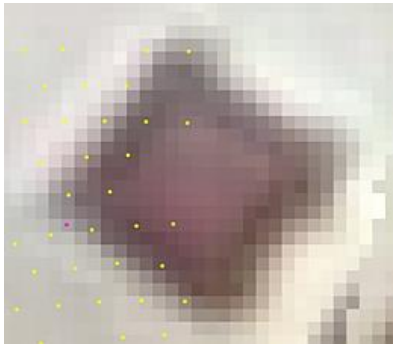
Figure 8 – Manhole as seen on a photo. On the left side yellow points of the point cloud.

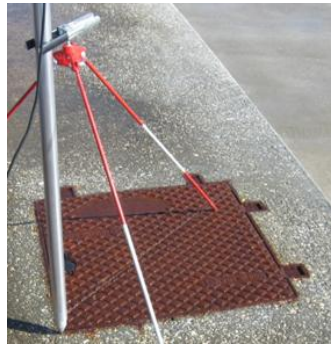
Figure 9 – Southwest corner of a manhole being coordinated.

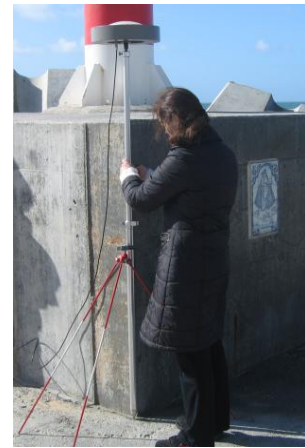
Figure 10 – Coordinating a point near the lighthouse.
