Anomalies detection in adhesive wall tiling systems by infrared thermography

Tomás Lourenço^a, Luís Matias^b, Paulina Faria^{c,*}

^a Dep. Civil Engineering, Universidade NOVA de Lisboa, 2829-516 Caparica, Portugal

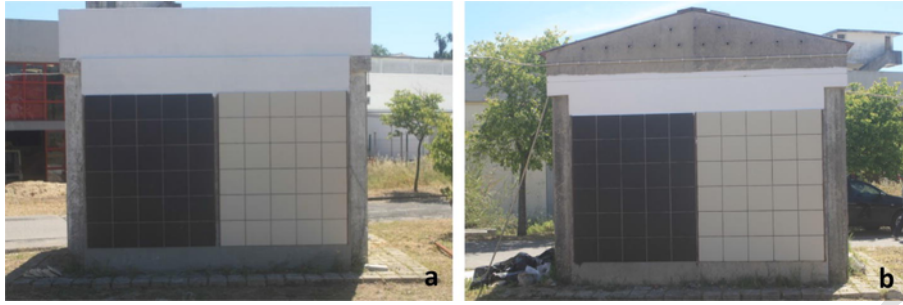
Fig. 1. Experimental cell 1 (a) and experimental cell 2 (b).

Four tiled panels were applied on two West facing facades (Fig. 1) of two experimental cells situated in National Laboratory for Civil Engineering (LNEC) Campus, Lisbon, Portugal. Panels have differ-

ences in terms of the tiles' colour and kind of support. Cell 1 tiled panels were applied as finishing coating of ETICS (External Thermal Insulating Composite System). Therefore, a thermal insulation is beneath the tiling system. Cell 2 tiled panels were applied on a traditional solution of a brick masonry cementitious regularization render. Each cell had then two panels, one with black tiles (on the left) and one with white tiles (on the right).

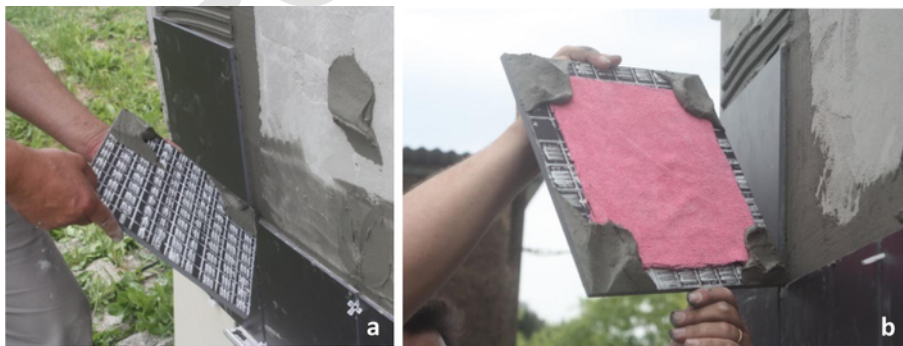
Fig. 2. Simulation of the anomalies of detachment (a) and placement of the water absorptive cloth beneath a tile (b).

Purposely within each panel there are tiles with provoked detachments. The detachments were simulated by leaving an empty space approximately between 2 and 3 mm beneath the tile where the adhesive grout was not applied (Fig. 2a). Each panel had also one tile on its top (Fig. 2b) where a piece of cloth was placed in the detached area aiming to help in further moisture testing by trapping the injected water and preventing runoffs. In order to prevent infiltrations before the moisture testing, a polyurethane sealant was used to seal the panel's edges.

Fig. 2 shows the anomalies' simulation (detached tiles and detached tiles with a cloth beneath).

For moisture detection the water was introduced beneath the two top detached tiles of each panel by a syringe inserted through the panels' edges sealant. The volume of water injected was decided by estimating the volume of the empty space beneath the detached tiles and early evaporation or absorption by the support could not be controlled.

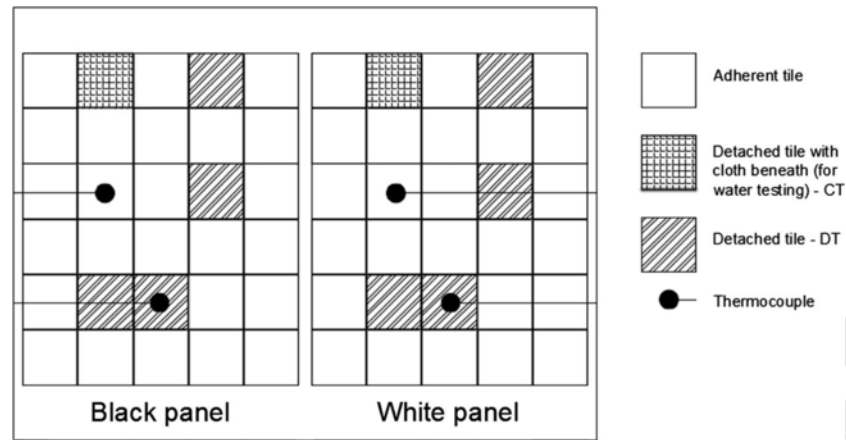
Fig. 3. Schematic representation of the panels with the detached anomalies and instrumentation.

The positioning of the detached tiles within each panel is the same for all the four panels according to the scheme on Fig. 3. On the same figure, it is possible to see the positioning of thermocouples type T - Copper/Constantan - that were placed beneath the tiles, in the adhesive layer, in order to allow continuously reading of temperatures and, therefore, reinforce the thermographic data. Those results were presented elsewhere [31].

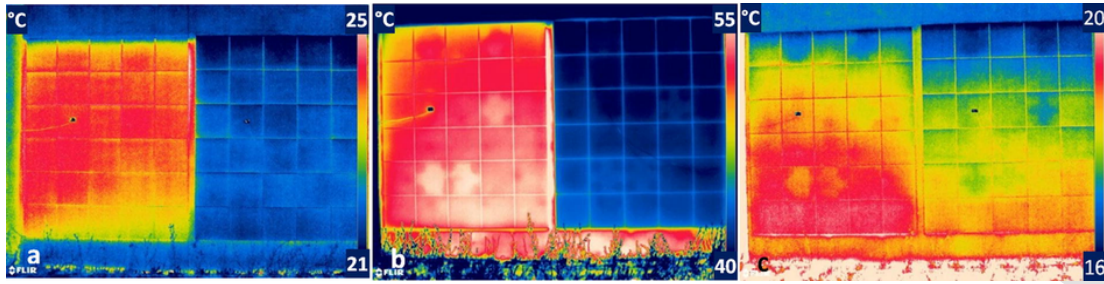
Fig. 4. C1 (ETICS) at 9:30 am (a); 3:30 pm (b) and 10:15 pm (c).

As a first result of this survey, Figs. 4 and 5 show two sequences of thermograms where the thermal variations during the same day are presented for each experimental studied cell. Therefore, on Fig. 4 there are three general thermograms: the first in the morning - before solar incidence (air temperature: 24 °C); the second after one hour of solar incidence (air temperature: 30 °C) and the third at night - cooldown period (air temperature: 21 °C) of the experimental cell 1. In each case the black panel (C1_B) is on the left and the white panel (C1_W) is on the right. Similarly, Fig. 5 contains three thermograms, each with a black panel (C2_B) on the left and a white panel on the right (C2_W). In the thermograms, black panels appear in reddish colours due to the higher emitted temperature when compared with the white panels (represented in bluish colours). The temperature scale had to be adopted to each thermogram containing both black and white panels (with major thermal differences between them), which compromises the visibility of smaller thermal differences such

as the ones that suggest anomalies. As mentioned, for analysis purposes two thermograms per panel were taken from closer distances allowing a narrower scale adoption and, therefore, facilitating the anomalous spots visualization. It is of note that thermograms from Fig. 4 and 5 are not in the same thermal scale.

In a first analysis, it is easy to identify the effect of moisture beneath tiles in these two thermograms. Comparing the results obtained with the “dry results” (Figs. 4 and 5) the main conclusion is that water lowers the cladding’s temperature resulting, for example, in a cooler area (bluish area in the thermogram), such as the one identified as “clearly humid area” in Fig. 4. In some cases, especially when there is a cloth beneath the detached tile, the water lowers the tile’s temperature hindering the differential expected.

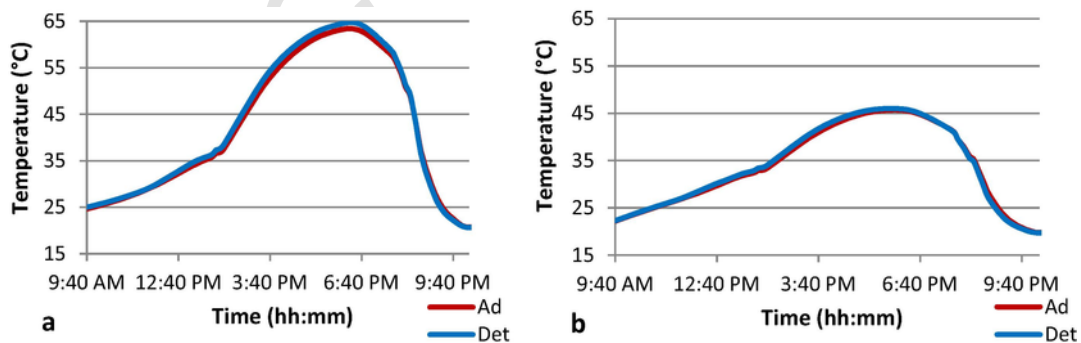
Fig. 6. Evolution of adherent (Ad) and detached (Det) tile's average temperatures in cell 1's black panel (a) and white panel (b).

Analysing both the thermograms and the graphics that describe the evolutions of the temperatures obtained for the detached (Det) and adherent (Ad) tiles it is possible to take some similar conclusions regarding the cladding's behaviour.

Comparing the results, it is notable that the curves are similar for all the tiles on the same panel. During the morning temperatures rise because of the incidence of diffuse radiation and the increasing ambient temperature; proximately at 2 pm, the curves' slope rises as thermal radiation from the sun starts reaching the wall. Furthermore, the difference between detached and adherent tiles' temperatures also starts being clearer at this period. Temperatures reach their maximum value between 5 pm and 6 pm and then start decreasing on the account of the decrease in the ambient temperature and also a decrease in the incident radiation. When sun sets, despite the irradiated energy remaining the same and the sun being more perpendicular to the wall, the distance that radiation has to overcome through atmosphere is much higher; and so, as atmosphere also absorbs a part of radiation, its intensity will be much lower at the end of the afternoon. Thus, when temperatures start dropping, especially after 7:45 pm (when the walls start getting shaded), the detached tiles drop below the adherent

tiles' temperature. The thermal differential between detached and adherent tiles starts to fade at around 9 pm (after around 1h15 without solar incidence).

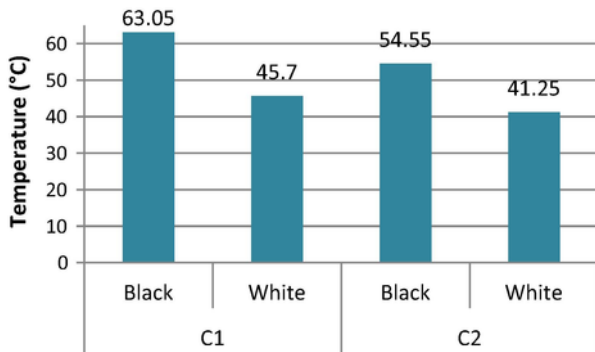
Fig. 8. Maximum average temperatures obtained in all panels' adherent tiles.

Observing Fig. 8 it is possible to compare adherent tiles' maximum temperatures verified during the survey.

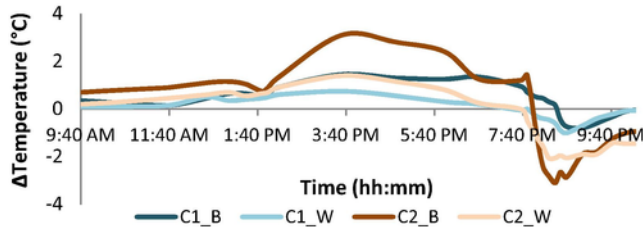
Fig. 9. Thermal differentials between detached and adherent tiles.

- In the morning there is no great difference between anomalous and normal tiles.
- After 2 pm the differential starts rising until it reaches its peak at around 3:30 pm (after 1h30 of solar incidence).
- The differential drops slowly until 7:30 pm
- With the panels' cooldown, the differential changes from a positive value (detachments' temperatures higher) to a negative value (detachments' temperatures lower).
- While temperature drops and the sun sets the differential also drops reaching its minimum at around 8:30 pm.
- After reaching the minimum the differential fades, making it more difficult to visualize the anomalies.

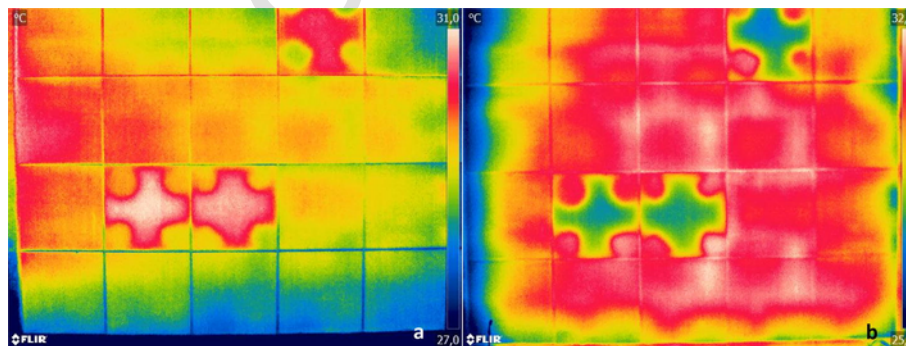
Fig. 10. Thermograms from the bottom half of cell 2's black panel taken during the day (a) and at night (b).

Fig. 10 presents two thermograms taken to the bottom half of the black panel from cell 2 (C2_B) taken during the day (maximum differential - 3:30 pm) and at night (minimum differential - 10:15 pm).

In these thermograms, taken from a closer distance to the panels, it is possible to verify that, as shown before on the quantitative analysis, the thermal differential is positive during the heating phase (day) and negative after some time of cooldown (night); ie in the first thermogram it is possible to see higher temperatures in the detached tiles (reddish/whitish coloured in the thermogram) and in the second the opposite, as detached tiles are colder (blueish).

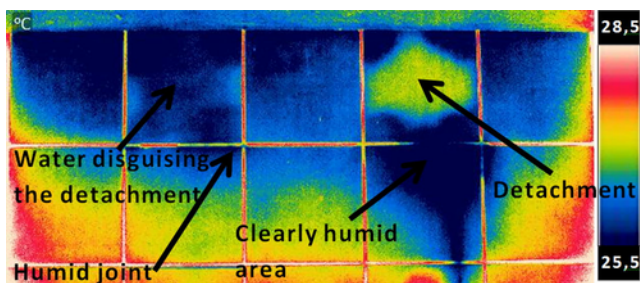
- Simply detached tiles in general presented a wide humid area after the injection, sometimes partially disguising the detachments (only partially because the water was only present in the bottom half of the tile: Fig. 12).

Fig. 12. Thermogram taken from C2_W at 12 pm – The classification of the anomalous tiles is presented in Table 1, where CT (second from the left) is classified with a 4 and DT (fourth from the left) with a 6.

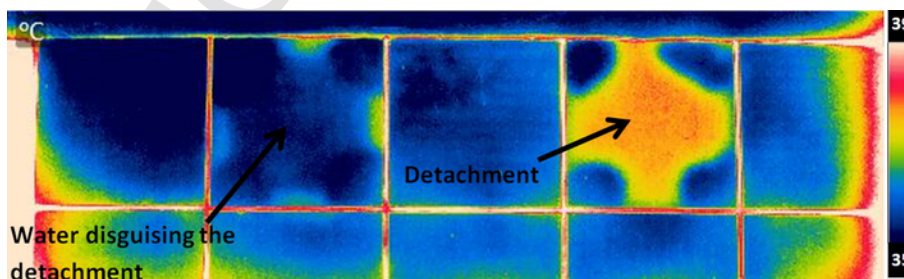
- With the heating of the panels during the day it was possible to verify a diminution of the wide humid area, with the humidity being presented only in the joints and its surroundings. The reason for the fading of this humid area with the passage of time was attributed to the evaporation of water that got out through the only water vapour permeable component, the grouted joints. The limited presence of this component might have hampered the reduction of water content within the cladding by evaporation, creating a time lag between the heat gain and loss of moisture in these areas.

Fig. 13. Thermogram taken from C2_W at 3 pm – The classification of the anomalous tiles is presented in Table 1, where CT (second from the left) is classified with a 4&5 and DT (fourth from the left) with a 3.
