## SAFETY CONTROL OF RIBEIRADIO DAM SINCE THE FIRST FILLING OF THE RESERVOIR

**Keywords: Ribeiradio, Concrete Dam, Reservoir, First Filling, Safety, Behaviour**

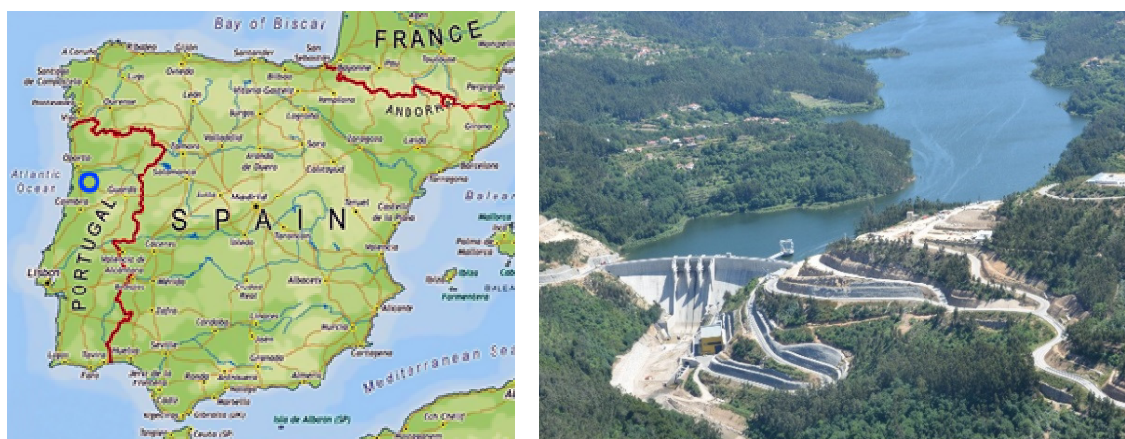
Figure 1: Location and general view of Ribeiradio hydropower project

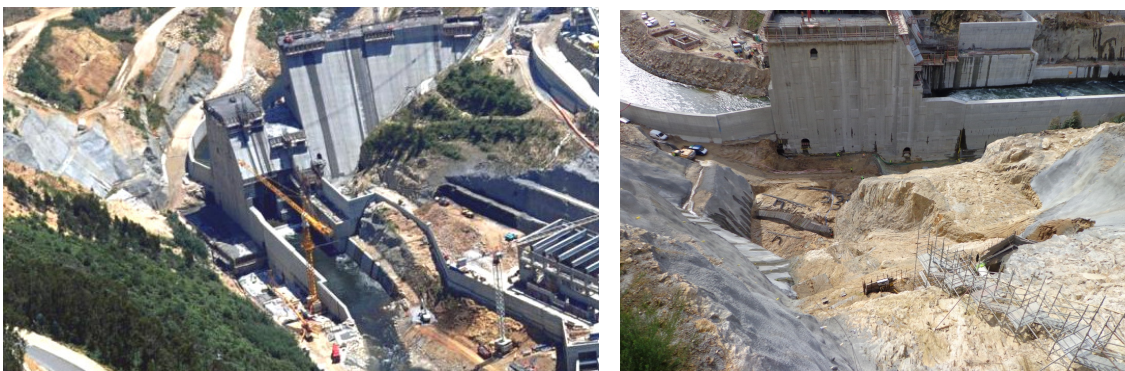
Figure 4: View of the site works and excavations on right bank in 2013

During the excavation works in Ribeiradio, a fault with geotechnical significance importance was identified on the right bank, which crosses the dam foundation surface along 4 blocks. This situation, unforeseen during tender design phase, required an unorthodox engineering solution considering fundamentally a deeper excavation exclusively on the upstream zone of the foundation (Figure 4). By maintaining the geometry of the downstream area intact, it was possible to significantly reduce the quantity of excavation and, consequently, of concrete. The dam geometry was then adapted to solve the strength and deformability constraints revealed by the rock mass. A major fault was also identified in the river bed that affected three other dam blocks.

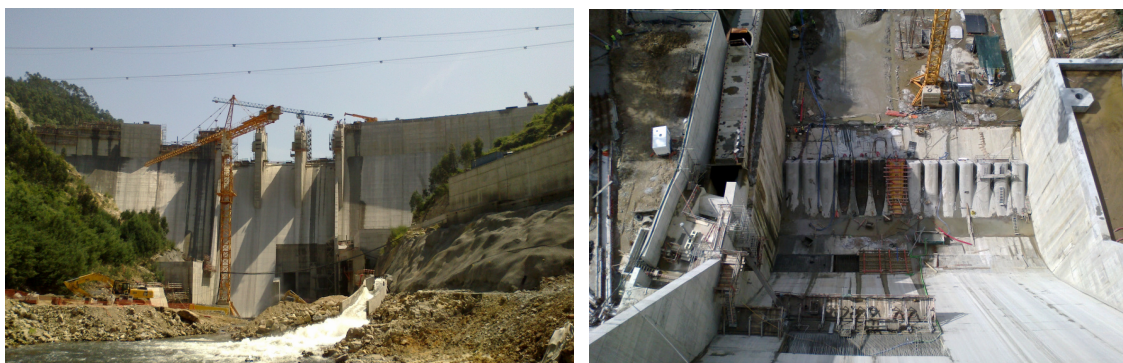
Figure 5: View of the dam site works and roller-bucket construction in 2014

When the results of the geological survey were introduced in the physical model, discharge carried out by LNEC [4], on the form of loose blocks simulating the rock mass discontinuities, the erosion pattern resulting from the jet impact proved to be deep and wide, putting the stability of the valley sides in risk. Physical model tests also showed considerable turbulence downstream, as expected. Since the physical model results were available, it was decided to replace the ski jump by a submerged roller bucket with a slotted lip (Figure 5), although the head and flow concentration were both outside the usual current practiced. As the high flow velocity over the toothed weir of the roller bucket (30 m/s) increases the risk of cavitation and erosion, the teeth edges were rounded and several different configurations were tried in order to select optimum width and spacing distances.

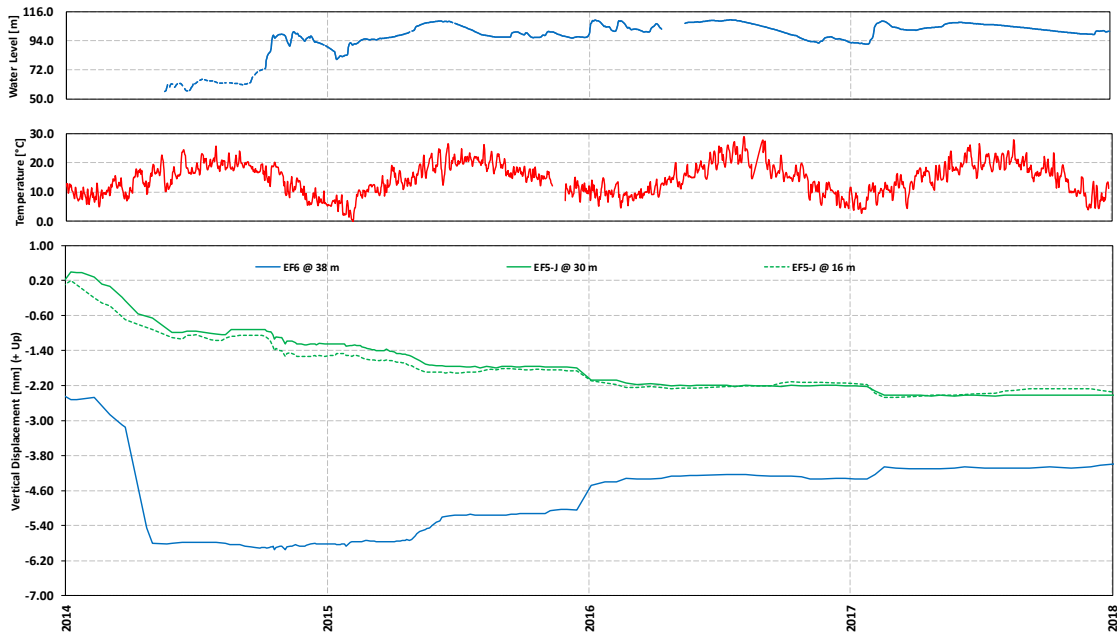
The displacements evolution observed in the rod extensometers was coherent with the variation of the main loads. The water level increase in the reservoir implied, as expected, an increment in the downstream settlement and upward displacement on the upstream zone. The upstream and downstream displacements observed in the central block (block 8) of the dam are shown in Figure 10. In spite of the limited magnitude of

the observed displacements, sudden rises of the water level in 2016 and 2017 have produced minor displacements that have been observed.

Figure 10: Vertical displacements in the foundation. Upstream and downstream displacements.

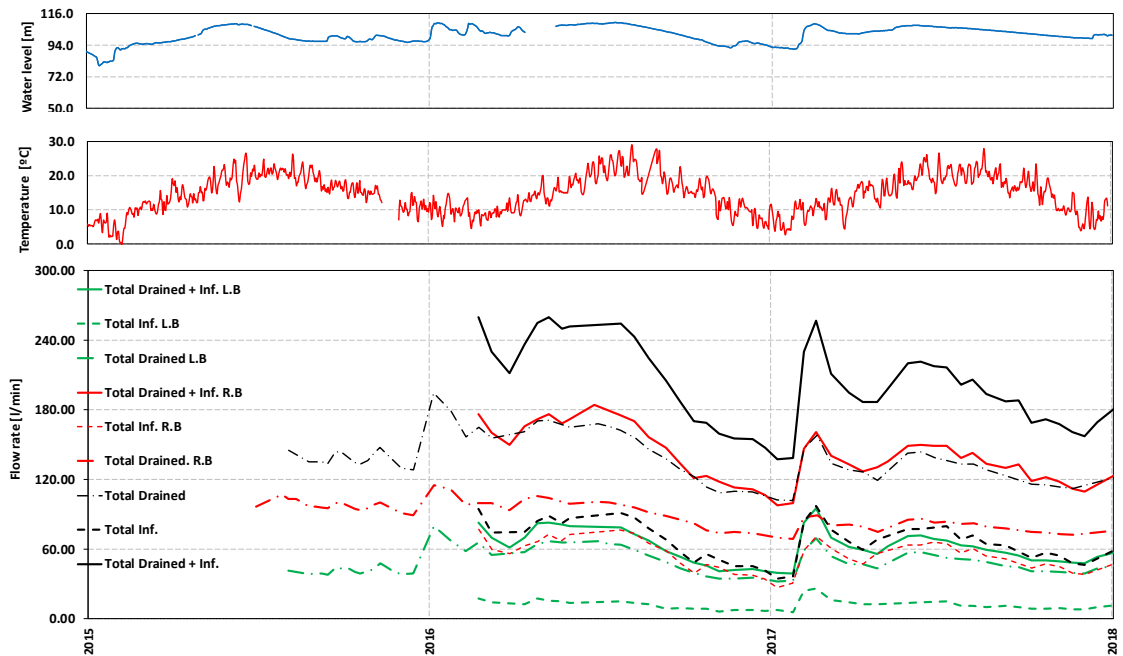
Figure 11 presents infiltrated and drained flow rates. As expected, considering geotechnical data, drained flow rates on the right bank are larger than on the left bank, nevertheless flow rates are within the usual values for this type of dam and foundation properties. Sudden water level rises have induced significant increases in the observed flow rates.

Figure 11: Flows seepage rates throughout Ribeiradio dam foundation

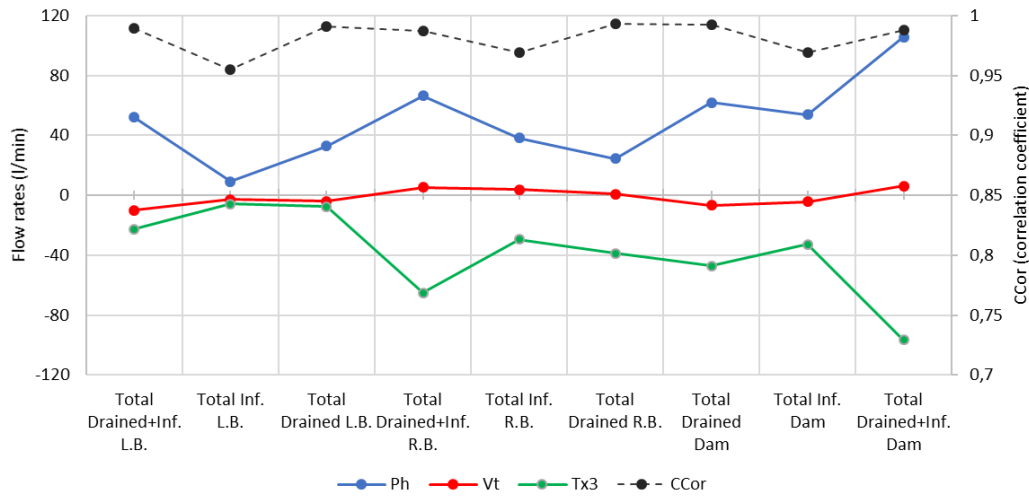
A slight tendency towards lower flow rates over time has been observed. Results from the separation effects analysis, presented in Figure 12, confirms this interpretation. The reduction of flow rates is greater in the right bank.

Figure 12: Results of the separation analysis model effects for total drained and infiltrated flows rates on dam foundation

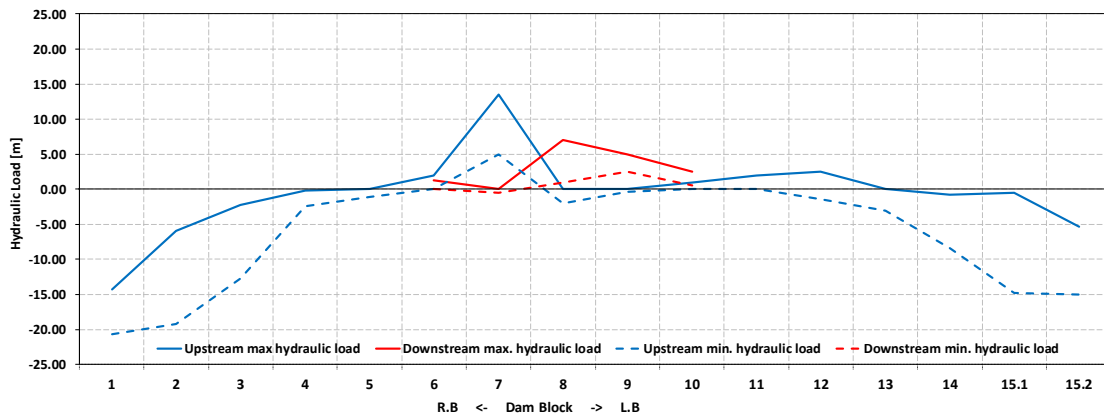
In general the uplift pressures are small, corresponding to percentages of hydraulic load always lower than 20% in all the piezometers. Figure 13 presents maximum and minimum water levels in piezometers of each block. Maximum uplift pressures have been observed in central blocks 7 (upstream) and 8 (downstream).

Figure 13: Uplift pressures throughout Ribeiradio dam foundation.
