Masonry walls of buildings with reinforced concrete structure - Detection of cracking due to the effect of temperature variations through NDT techniques

José Miranda Dias

Laboratório Nacional de Engenharia Civil, Lisboa, Portugal; mirandadias@lnec.pt

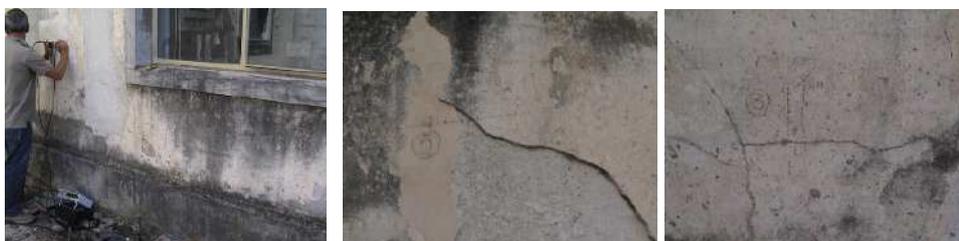
Figure 2 - Use of ultrasound testing (indirect measurements) for the detection and evaluation of anomalies occurring in a building façade [6]

Previous study [6], where US was used in the analysis of anomalies of the facade of a heritage building showed that, with the indirect measurement, it was possible the detection of cracking and local detachment of the facade renders (Figure 2).

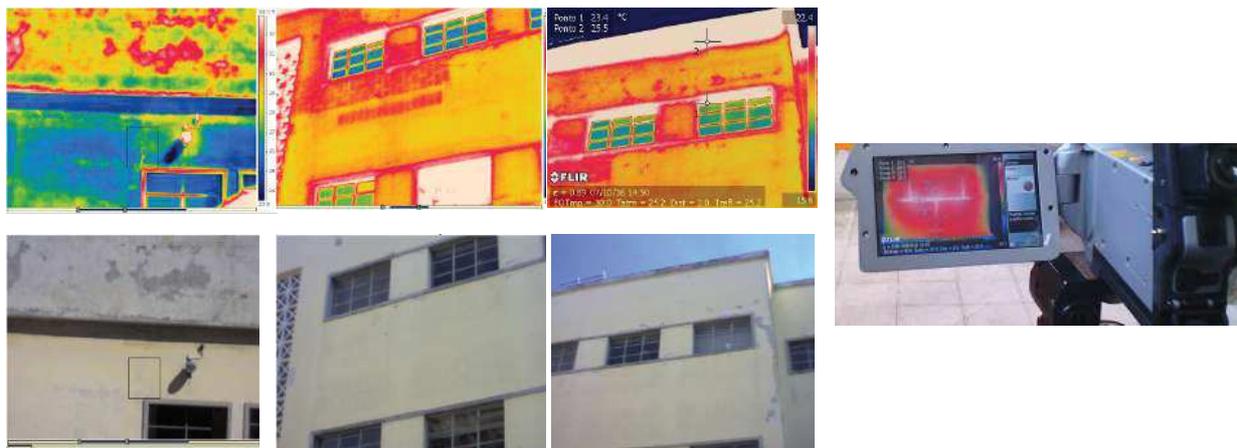
a) Facade showing rendering crack that can probably be associated, in part, to temperature variations

b) Facade showing structural concrete elements (in particular the column of East corner zone of the façade - in the photo at right), and also signs of cracking that can be attributable, in part, to the effect of temperature variations

c) Example of use of IRT to highlight the presence mortar joints in a masonry specimen

Figure 3 - Use of infrared thermography for the detection and evaluation of anomalies related to cracking [6]

IRT (active and passive methods) can, possibly be used to the search cracks due to thermal effects, because they probably can introduce a change of thermal properties that alters heat transfer. For instance, a different temperature pattern might appear or not at the surface depending on the thermal properties of the materials or air presence; this feature could be, particularly, interesting to analyse masonry mortar joints, with possible cracking (Figure 3c), but also the current zone of rendering.

IRT was used, in a previous study [6], for detection of cracking and local detachment in the wall renders and in concrete elements, and detection of transition zone between concrete elements and masonry walls. Using solar radiation for imposing a heat flux (passive method), IRT detected cracks in facade (Figure 3a), difficult to spot when seen at ground level. In other facade, the structural concrete elements could be visible with IRT, and the zone of interaction of the vertical concrete element and the masonry wall (Figure 3b). The area under the window on the left side is more noticeable (warmer) probably due to the presence of a heater inside the room (Figure 3b). The white area between the windows identifies detachments of coatings.

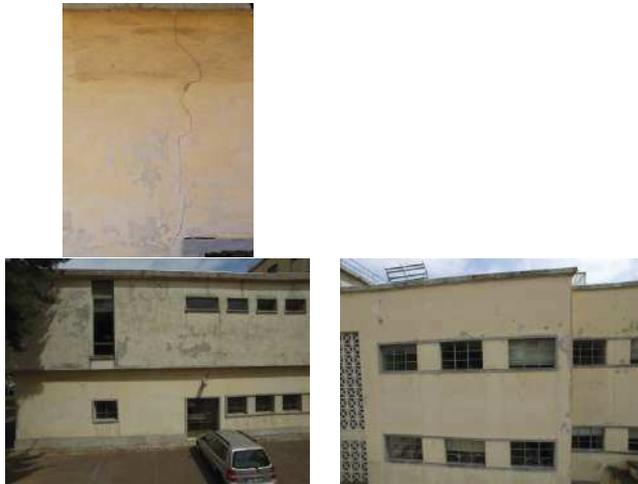
Figure 4 - Photos taken by the drone of building facades with signs of cracking that can probably associated, in part, to temperature variations [6]

Photogrammetry was used to get orthomosaics of facade of a building and a point cloud of the set [6]. There were made a terrestrial survey in the facades of a building and an independent aerial

survey, with a drone DJI Inspire 1V2 (Figure 4). It was applied image processing techniques in the analysis of anomalies, for detection of the cracking and detachment in the wall renders, and the cracks and repair zones in concrete elements.
