## Semi-automatic Mobile System for Detecting Defects in Landfill Liners: Tests in a Pilot Plant at LNEC

*Laboratório Nacional de Engenharia Civil, I.P., Lisbon, Portugal*

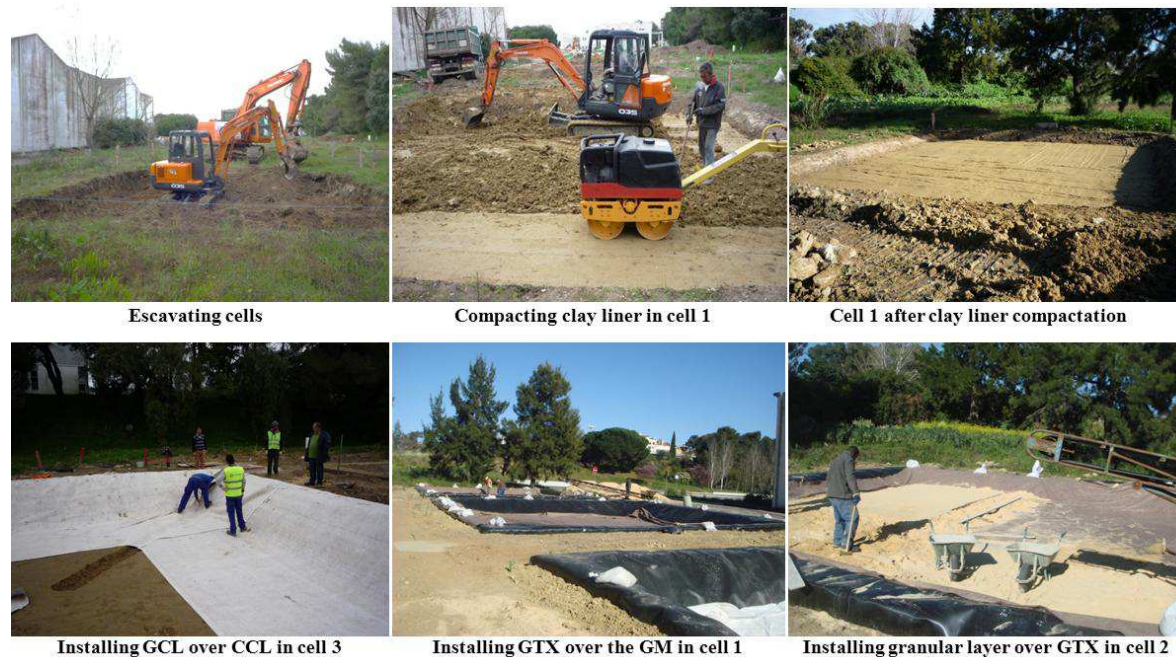
A large scale pilot plant was constructed at LNEC campus in order to study the suitability of the prototype to detect and locate defects in different types of lining systems. The pilot plant consists of three cells of approximately 10m×10m×1m. Figure 2 presents an overview of cells construction.

Figure 2. Pilot plant construction

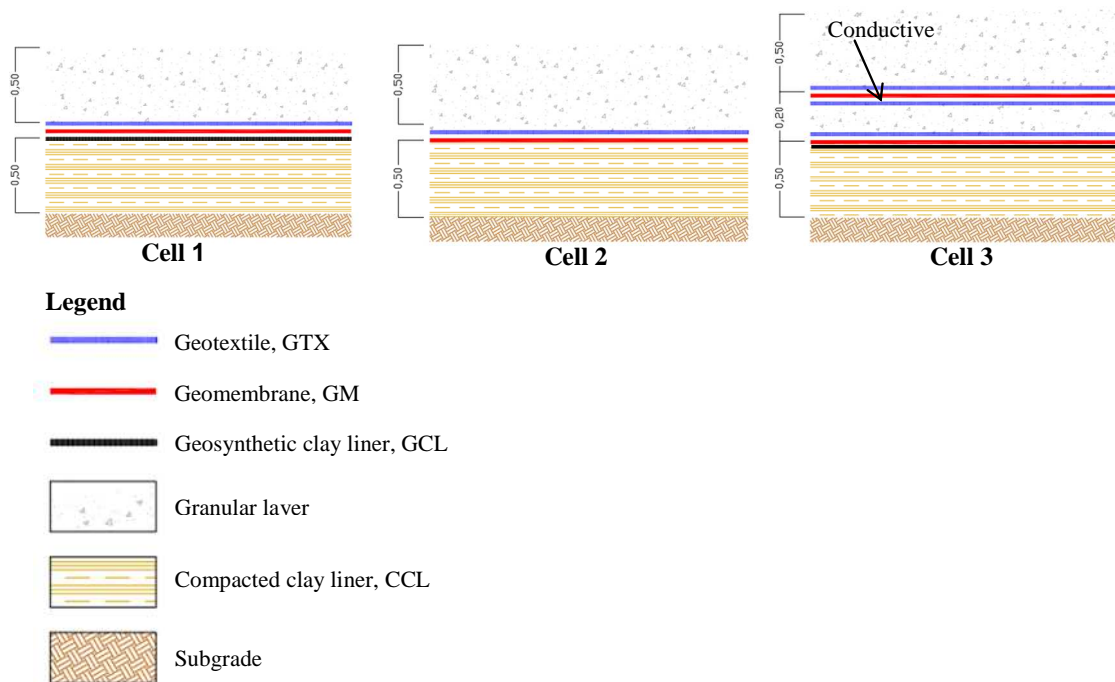
The cells comprise the following layers, from bottom to top (Figure 4):

- 0.5 m thick layer of compacted clayey soil (CCL) as part of the passive barrier;
- GCL as part of passive barrier ( $5000\text{g}\cdot\text{m}^{-2}$ );
- GM as active barrier (HDPE, 2 mm tick);
- GTX to protect the GM against puncturing (polypropylene,  $300\text{g}\cdot\text{m}^{-2}$ );
- 0.2 m thick layer of sand (0.18/2.0 mm), to simulate the PLCS.

- 0.5 m thick layer of compacted clayey soil (CCL) as passive barrier;
- GM as active barrier (HDPE, 2 mm tick);
- GTX to protect the GM against puncturing (polypropylene, 300g.m<sup>-2</sup>);
- 0.2 m thick layer of sand (0.18/2.0 mm), to simulate the PLCS.

- 0.5 m thick layer of compacted clayey soil (CCL) as part of the secondary lining system;
- GCL as part of the secondary lining system (5000g.m<sup>-2</sup>)
- Geomembrane (secondary) as part of the secondary lining system (smooth, HDPE, 2 mm thick);
- Geotextile to protect the GM against puncturing (300g.m<sup>-2</sup>, white);
- 0.15 m thick layer of sand (0.18/2.0 mm), to simulate the SLCS
- Conductive geotextile to facilitate the detection of defects (polypropylene with black carbon impregnation, electrical resistance  $\leq 10^5 \Omega$ , 200g.m<sup>-2</sup>);
- Geomembrane (primary) as part of the primary lining system (HDPE, 2 mm tick);
- Geotextile to protect the GM against puncturing (polypropylene, 300g.m<sup>-2</sup>);
- 0.2 m thick layer of sand (0.18/2.0 mm), to simulate the PLCS.

Figure 4. Scheme of the lining systems used in cells 1 to 3 (based on Dores *et al.*, 2012)

Pilot plant was designed taking into account the lining systems typically used in different landfills in Portugal. Accordingly, cell 1 represents a lining system similar to the ones that have been used in large MSW landfills. Cell 2 simulates a lining system used in small landfills and cell 3 a lining system of a hazardous landfill. Details about cells design can be found in Dores *et al.* (2012).

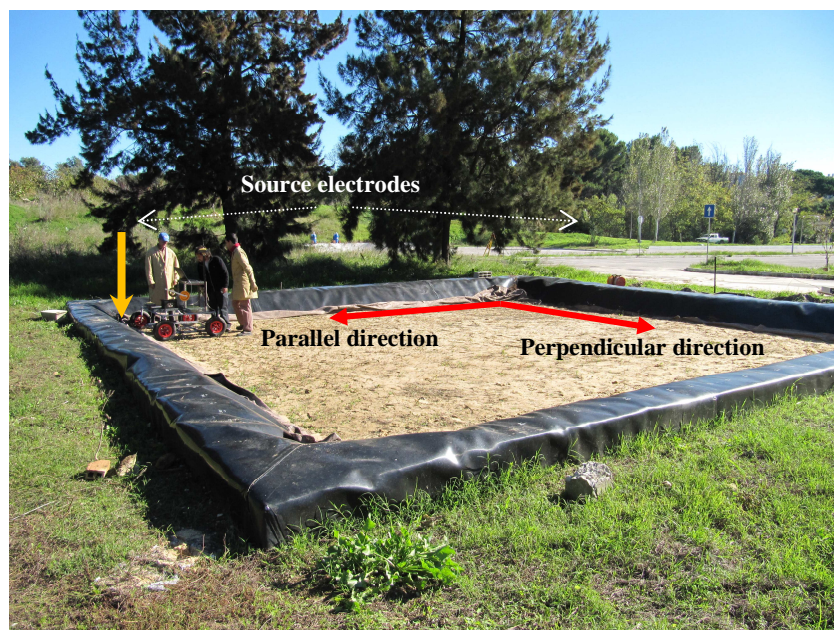
In the pilot plant, point-by-point measurements were performed using a 0.3 m dipole configuration (dipole = two electrodes) with automated digital data acquisition. Measurements were conducted along survey lines both parallel and perpendicularly to the source electrodes (Figure 6).

Figure 6. Electrical potential measurements with the prototype

It should be noted that the defects, consisting of a circular hole, 2 mm in diameter, were deliberately made in GM liners. In cell 3 the hole was made in upper GM (primary lining system).

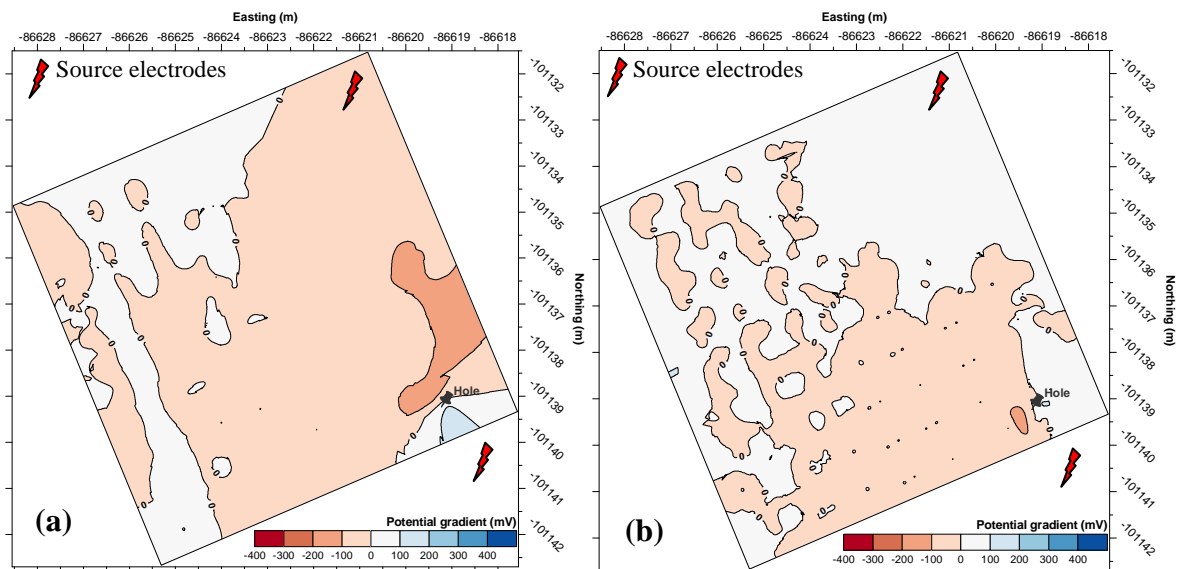
Figure 7 shows the electrical potential field obtained with measurements performed with the potential electrodes installed parallel and perpendicular to the source electrodes at cell 2. As it can be seen, the electrical potential field is quite constant, in the range -100 to +100 mV, except near the defect. In this area, a high gradient in the electrical potential field was found (between -200 and +200 mV). Although both measurements (parallel and perpendicular directions) show a gradient near the defect, the most significant was obtained in the direction parallel to the source electrodes.

Figure 7. Electrical potential field: (a) measurements parallel to the source electrodes; (b) measurements perpendicular to the source electrodes

Similar results were obtained at cell 1. They are not included in this paper for the sake of brevity. Tests on cell 3 are still in progress and will be presented in a near future. Nevertheless, results obtained until now for cells 1 and 2 suggest that the prototype is able to detect and locate the defects in different types of lining systems.
