# PORTUGUESE MULTIMUNICIPAL LANDFILLS: DESIGN AND CONSTRUCTION

Barroso, Madalena C. P. & Lopes, M<sup>a</sup>. da Graça D. A.

*Laboratório Nacional de Engenharia Civil (LNEC)  
Av. do Brasil, 101 PT-1700 - 066 Lisboa, Portugal*

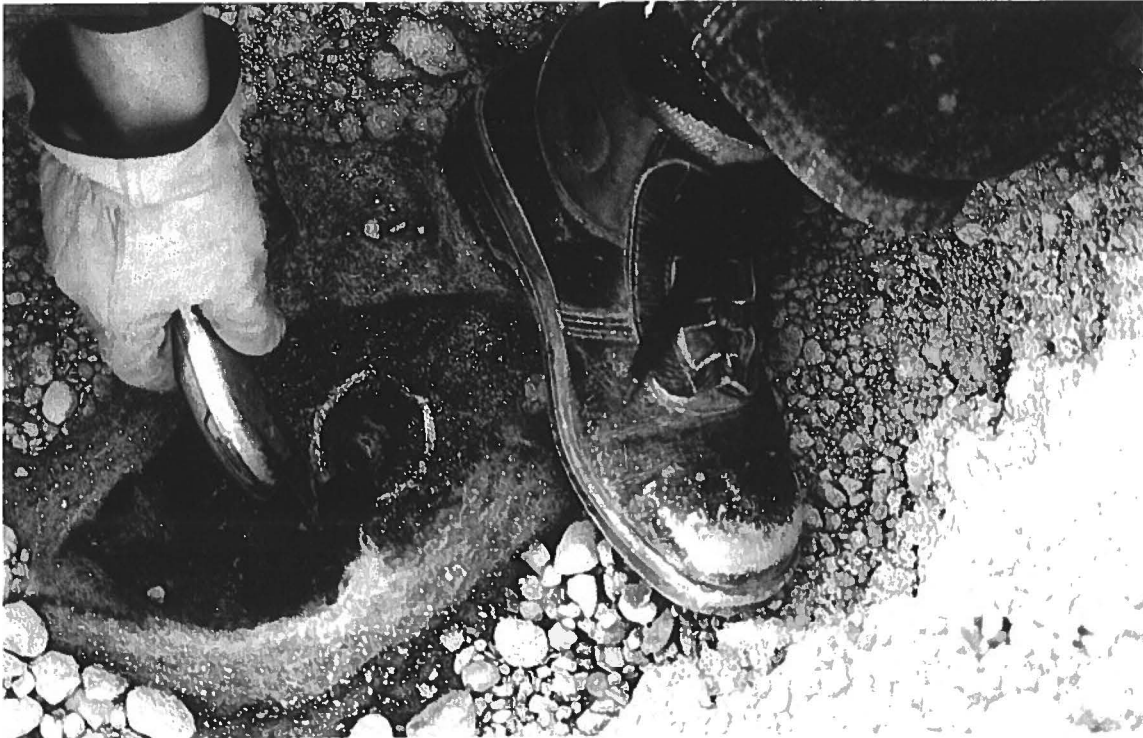
In one of the sanitary landfills where a geomembrane leakage detection system was installed, a peculiar problem has been observed. For general surprise, more than half detected damages were due to the seagulls. They transport on the beak and feet objects, namely small bones that remained on the geomembrane producing holes (Figure 2).

Figure 2. Example of geomembrane damage caused by the seagulls

The above mentioned system was useful on the one hand because it emphasised the importance of carrying out thorough visual inspections before installing the geomembrane protective layer. On the other hand, it made it possible to detect small imperceptible tears (for instance made with a cutter on a patch execution) that can turn the geomembrane liner inoperative.

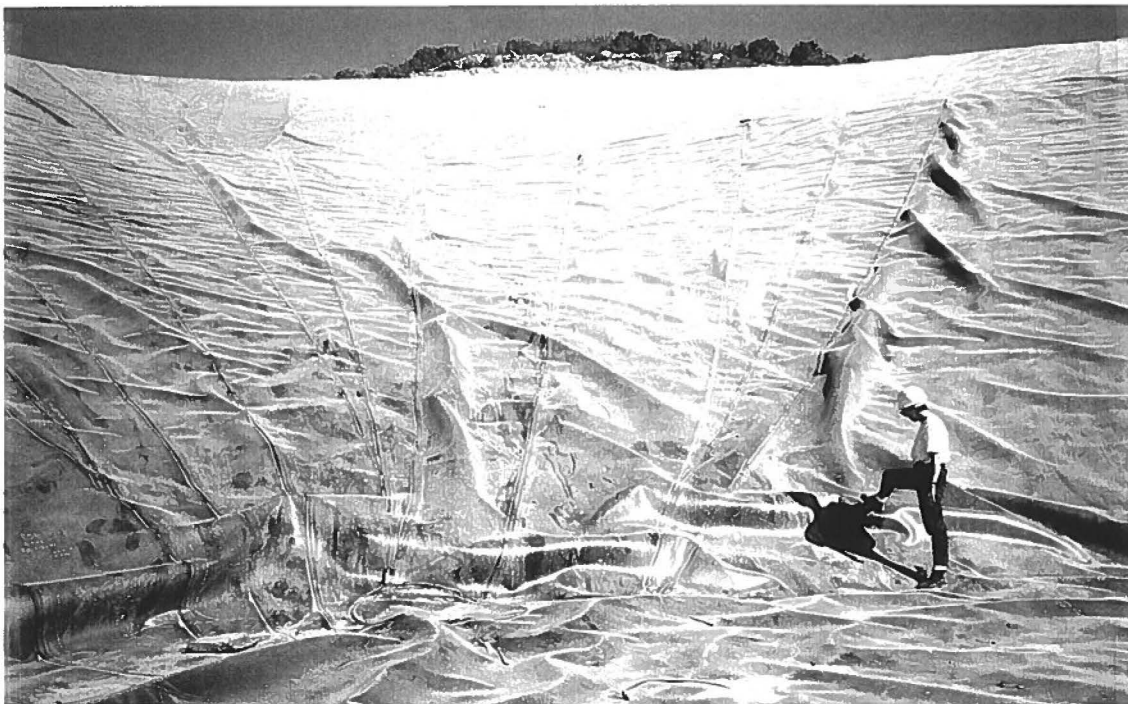
A significant problem arose due to slipping of the geomembranes on the side slopes. In spite of a proper anchor trench design, geomembranes slipped down forming big waves on the slope bottom. These waves were visually identical to the ones caused by thermal expansion of the geomembranes (Figure 3), but they did not disappear when the temperature dropped, because they resulted from inadequate anchor trench weight.

Figure 3. Example of geomembrane waves
