The Contribution of Drones to the Monitoring of Rubble-Mound Breakwaters

Abstract: Breakwaters are built to promote sheltered areas, for people, ships, and harbour activities. In the design of rubble-mound breakwaters, a common type of breakwater in many countries, including Portugal, it is assumed that damage may occur in certain stretches of the structures, and therefore maintenance and repair works will be quite certainly needed. To successfully carry out these interventions, in a timely and cost-effective manner, the structures must be observed and monitored systematically. This enables one to follow their structural behaviour and, through diagnosis analysis, to specify the most suitable timespan to undertake any necessary intervention. The severity of the sea on the Portuguese coasts justified the establishment, by the National Laboratory for Civil Engineering (LNEC), of a program of Systematic Observation of Maritime Works (OSOM) which, in 2018, was improved with the introduction of drones to monitor the structural present condition, evolution condition and risk condition of the structures, namely movements and falls of blocks in the armour layers. This communication present

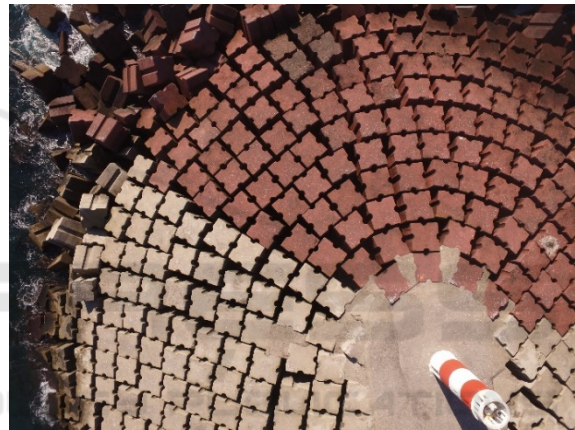
Figure 5: The head of Sines west breakwater.

The three ports managed by APS – Sines, Faro and Portimão – have several breakwaters, all rubble-mound breakwaters (Figure 5 and Figure 6, photos taken by one of LNEC's drones). Sines has a total of six breakwaters (one of these, the less exposed, is not monitored); Faro-Olhão inlet and Portimão harbour have two breakwaters each. All the breakwaters of Sines were constructed to protect several infrastructures that exist in the area: five

These rubble-mound breakwaters consist of a core of finer material covered by large blocks forming the so-called armour layer. The blocks are of rock being that in areas more exposed the armour layer blocks are made in concrete in several shapes (tetrapod, Antifer, or parallelepiped). The superstructures of the breakwaters are also made in concrete. Some breakwaters have public access, while others are in (very) restricted non-public access areas.

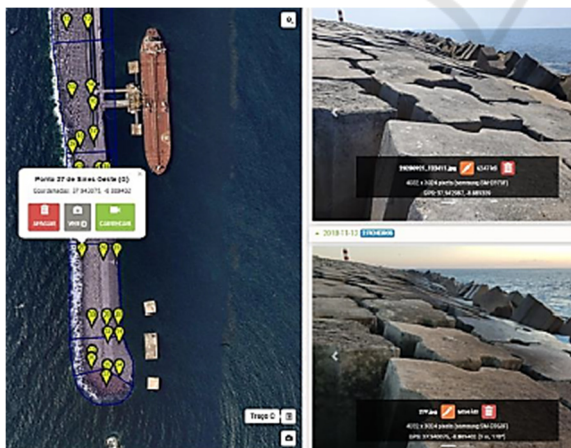
Figure 7: Interface ANOSOM-WEB – Breakwater Sines west.

More recently, ANOSOM-WEB interface app was developed, a web mapping platform accessible by any device (smartphone, tablet, or PC) equipped with web connection. During visual observation campaigns, this app allows the observer to carry out, on a mobile device, various operations such as, as examples, consultation of information from previous campaigns (Figure 7) and accessing, *in situ*, the current, evolution and risk conditions of the structure, and whether the structure needs immediate repair or maintenance works.

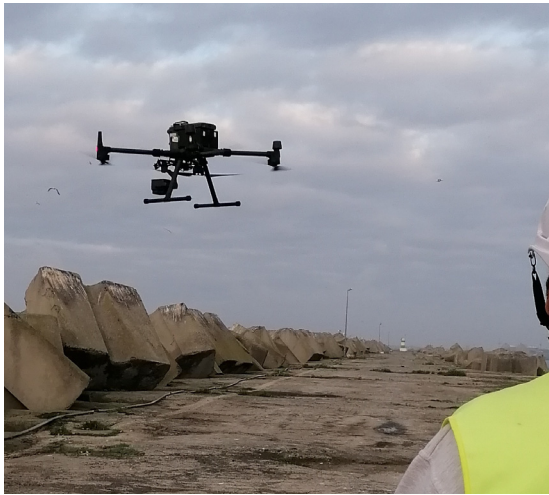
Figure 8: DJI Matrice 300 RTK drone while taking off Sines east breakwater.

The first surveys with the drone (2017), used a DJI Inspire V1 and a camera Zenmuse X3; since June 2022, it has been used a DJI Matrice 300 RTK and a camera Zenmuse H20 (Figure 8 and Figure 9). Due to the use of this drone with RTK, the security of the landing was improved, especially with mild to strong winds (up to 54 km/h). Both cameras have sensors CMOS, the first one with 12.4 MP, the second with 20 MP. At an altitude of 100 m, a pixel in a photograph taken by the X3 covers about 5 cm², with the H20 3.4 cm². H20 camera has zoom capabilities.

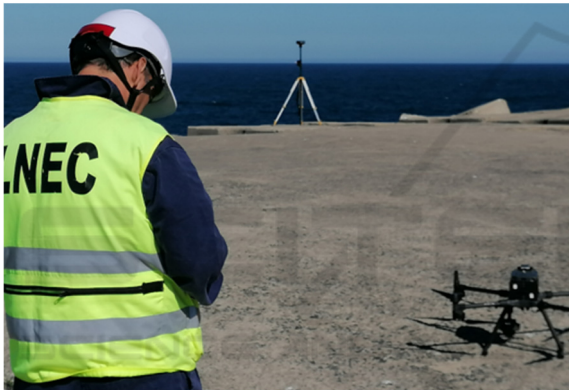
Figure 9: Preparing the flight on Sines west breakwater. Shown on top is the RTK GNSS antenna base.

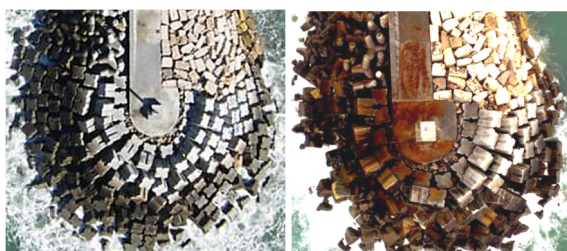
Figure 13: Head of Ericeira breakwater. Two orthomosaic extracts with five years of difference are shown.

To obtain it, following processing steps are used, in this order, and for each breakwater: point cloud computation, DSM creation (Figure 12). After the orthomosaic is generated (Figure 13).

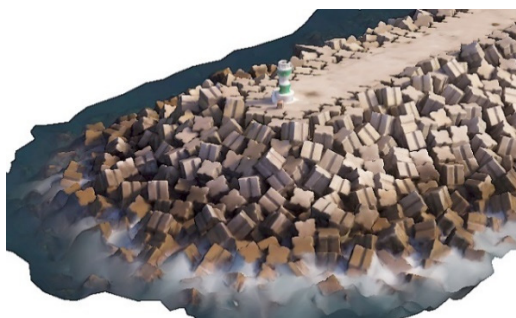
Figure 14: Mesh of the head of Sines east breakwater.

For presentation purposes, in reports, DSM are sometimes generated in the form of a mesh (Figure 14 and Figure 15).

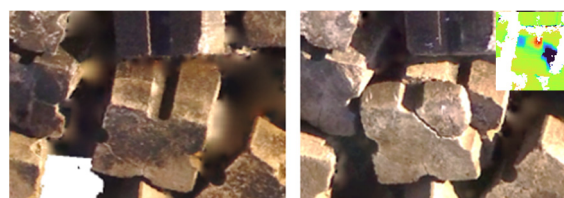
Figure 18: A block that broke.

This is the case of Figure 17 to Figure 20, that show extracts of orthomosaics and DSM that illustrate some of the detected changes. Differences between DSM are illustrated in colour to clearly identify relevant evolution.

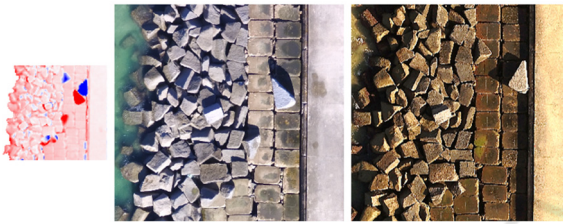
Figure 20: Displacements of blocks.

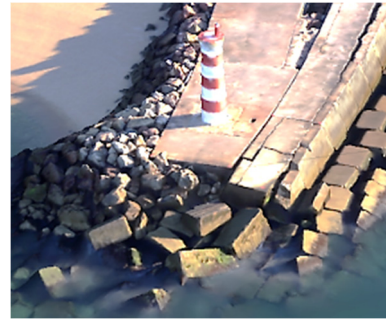
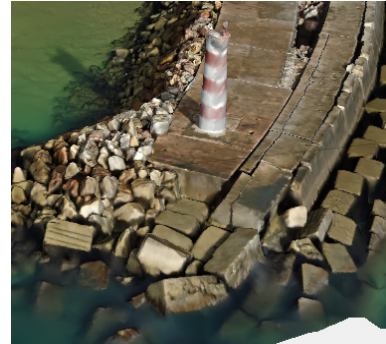
Figure 22: Meshes of Faro-Olhão west breakwater show the movements of the blocks.

Figure 21 presents the comparison of DSM of the head of Faro-Olhão west breakwater (2023-2018) and Figure 22 presents the two meshes produced by Metashape where one can easily see the changes in the position of the blocks and verify that the concrete structure of the crest is less protected.

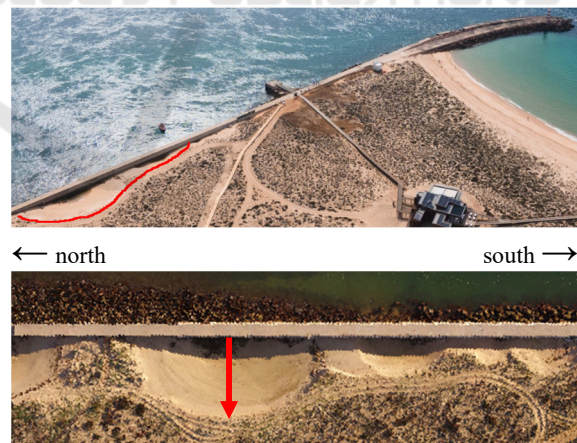
Figure 23: Faro-Olhão inlet west breakwater (aerial photo and orthomosaic). Indication of the area analysed situated on the north side. The red arrow shows the beginning and direction of the X axis of the graph of Figure 25.

Figure 23 shows the aerial photo and the orthomosaic at the Faro-Olhão inlet west breakwater. There, it can be seen the quite apparent (and, lately, quantified) erosion of sand in the northern area, on the land side, leaving the foundation of the breakwater exposed.

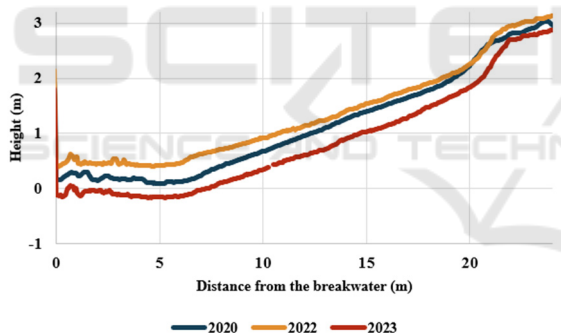
Figure 25: Profiles, starting from de breakwater, in the direction of land calculated in the lowest area.

Examination of the historical images available on Google Earth revealed that, in 2006, this problem already existed, although in a much smaller extent. As only planimetric information exists, the only values that can be obtained are distances. It was found that in 2006 the largest depression had an opening of 6 m. This area increased until it was clear, from the 2013 image, that, the depression stabilized. In 2023, the opening was 22 m, according to the DSM, as can be seen in Figure 25.
