**C2IMPRESS**

**D1.1: Analysis of past extreme events, lessons  
learned and SoA models V1**

**WP1**

**30 July 2023**

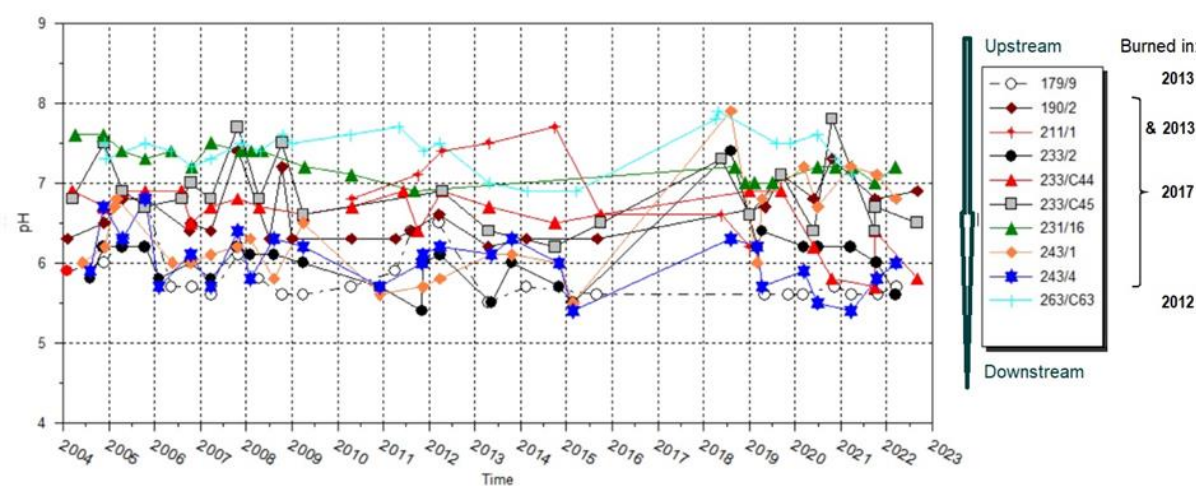
Figure 3: Variation of pH concentration in the groundwater of 10 wells located in burned areas of Mondego watershed.

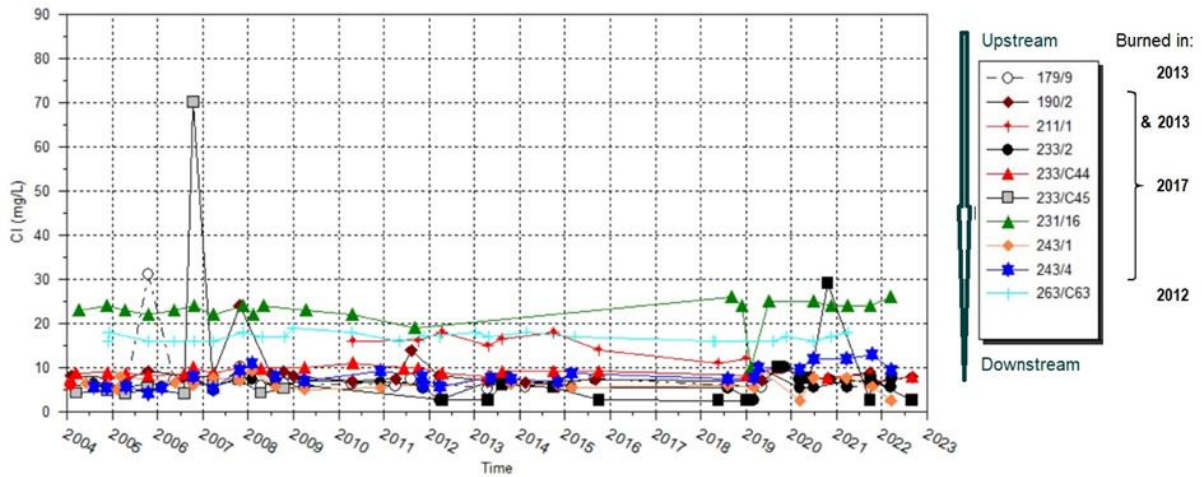
Figure 4: Variation of chloride ( $\text{Cl}^-$ ) concentration in the groundwater of 10 wells located in burned areas of Mondego watershed.

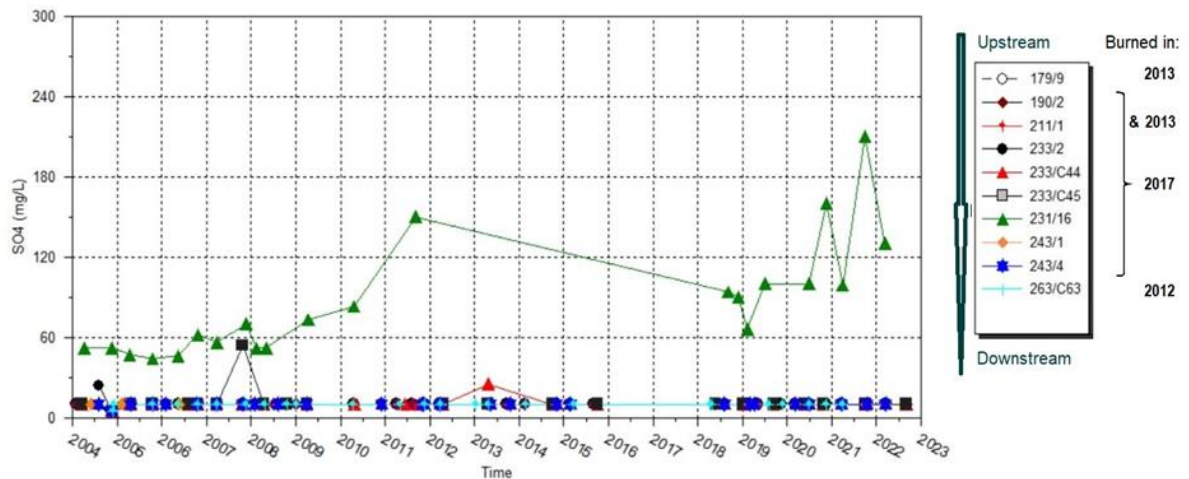
Figure 5: Variation of sulphate ( $\text{SO}_4^{2-}$ ) concentration in the groundwater of 10 wells located in burned areas of Mondego watershed.

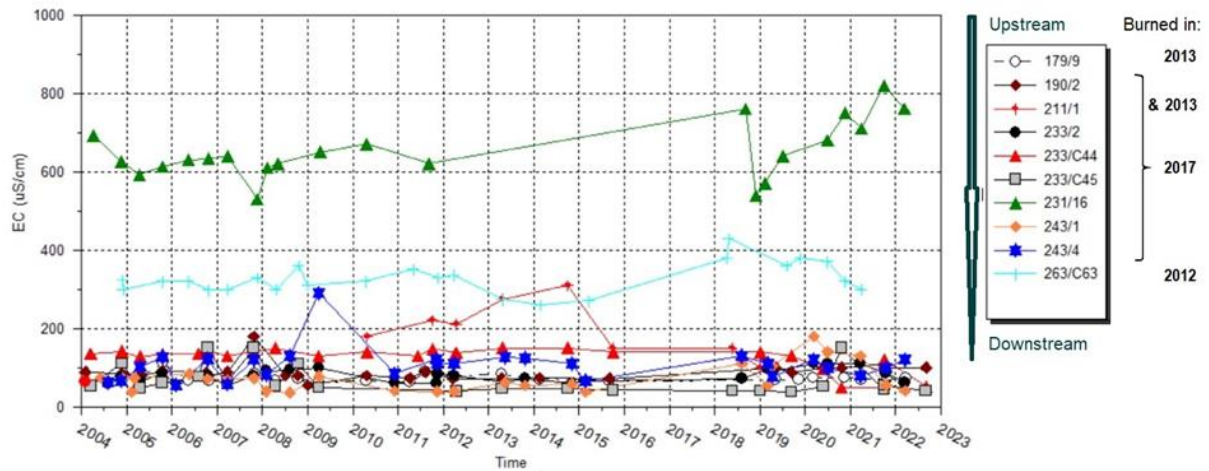
Figure 7: Variation of electrical conductivity (EC) concentration in the groundwater of 10 wells located in burned areas of Mondego watershed.

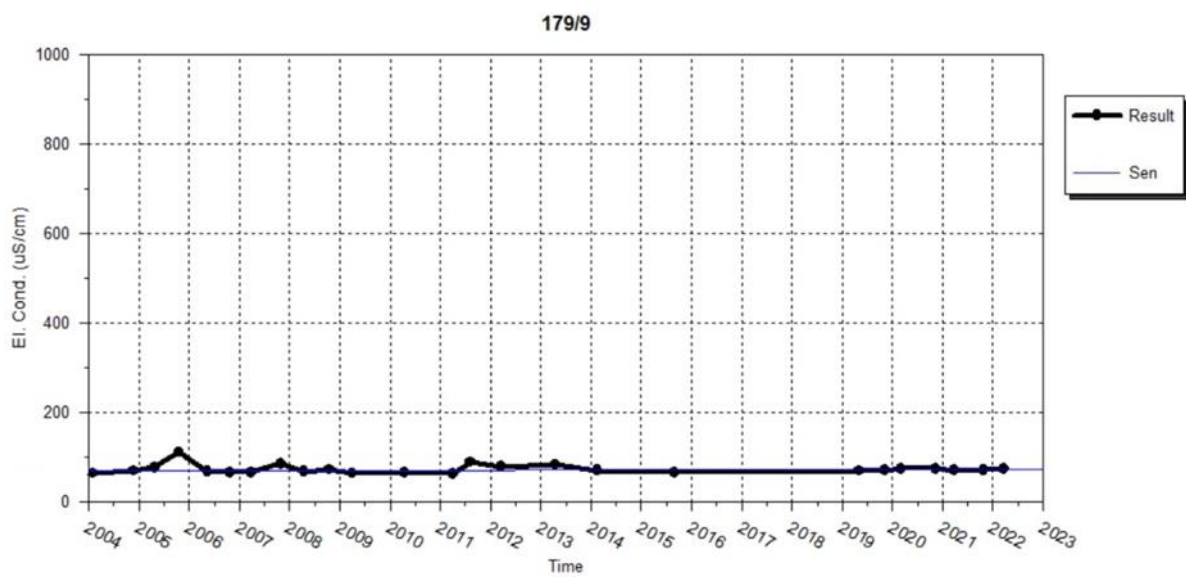
Figure 9: Increasing trend of EC (only MK Seasonal) in well 179/9 located in burned areas of Mondego watershed.

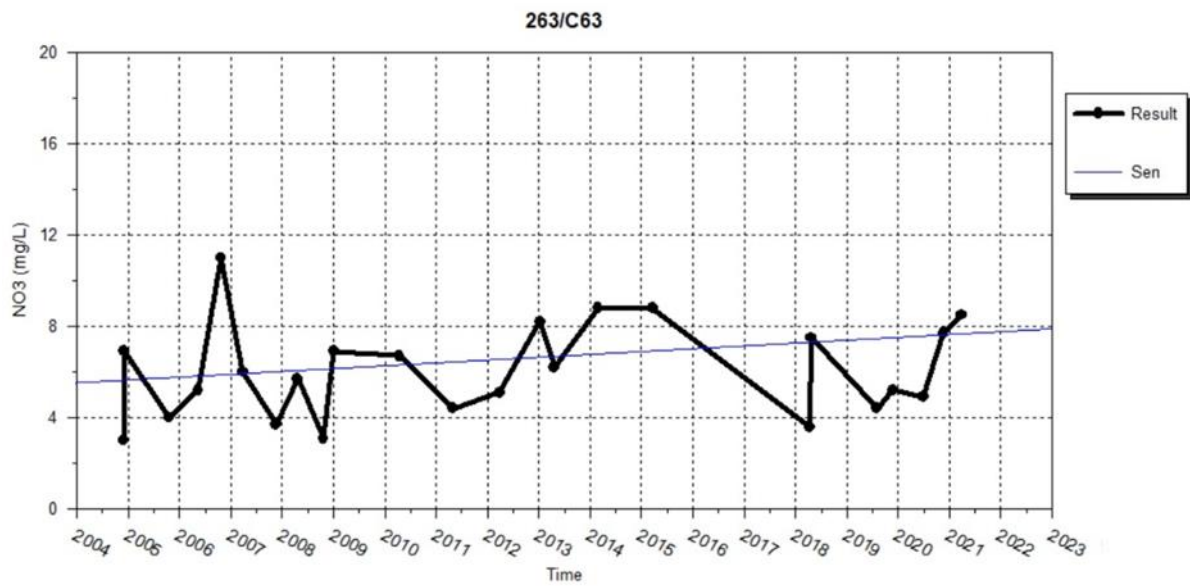
Figure 16: Increasing trend of nitrates (only MK Seasonal) in well 263/C63 located in burned areas of Mondego watershed.

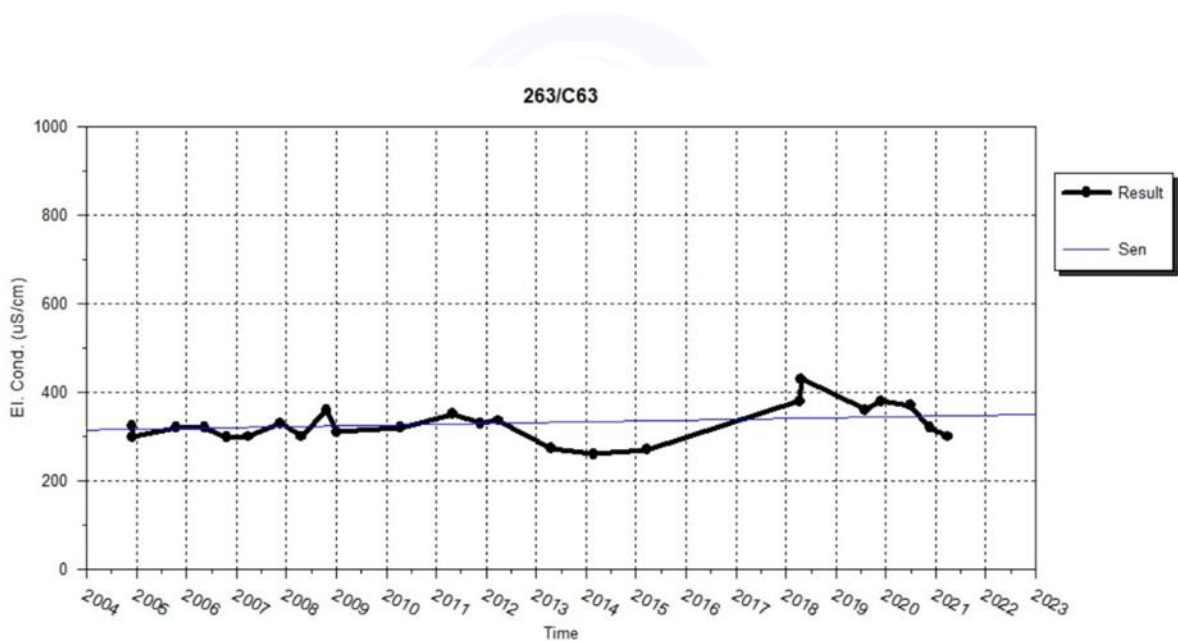
Figure 17: Increasing trend of EC (only MK Seasonal) in well 263/C63 located in burned areas of Mondego watershed.
