# Monitoring the state of conservation of Paimogo Fort - digital survey

**Abstract.** This article discusses and presents the methods and results of the digital survey carried out, in 2025, of Paimogo Fort, a military structure built in 1674 in the municipality of Lourinhã. The digital survey aims to safeguard and monitor the conservation state of this classified coastal heritage site. Paimogo Fort underwent a conservation intervention in 2024 to preserve and strengthen the values of its individual and collective memory, transforming it into a meeting point for the memories of local communities and as a source for recovering and bringing awareness of traditional knowledge within the region.

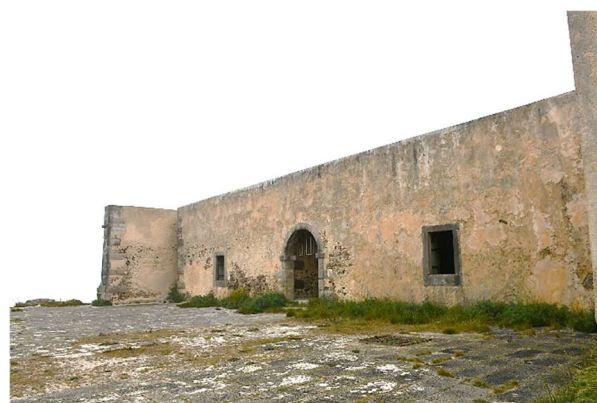
**Fig. 3.** Paimogo Fort, in 2021.

The fort comprises a single-storey masonry structure, constructed from irregular limestone and sandstone, sourced from nearby quarries, bonded using traditional air lime mortar. Both the interior and exterior surfaces of these walls were originally finished with successive layers of air lime mortars, providing both protective and decorative functions. The vaulted ceilings in the interior were built using porous clay bricks, also coated with air lime plasters.

The rehabilitation process began with structural consolidation by filling cracks with hydraulic lime grouts. Afterwards, the mortars applied in 2006 were carefully removed. After cleaning masonry surfaces, repairs of active water infiltrations were conducted, along with the construction of new water drainage channels and enhancements to the natural ventilation system. In addition, new windows were installed within the existing openings, preserving the original architectural configuration.

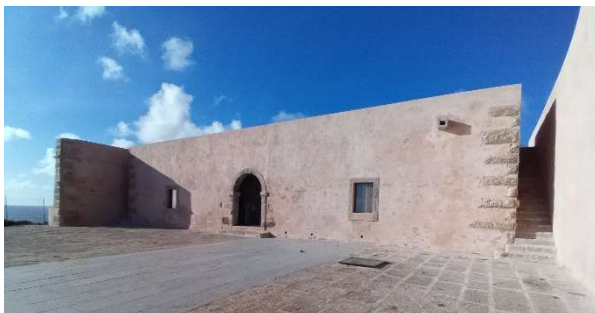
Fig. 4. Paimogo Fort after the intervention work, in 2025.

The new renders and plasters were applied in August 2024. Furthermore, for the exterior walls, in the finishing layer, an inorganic natural pigment, rich in  $\text{Fe}_2\text{O}_3$ , at 2% of lime weight, diluted in the mixing water, was added to the lime-based mortar selected [10]. This pigment gave to the render a pale rose tone (Figure 4).

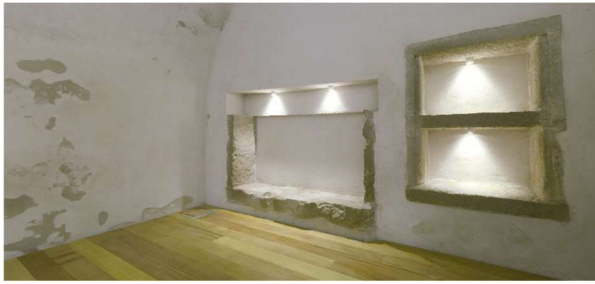
**Fig. 7.** The interior of a room, natural colour.

During the survey, the intensity of the reflected signal is automatically recorded for each point. This information can be used to colour the cloud (instead of the usual RGB colour). This is also useful for highlighting certain anomalies on the surface of the construction elements. An example is provided, featuring a wall depicted in natural colour in Figure 7, and in Figure 8 coloured according to the intensity of the reflected signal.

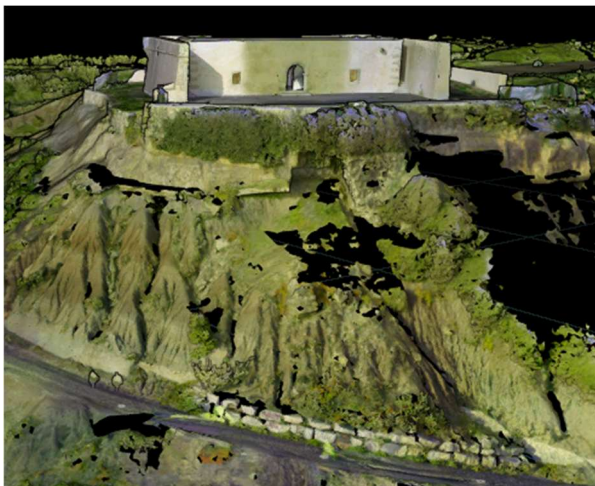
**Fig. 9.** 3D model of Paimogo Fort and cliffs seen from SW.

A 3D model of the fort and the cliffs was already created, based only on the TLS data. As the final (merged) cloud is not created yet, the 3D model of the fort and the cliffs (Figure 9) was developed using a lighter cloud. On the other hand, as the interior of the fort has been fully surveyed, the final 3D model was already created as exemplified for one of the rooms in Figure 10.

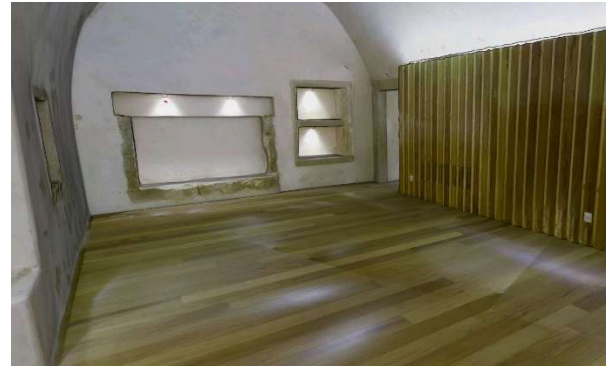
**Fig. 10.** 3D model of one room of Paimogo Fort.
