In-depth investigation and reconstruction of bus accidents: lessons from a 17 fatalities accident

Characteristics of the bus accident at km 77 of motorway A23

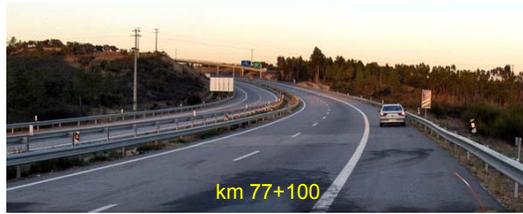
The accident occurred on the 15th November 2007, at late afternoon, near km 77.200 of the Portuguese A23 motorway (Figure 2). The weather and visibility conditions were good; the wind was not strong.

Figure 2 – Overall aspect of A23, on the approach to the accident site

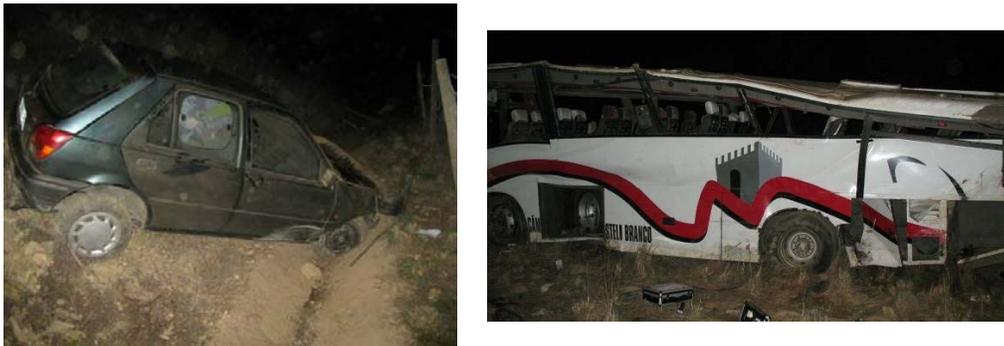
The accident involved a Ford Fiesta 1.1 passenger car (with four occupants) and a MAN model 13.230 HOCLA 206 bus (37 occupants); injuries (17 fatalities and 20 serious injuries) were produced in the bus only. Figure 3 presents the vehicles in their final rest positions.

Figure 3 – Overall aspect of the vehicles involved in the accident

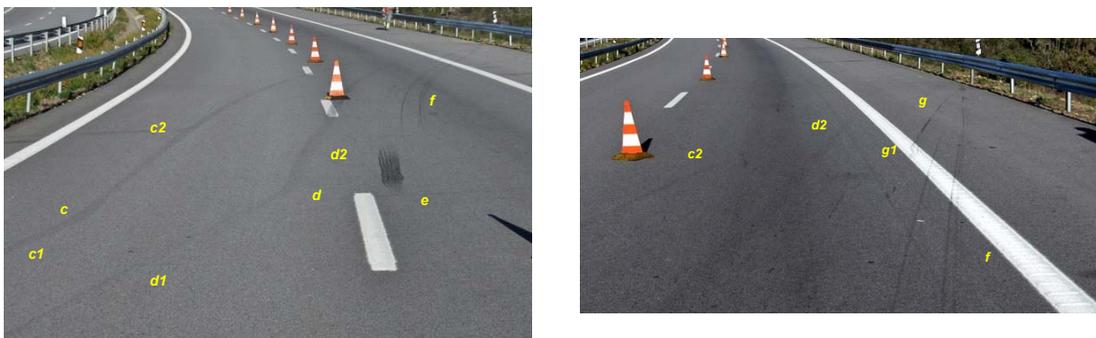
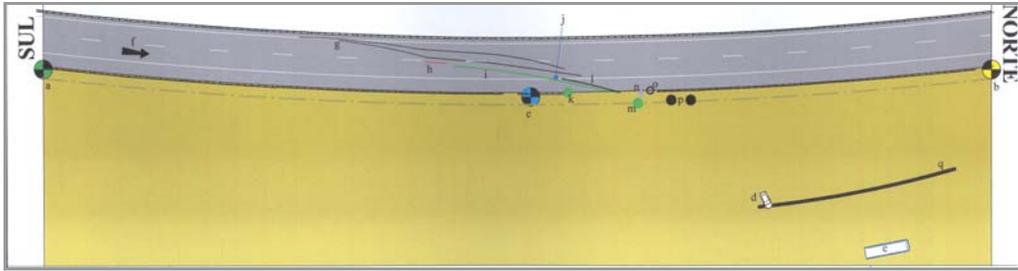
Figure 4 – Tire marks in the pavement surface and map of reported evidence on the road environment

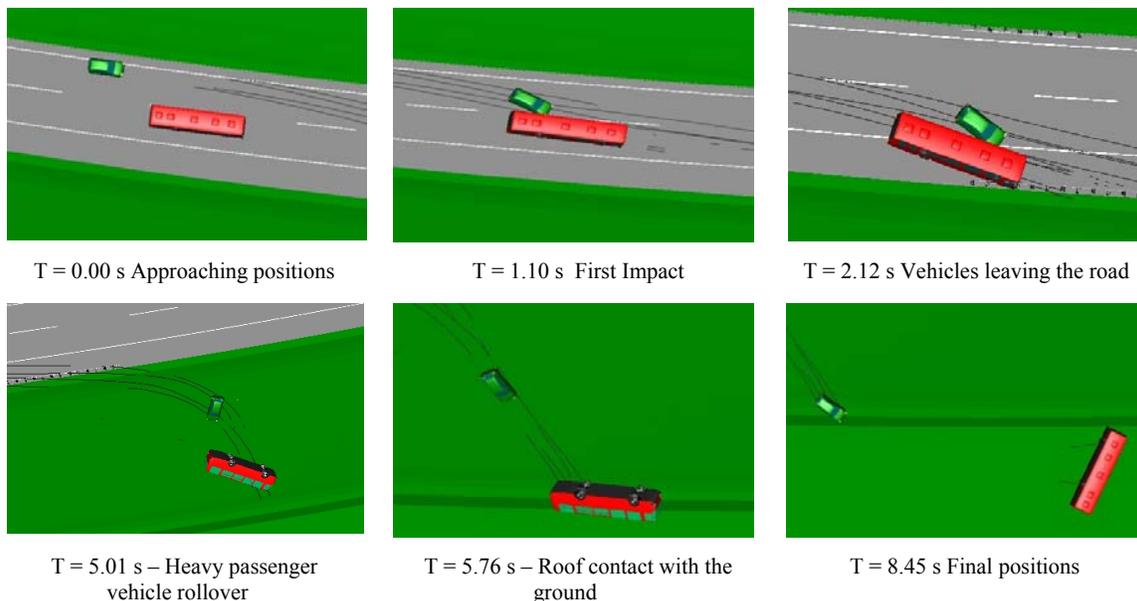
The accident scenario that fits all the tyre evidences on the road and vehicles, the sequence of events started with a passing manoeuvre by the passenger car, in which the driver lost control of its vehicle when passing over the left rumble guideline, due to the combined actuation of the steering wheel and the brakes; the car skidded to its right, towards the centre of the carriageway and collided with the bus rear left panel, hitting in the process the outer left rear tire, which deflated suddenly. At the time of this impact the bus was in the right lane, almost on top of the carriageway centre, smoothly leaning to the right side of its lane. Then the passenger car rebounded and for a few metres travelled sideways with the bus, until it collided again with the bus, this time with the left front wheel. Afterwards, both vehicles slipped to the right roadside, where the bus crushed the lateral restraint system; at the same time, the car passed over the barrier. Both vehicles run over the embankment slope where the bus overturned laterally, hitting the ditch and crushing the rear body structure; the passenger car stopped after colliding with the ditch.

Figure 5 – Computer simulation of side impact followed by rollover.

The sequence of events is presented in Figure 6.

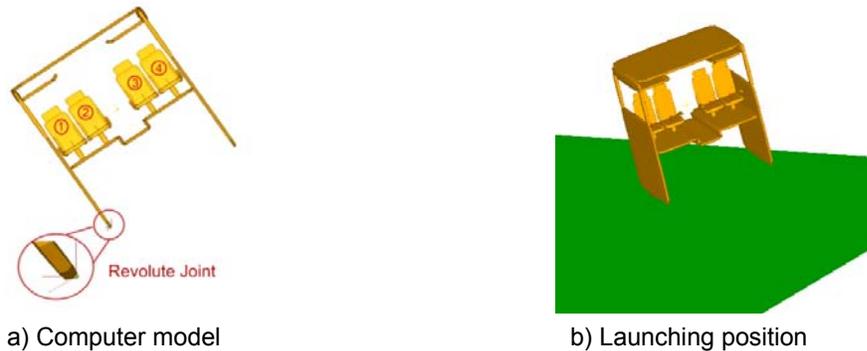
A study at three dimensional sections, departed from the ends of the vehicle, as represented on figure 3a was carried out. This kind of section is commonly used in simulations with passenger heavy vehicles, on one hand because it allows an important economy of processing time and on the other hand because it achieves precise results.

The positions are numbered from 1 to 4 in order to identify the anthropomorphic models easily. Regarding launching position the model was placed on the beginning of the higher altitude of the slope with an initial rotation velocity of 0.6 rad/s (figure 3b).

Figure 6 – Computer model of passenger heavy vehicle.

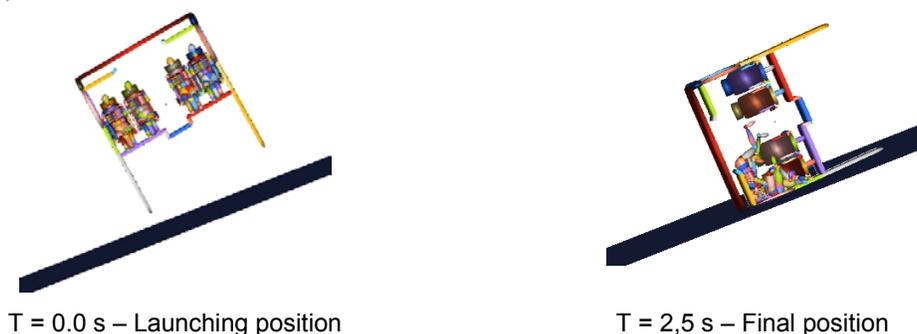
This test has the particularity of permitting the analysis of anthropomorphic models dynamic in the rollover event and where the operation of the two-point safety belt was considered inefficient. It should be remarked that it is within this test that the passengers most interfere in one another injuries. (Figure 4).

Figure 7 – Simulation dynamic photogram's.

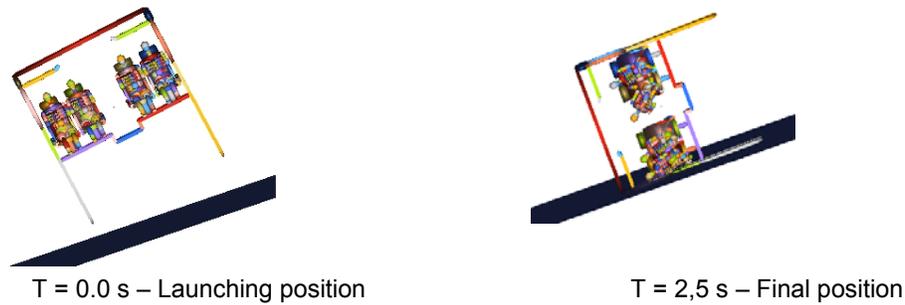
This test enables to observe the anthropomorphic models in the rollover event with a proper use of the two-point safety belt by the passengers. In this case one can notice that any of the models left their seat place. (Figure 5).

Figure 8 – Photogram's of simulation dynamics.

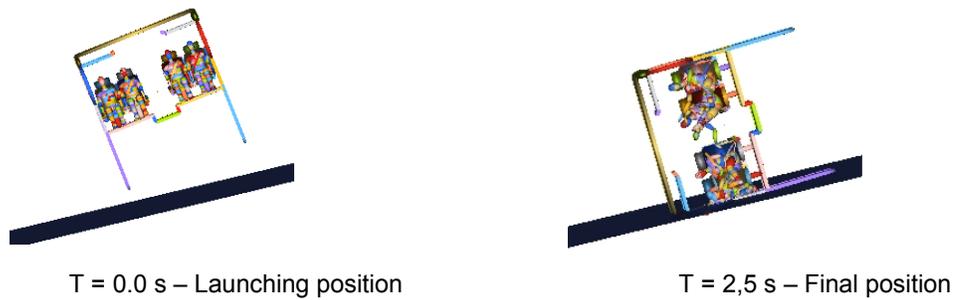
In what concerns this test and similarly with the test of the two-point safety belt it was possible to determine that any of the anthropomorphic models were not ejected from the occupied position (figure 6). The advantage in using the three-point safety belt lies in the possibility of retention of the chest region. It should be highlighted that in this case were used the anthropomorphic models *Hybrid III* because they include defined contact features for the thorax.

Figure 6 – Photogram's of simulation dynamics.
